Incident and Injury Investigation Report

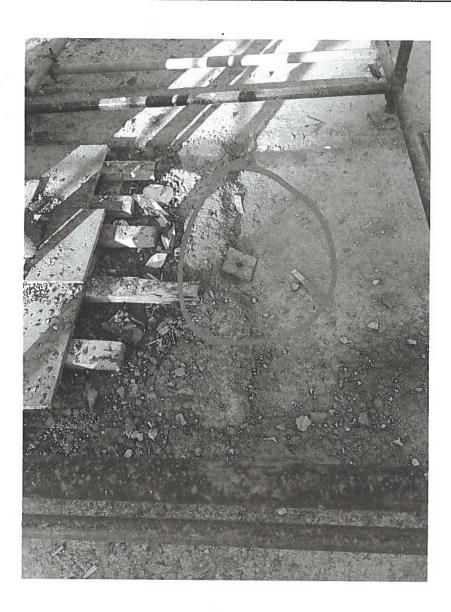
Workplace: Loose material kept on platform by worker. Open gaps on the platform.						
	Elimination: N/A						
	Substitution: N/A						
Corrective Action to prevent reoccurrence:	Engineering Control: All gaps on the platforms must be closed						
	Administrative Control: Proper housekeeping after finishing the work. Area from downside must be barricaded with proper signage. While work at height, Depute one person downside to monitor the access.						
	PPE: Necessary PPEs at site must be worn.						
Were there any	NY.	Type of					<u> </u>
witnesses?	None	witness/s				Public	
Witness Details			Badg Num		lobile umber		
Witness Statement:

Additional Details:
