Incident and Injury Investigation Report

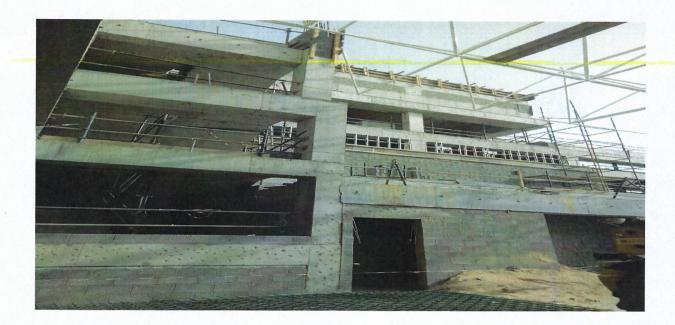
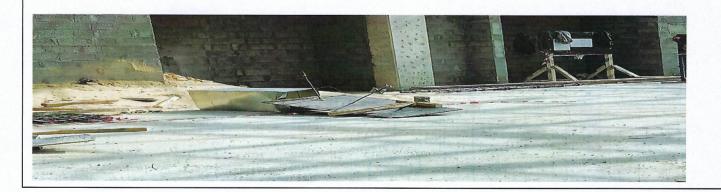
Name of Employee	Hussain Gindi Ramadar	ussain Gindi Ramadan Farag Badge No. 30040448			Actual Severity:	3			
Safety Awareness Training Date	2/14/2019		Proof of Induction Training		Worst Potential Severity:	3			
Name of Line Manager	Sherif Ismail Fahmi Moh	amed Ay	Badge No.	30104097	Profession/ Designation		Sr.Engineer Civil		
Name of Supervisor	Ehsan Ahmad		Badge No.	30038473					
Division / Department	Civil Department		Project Name	097-C76 R	Project Location	JUC	JUC		
Place of the Incident/Injury	Sports Centre		Date of Incident	3/8/2021	Time of Incident	02:05 PM	02:05 PM		
Nature of the Incident/Injury	Occupational Incident/Injury		No	Near Miss Other, Pleas		e specify :			
	Road Traffic Incident/Injury	I	No	Yes					
Brief Description of the Incident/Injury Details of the Injury	space frame struct plywood removed property damage Injury /Accident.	from th	e tie rod a	nd fell down fi	rom the sec	ond floor no

Was Pre- Task / Toolbox meeting conducted		Yes		Was the perequired Protective (PPE)	ersonal	Ye	es		
Specify the Personal Protective Equipment (PPE)			Helmet, saf	safety shoes, vest, gloves and goggles					
What was the injured p of the incident?	erson/employee do	ing at	the time	N/A					
What was the machine/equipment doing at the time of the incident?			NA						
What was the material, the incident		ng at t	he time of	Shutte	ering of Colur	nn work			
Immediate Cause/s of to During shuttering of col-		ood wa	s not secure	d prope	erly.				
	Paopla Worker n	ot naid	l attention v	while f	iving chutto	ing of solven			
Root Cause/s of the Incident/injury:	People: Worker not paid attention while fixing shuttering of column. Process / Procedure: Shuttering plywood was not secured properly.								
	Equipment: N/A								
	Workplace: Safe platform was not provided for the shuttering work. Downside work area was not barricaded properly.

Elimination: N/A								
Corrective Action to prevent reoccurrence:	Substitution: N/A								
	Engineering Control: Ensure to provide safe platform for shuttering works with columns. Ensure the plywood using for shuttering works must be secured properly.								
	Administrative Control: Ensure trained and competent people only perform shuttering work. Ensure proper supervision for the work. Ensure downside area properly barricaded all time during shuttering of column works.								
	PPE: Ensure to use all required ppe, s during shuttering of column works.								
Were there any witnesses?	None		Type of witness/s	Emp	loyee		Public		
Witness Details -				Badg Num		Mobile Number
