REZAYAT GROUP Health and Safety

Initial Incident/Accident Report

Fill the Information Below								
Company: Rezayat Cmpany Limited						Date: 10/29/2021		
Location: Al Ula					Tir	Time:		
Project / Site Name: Ouran Charity Hotel Facade design and huild						orst Potential Severity: 5 tual Severity: 1		
Person(s) Involved:	X	Employee		Contractor		Others

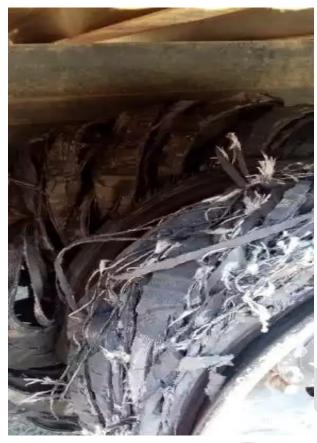
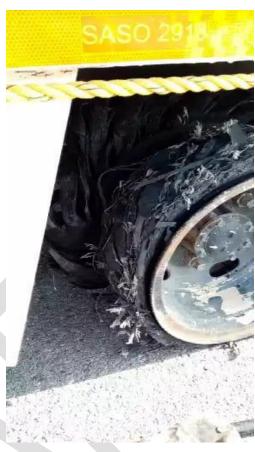
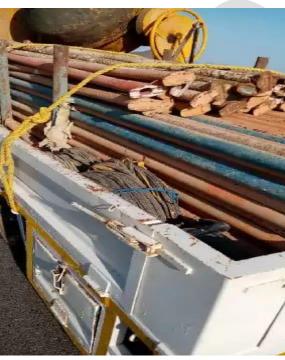
-								
On 20 Oct around 2 20nm	1+ k	as been reported by Dyna	dri	vor Mr Shazaman that	t hath tha	tires on rear left side of ve	hiclo	
On 29 Oct around 3.30pm, It has been reported by Dyna driver Mr.Shazaman that both the tires on rear left side of vehicle

# 7402 VHA were burst out in the middle of road during the travel from Yanbu to Al ula. This happens due to heavy load on								
left side of the vehicle as p	er (driver and Auto workshop	Fησ	ineer				
iere side of the vernere as p	<i>.</i>	anver una riato wontonop	6	incer.				
Immediate Action(a) Taken to Drayant Decompress (If Ann).								
Immediate Action(s) Taken to Prevent Reoccurrence (If Any):								
Reported to Auto workshop Engineer for replacement of tires.								
Advised the driver to place warning triangles								
	1							
Person Created the Report:
