Memorandum

SUBJECT: Dolomite Inc. (Facility I.D. #FL0101192)

## Memorandum

SUBJECT: Dolomite FL0101192 - Jackson County; Site Inspection

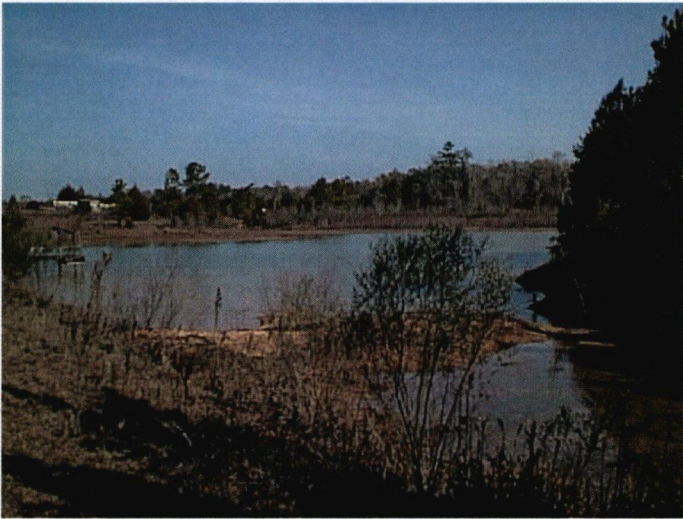
4. The runoff from the southeastern half of the plant processing area consists only of storm water, some of the storm water contacts stored piles of dolomite. The stormwater flows overland into two sediment basins #4 and #5 and stormwater from basin #4 flows into basin #5. Basin #5 (photo 1) discharges via a standpipe (photo 2) into the first of the lakes (photos 3 & 4) via a standpipe at the southwest end of the basin.

1. Basin #5 looking northeast from the discharge end.

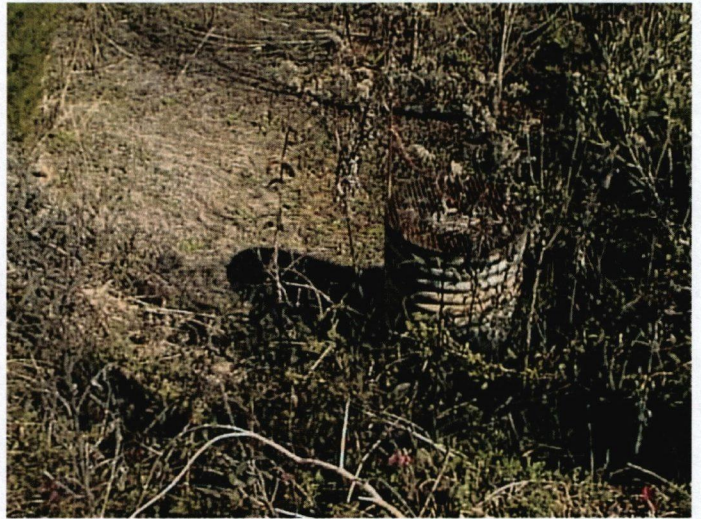
2. Basin #5 discharge standpipe - southwest end of basin.

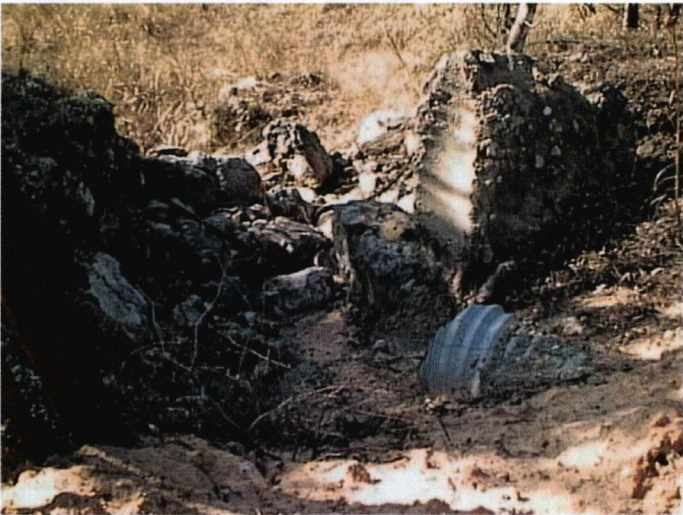
3. Basin #5 discharge pipe to the "lakes".

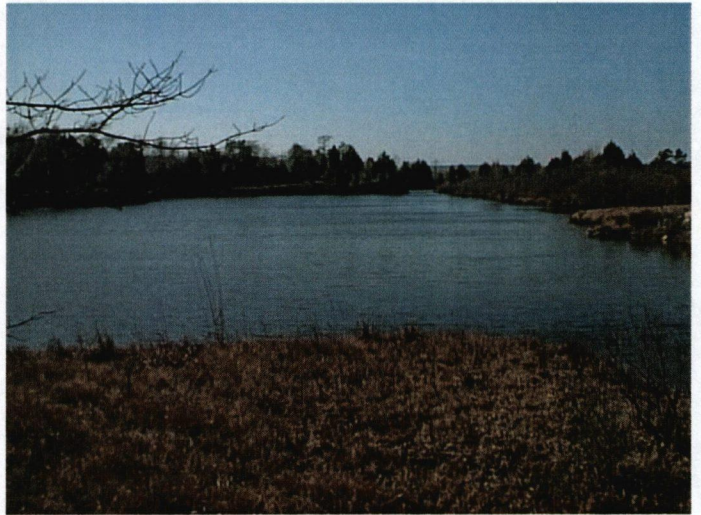
4. The first "lake" looking southwest from Basin #5 discharge.

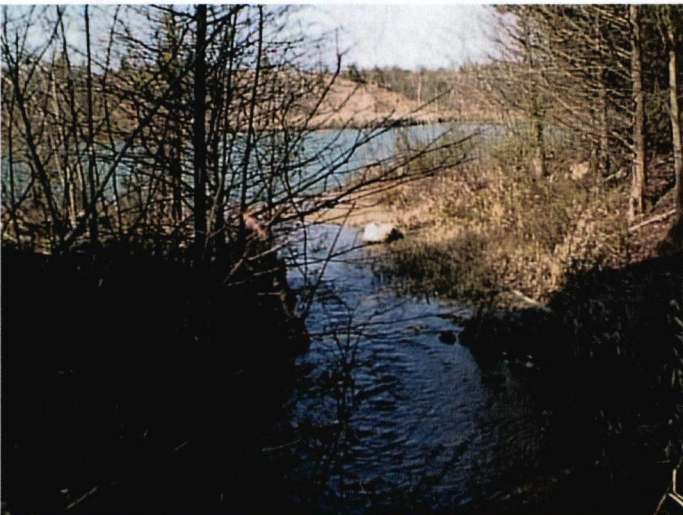
5. The unpermitted discharge (photos 5, 6 & 10) appears to be a continuous flow of clear (photos 7 & 11), spring water from the lakes. It discharges into Rock Creek (photos 8 & 9) which empties into the Chipola River (photos 17 & 18). The volume of flow without storm water augmentation appears to be somewhat greater than the flow from the permitted mining operation discharge (photo 16).

6. The permit application for this facility indicated that the water from the lakes flowed into the mining quarry and exited via the permitted outfall. The inspection indicates that the spring water from the lakes has discharged at the unpermitted discharge point for a considerable time. The banks around the lakes are far too high for any overland flow into the mining quarry to occur. Therefore the previous flow data for the mining operation did not include the flow from the lakes and the stormwater discharge from the plant administrative and processing area.

5. Unpermitted discharge from second "lake" looking northwest toward the "lake".

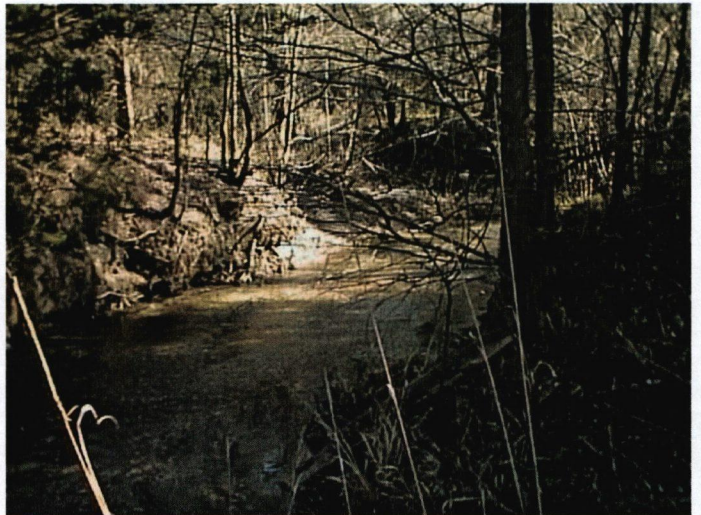
6. Unpermitted discharge from second "lake" looking southwest toward Rock Creek.

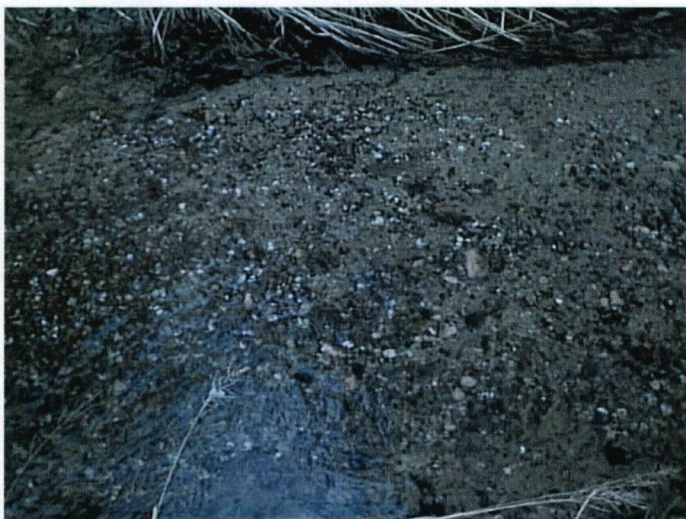
7. Clarity of unpermitted discharge (at position in photo #5).

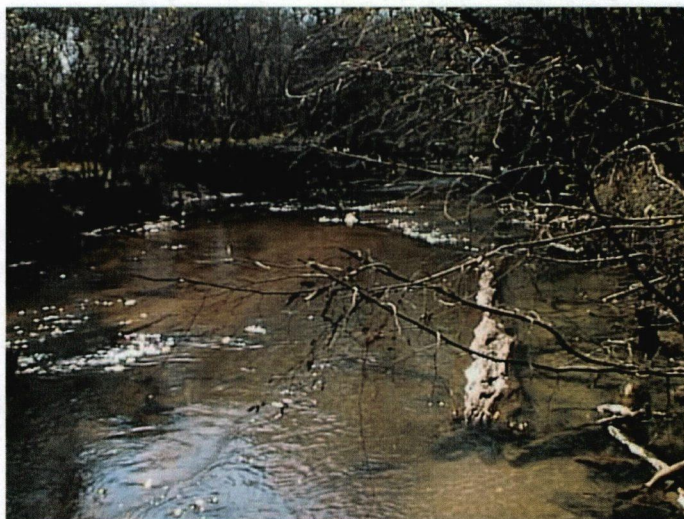
8. Rock Creek where discharge enters - looking downstream toward the southwest.

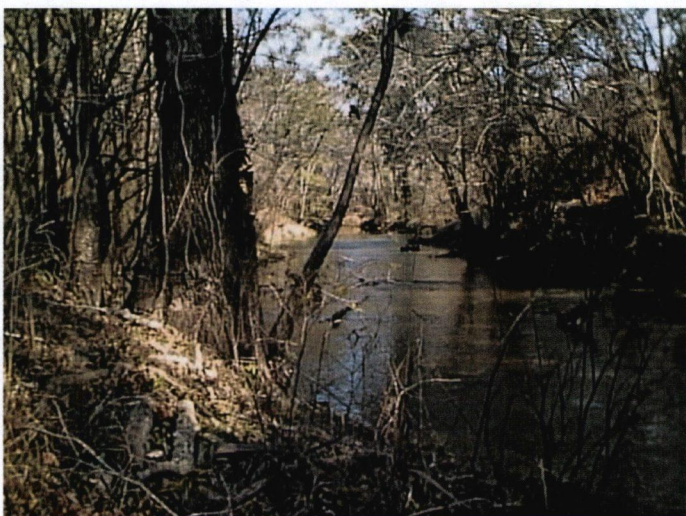
9. Rock Creek where discharge enters - looking upstream toward northeast.

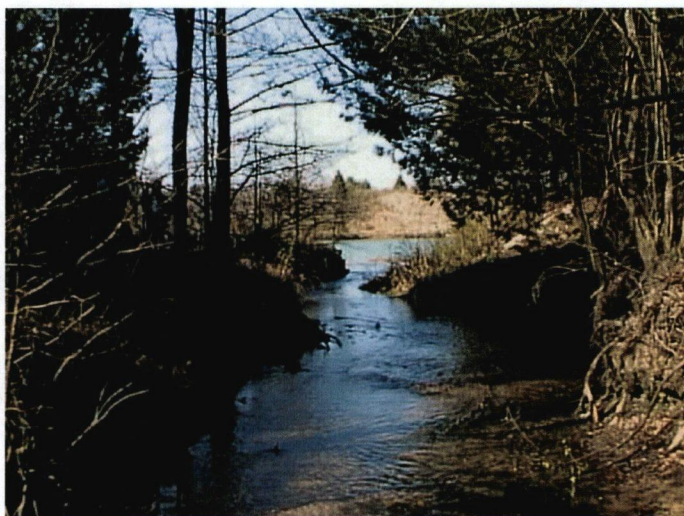
10. Discharge - looking from entry point at Rock Creek toward the northwest.

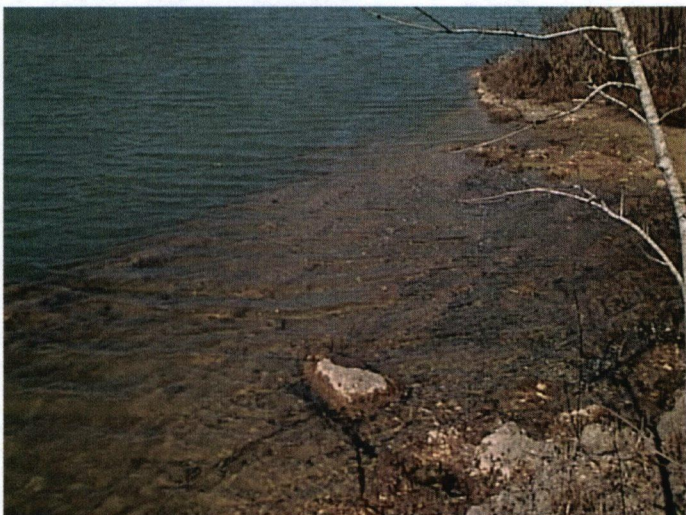
11. Discharge - point of exit from "lake".

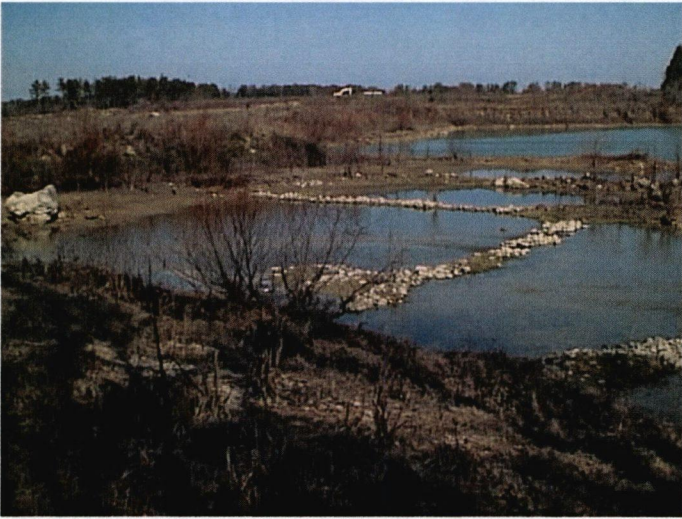
13. Mine operation - sediment treatment system - riprap

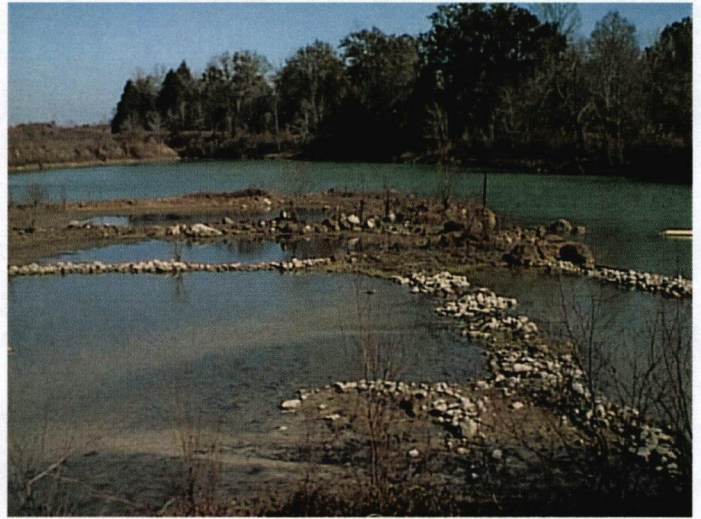
14. Mine operation - sediment treatment system - riprap

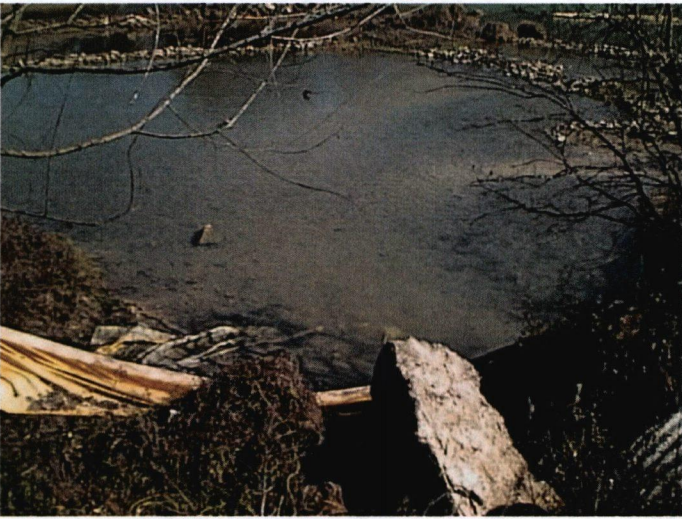
15. Mine operation – silt screen down.

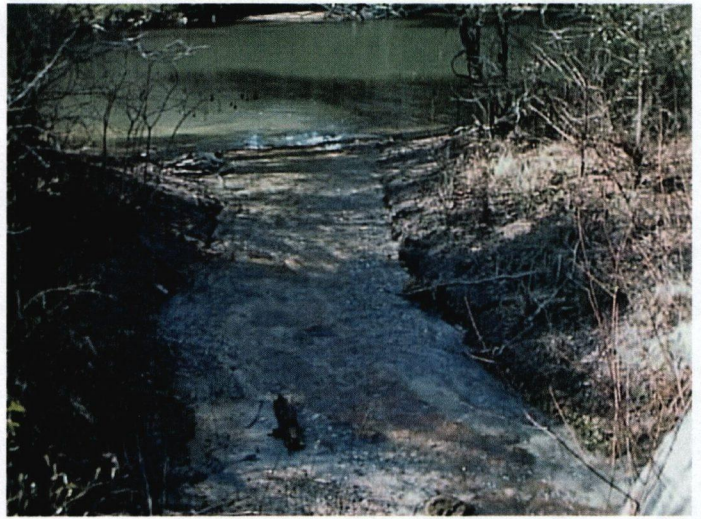
16. Discharge (D-001) to Chipola River (pipe - lower left corner)

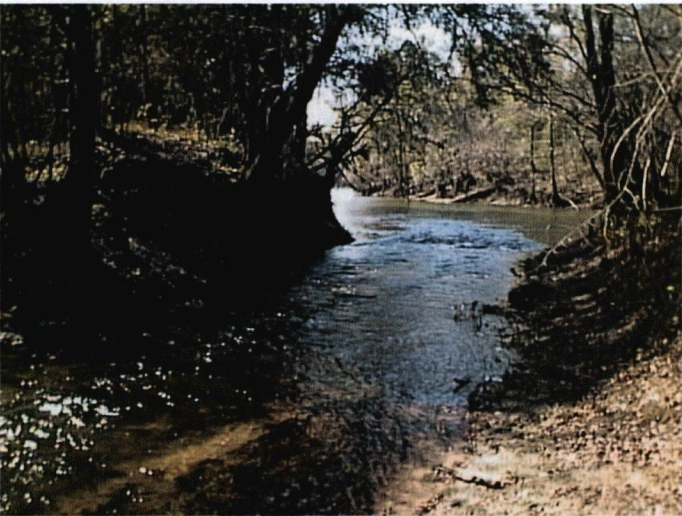
17. Rock Creek discharge into Chipola River

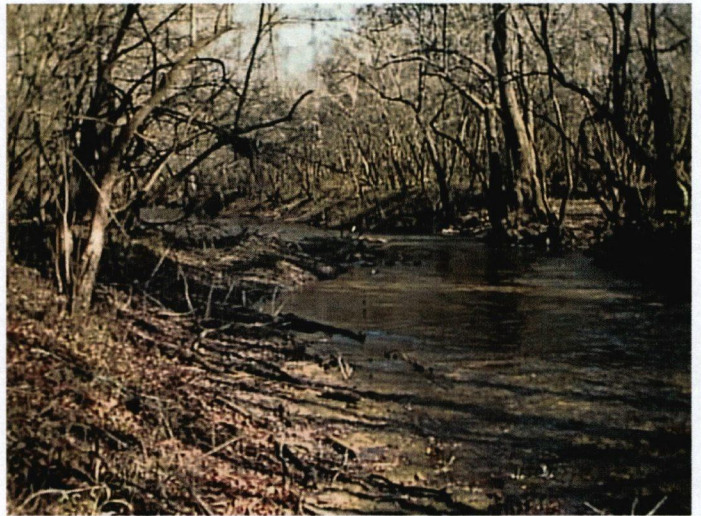
18. Rock Creek looking upstream from Chipola River

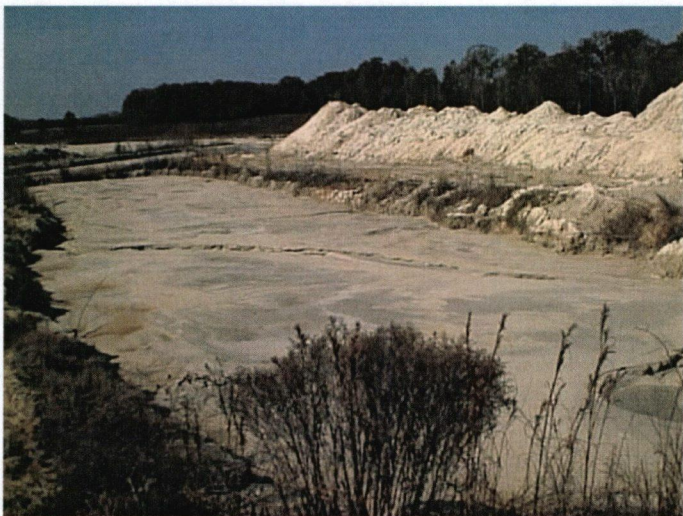
19. Sediment Basin #2 for rock crushing operation

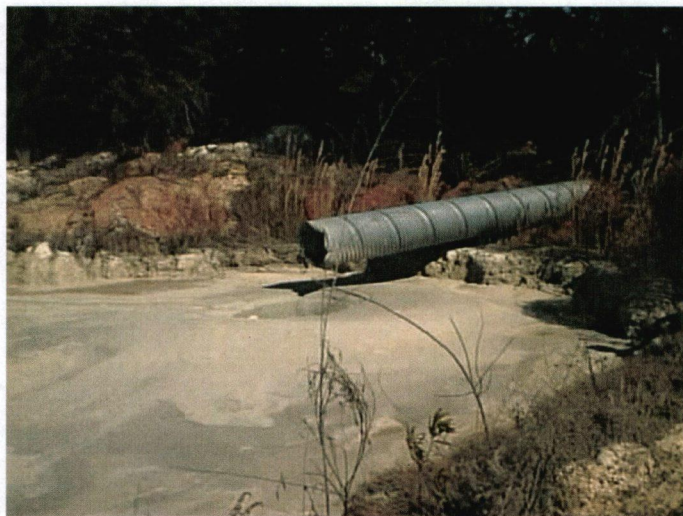
20. Sediment Basin #2 discharge pipe

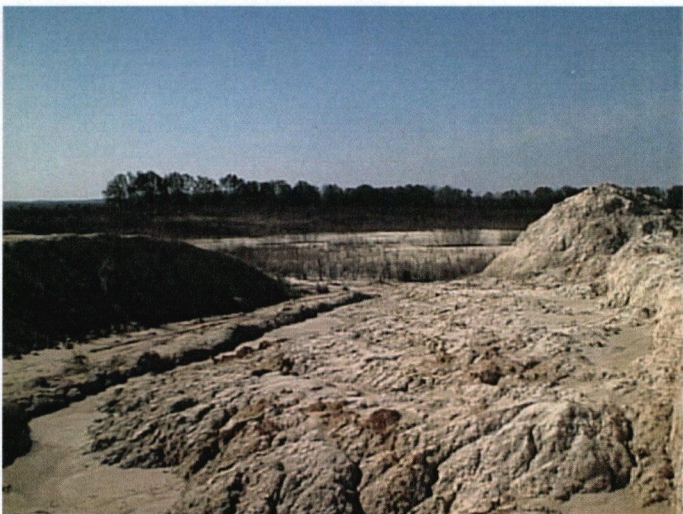
21. Reclaimed material from sediment basins;  
note overland flow area in background.
