**RE: Rocky Creek Mine DEP File No. MMR\_215039 – Site Inspection Report**

Project: Rocky Creek Mine  
Date: May 16, 2023  
Attendees: Bethany Carrell and Christine Keenan – DEP;  
David Thompson – Dolomite  
Location: Jackson County

# Rocky Creek Mine

## May 16, 2023 Inspection Photos

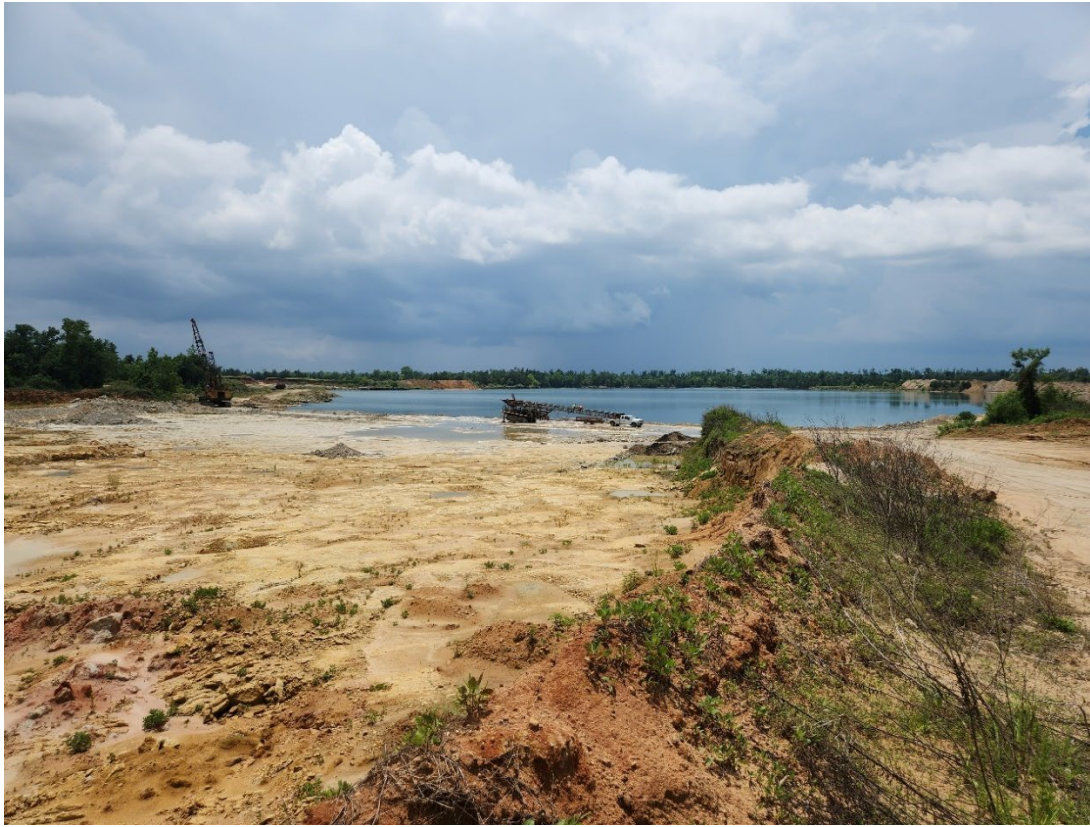
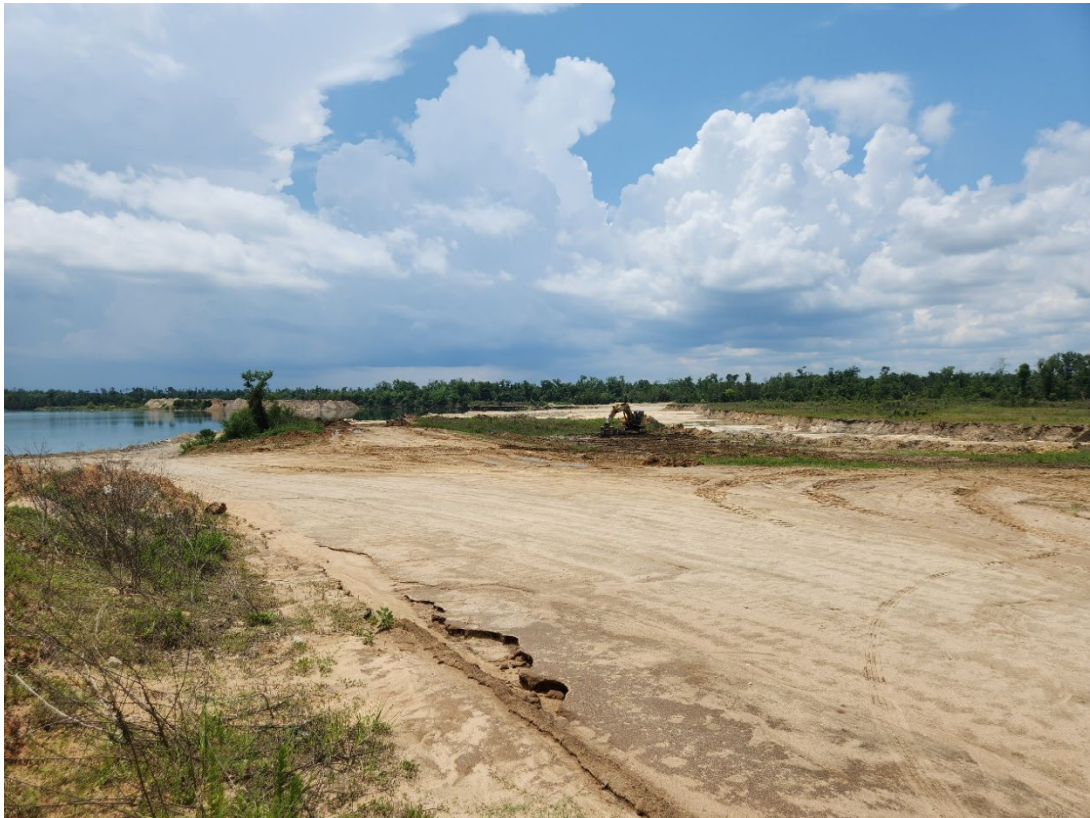
Point 2: Facing

- The Department observed preparations for blasting happening at Points 2 and 9 and removal of overburden at Points 2 and 10.
- Dolomite stated they wet mine with a dragline about 40 feet deep and about 3-3.5 acres are mined each year.

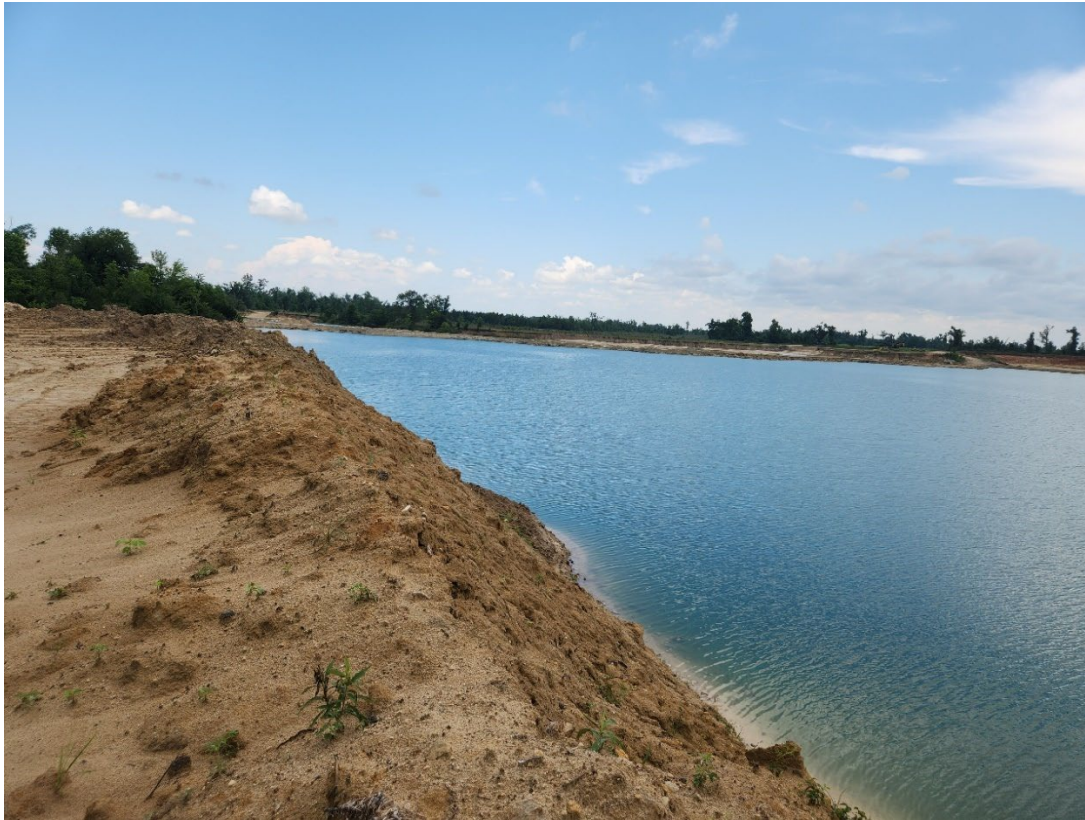
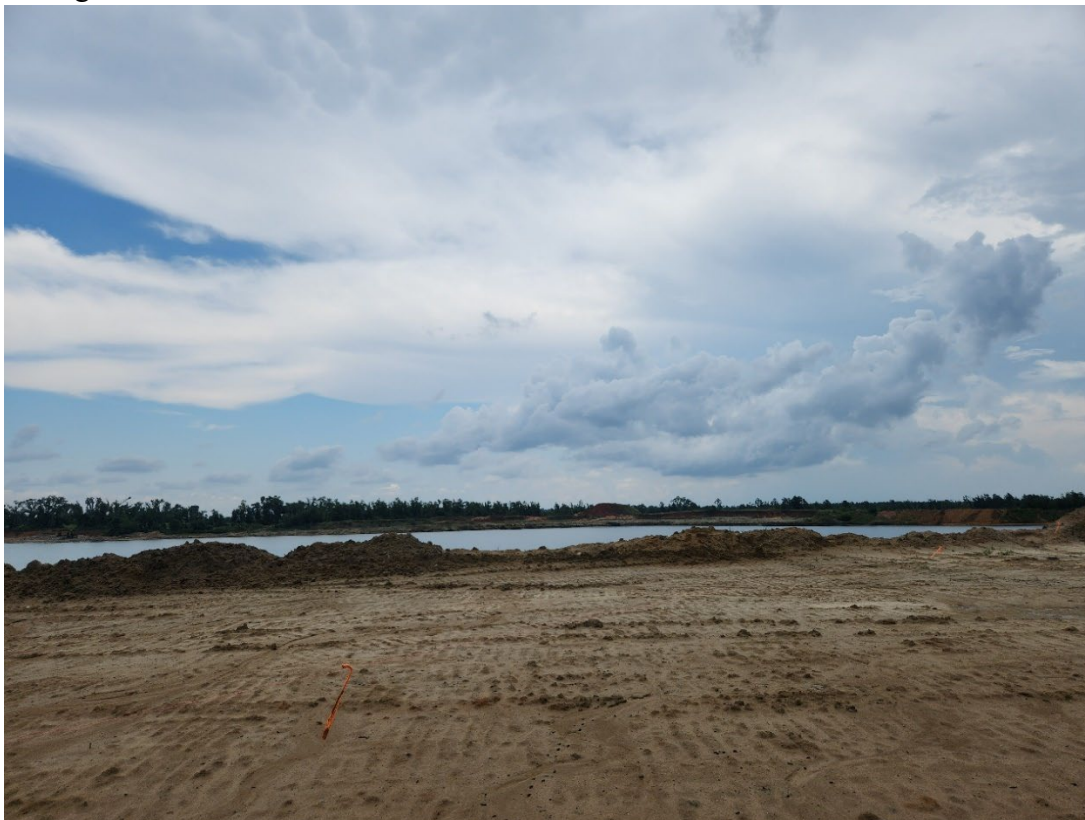
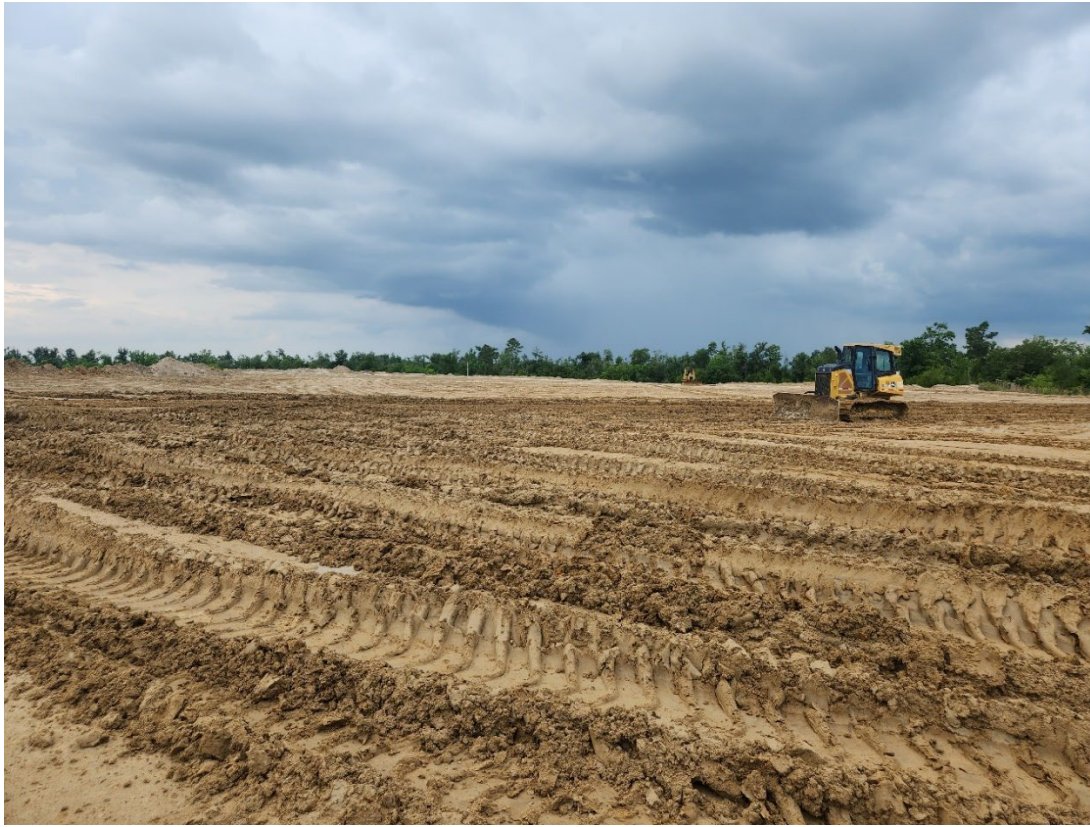
Point 4: Facing north

- The Department observed evidence of sediment inadvertently running off the road toward the river at Point 5 due to no BMPs being utilized.
- Dolomite stated overburden is dumped into pond (Point 4) and used to backfill areas and then slope these areas to no greater than 4 feet vertical to 1 foot horizontal when done. Dolomite stated they will begin reclamation when mining is complete.

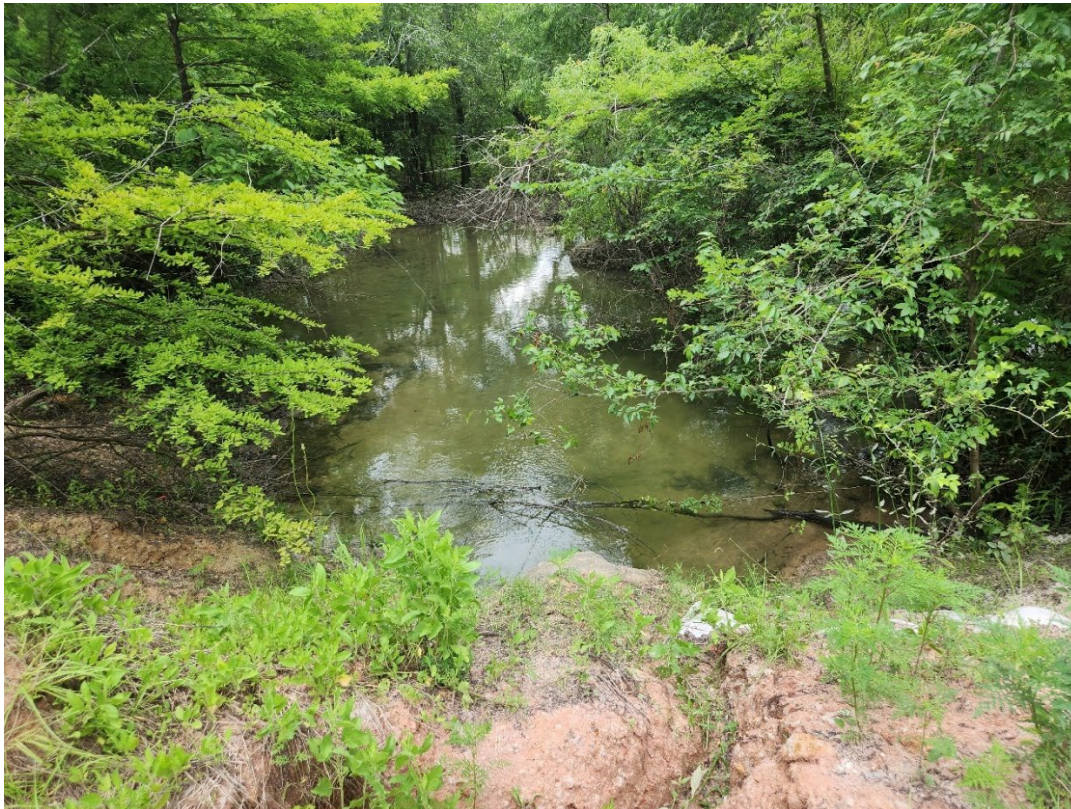
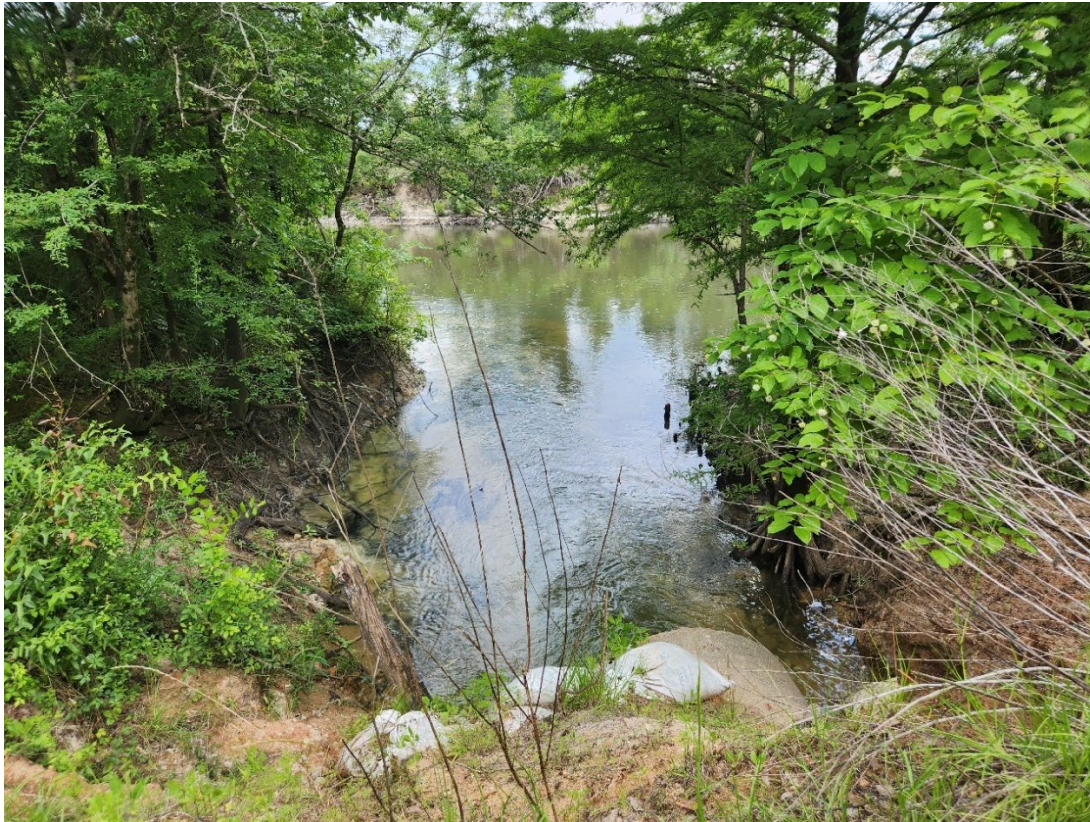
Point 7: Facing east

- The Department observed the outfall to the Chipola River at Point 7 and connection to the pit at Point 8.
- Dolomite stated that the stockpile of red sand at Point 12 is sold off.

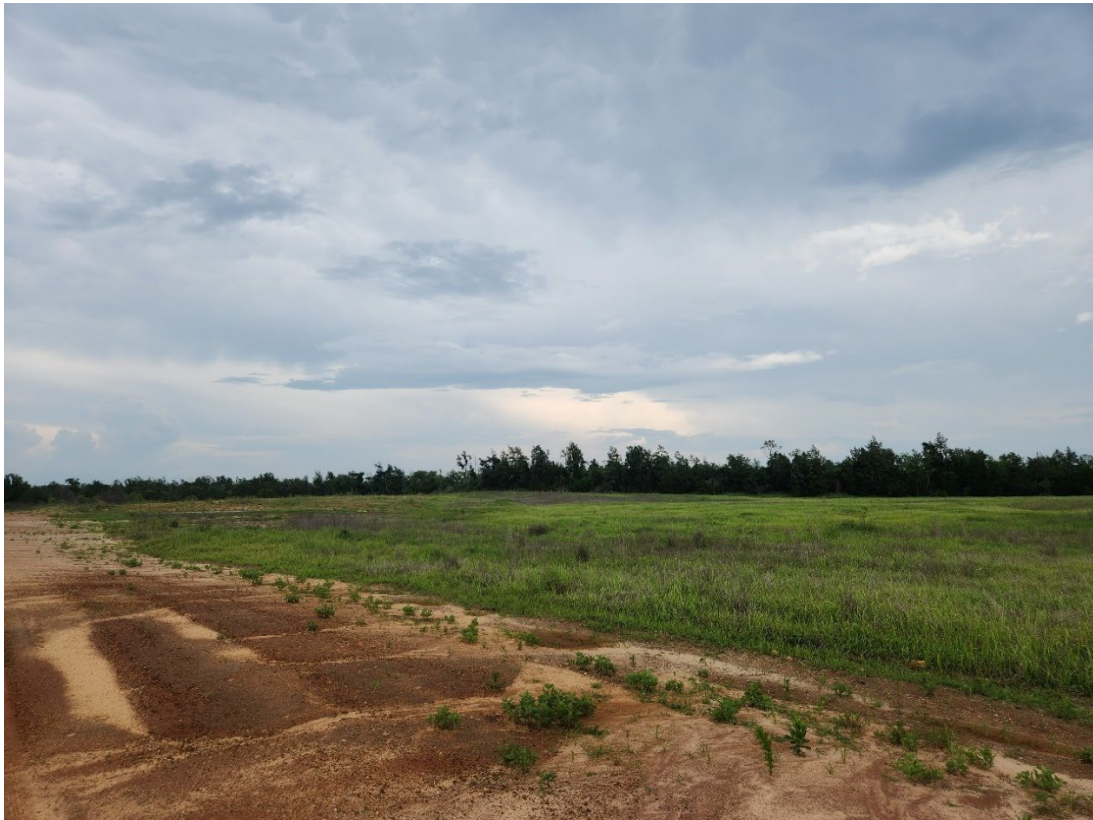
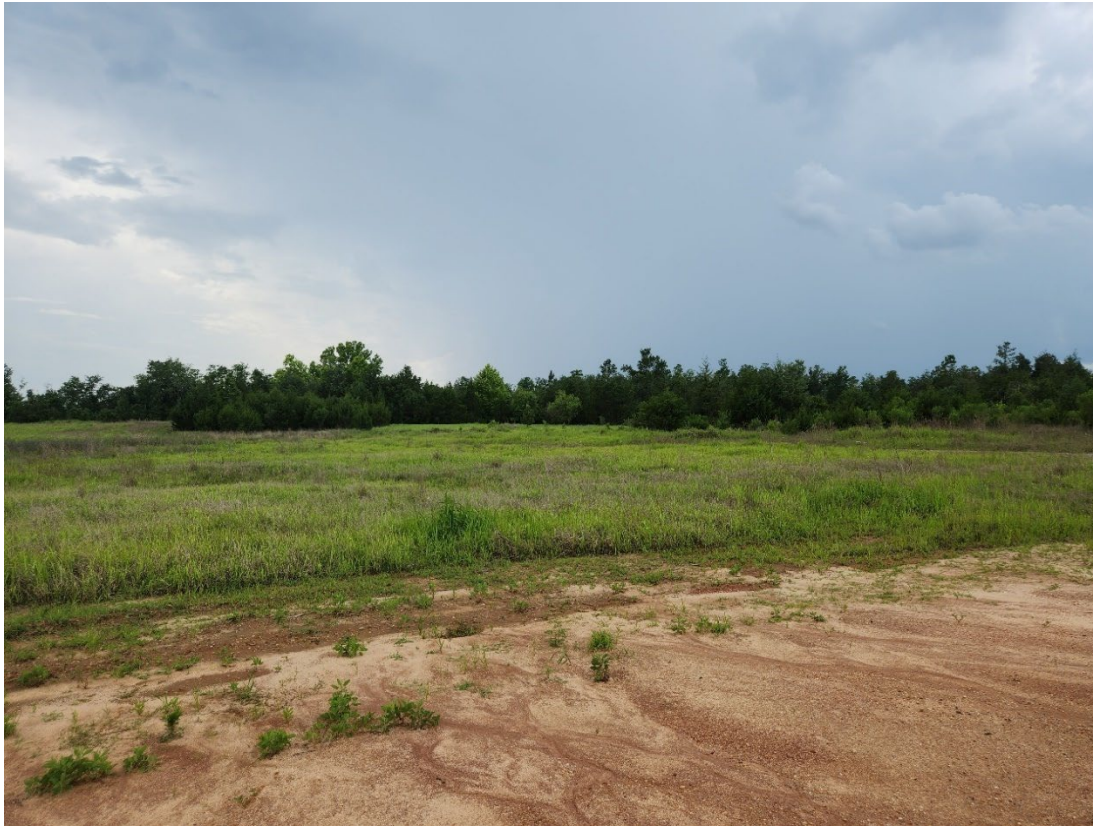
Point 15: Facing east

- Dolomite stated that area south of Points 14 and 15 has been refilled. The Department observed cogon grass (*Imperata cylindrica*) in these areas.
- Dolomite stated that tailings are moved to the area west of Point 16 where it is allowed to dry, and it is then used for aglime (agricultural limestone).
