**Re: Warning Letter  
Rocky Creek Mine  
DEP File No.: MMR\_215039  
Jackson County**

**RE: Rocky Creek Mine DEP File No. MMR\_215039 – Site Inspection Report**

Project: Rocky Creek Mine  
Date: March 17, 2026  
Attendees: Bethany Carrell – DEP  
David Sloan and David Thompson – Dolomite  
Elva Peppers – Florida Environmental & Land Services, Inc. (FELSI)  
Location: Jackson County

## March 17, 2026 Inspection Photos

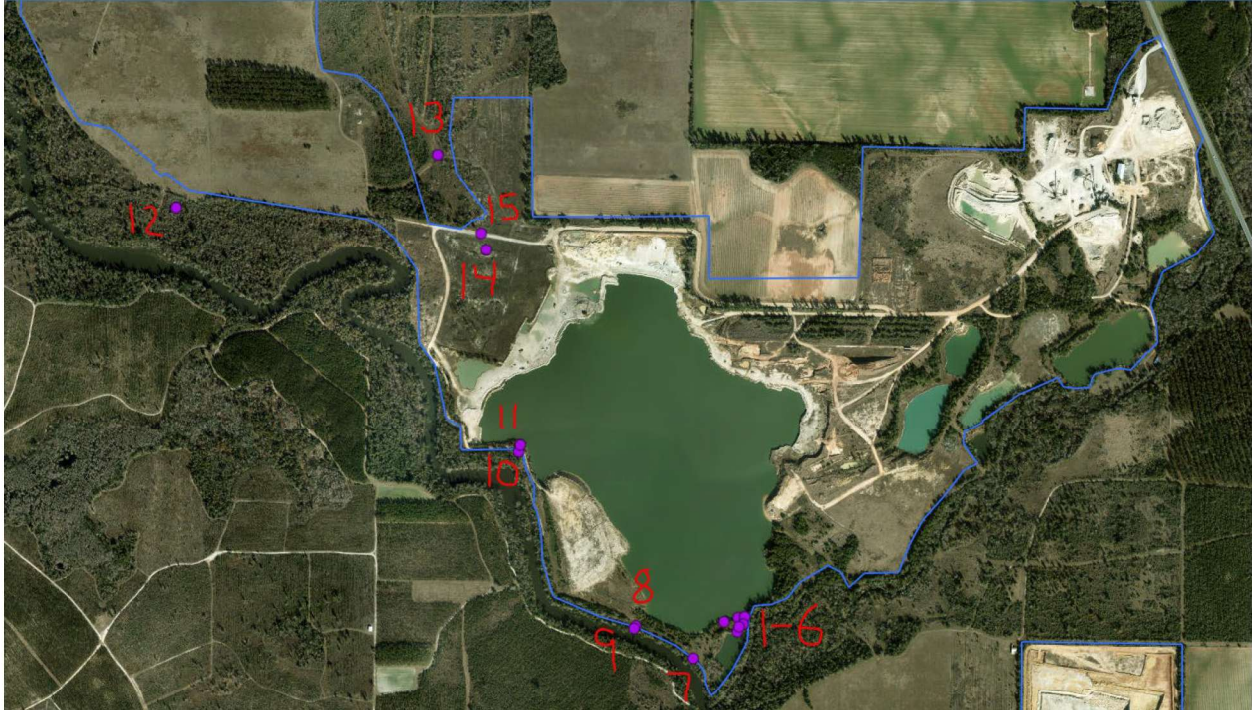
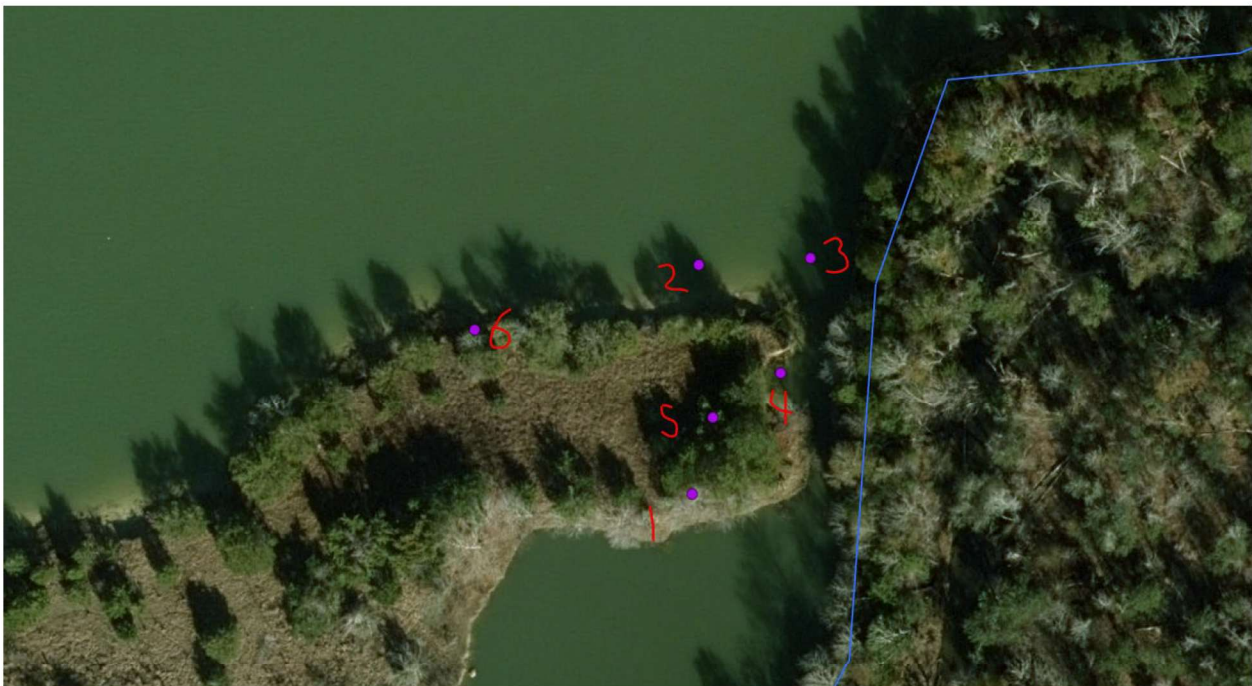
**Point 1:** Facing northeast

- The site appeared to be active at the time of inspection.
- The Department observed the recently installed spillway 6 and outfall structures (OFS-1 and OFS-2) at Points 1-6, which appears to be working as designed. Dolomite stated that the disturbed area around the spillway have been seeded. The Department recommended sloping some areas more so that they meet the reclamation requirements of Chapter 62C-36 F.A.C., and noted that further disturbance would not be required once the area has been stabilized.

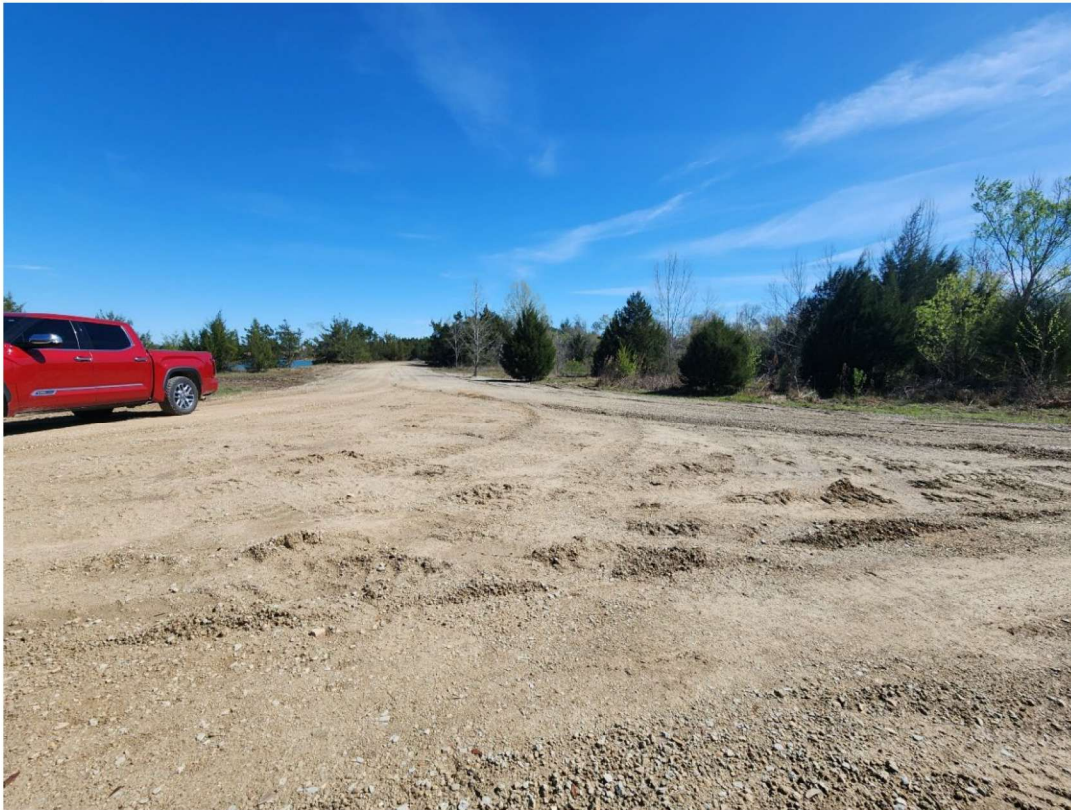
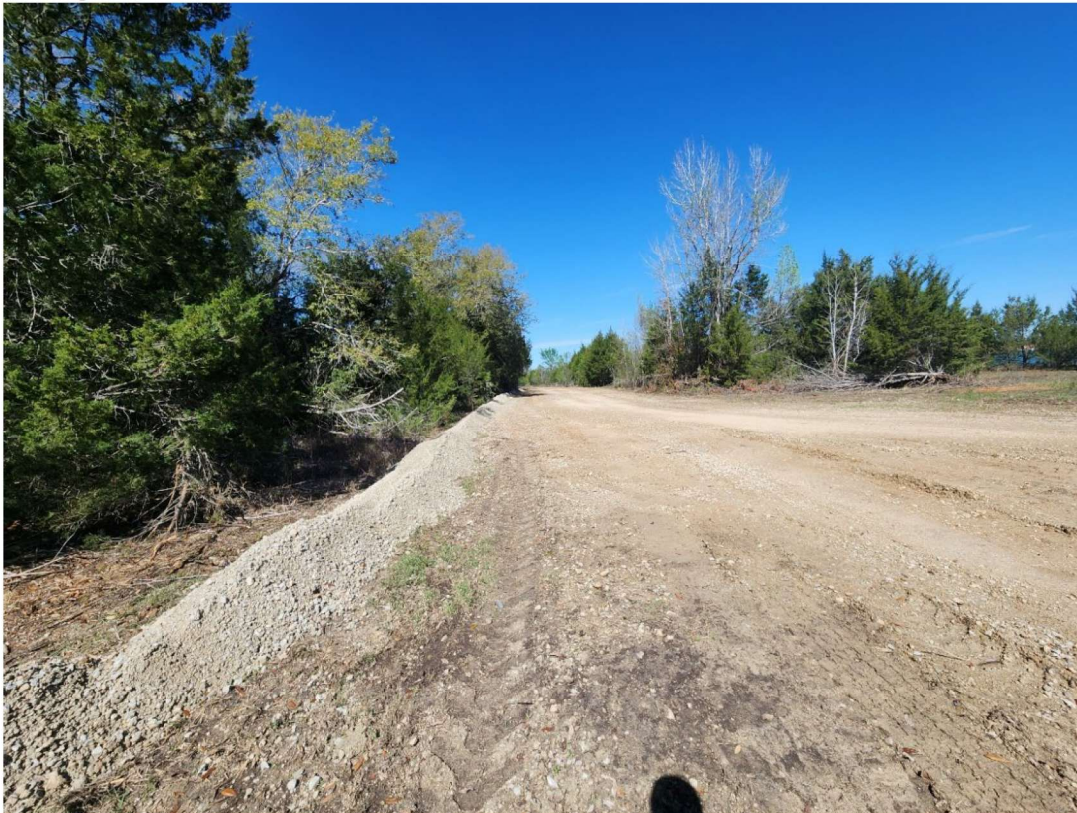
**Point 7:** Facing northeast

2. It appears that the 50-foot setback has not been maintained between any earth-disturbing activities and the Ordinary High Water Level (OHWL) of the Chipola River in accordance with Specific Condition 3 of the ERP potentially impacting Sovereign Submerged Lands.

- The Department observed both monitoring wells and both piezometers (Points 12 and 13).
- The Department observed where the old access road along the Chipola River had been expanded and regraded between points 7 and 10. Dolomite stated that this was done so the cement trucks could reach the southern tip of the site during the construction of the spillway and outfall structures. It appears that much of this expansion occurred within the 50-ft buffer provided for the Ordinary High Water Level (OHWL) to the Chipola River, an OFW and SSL, and some expansion was outside the ERP permit boundary. It appears that a 50-foot setback has not been maintained between any earth-disturbing activities and the OHWL of the Chipola River in accordance with Specific Condition 3 of the ERP.

- **Begin reclamation activities to restore the 50-foot buffer in areas that have been disturbed as described in the inspection observations above.**
- **Install silt fence immediately along the western side of the site between the Chipola River and immediately adjacent to the access road disturbance until the entire area has been stabilized through vegetation.**
- **Re-seed all areas of disturbance within the 50-foot buffer within 15 days, including the access road.**
- **Submit photo documentation of the completed activities within 15 days.**

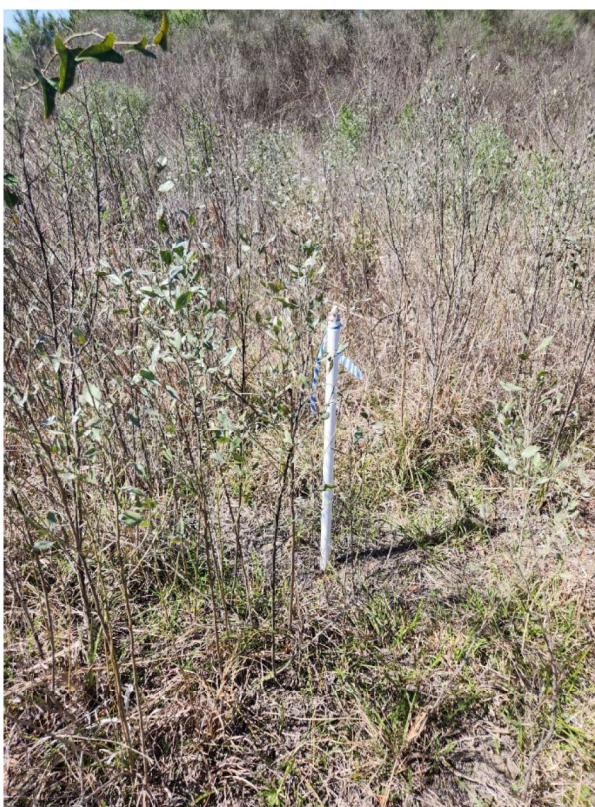
**Point 13:**

- Dolomite and FELSI stated that they are working on marking/flagging the permit boundary and the wooden stakes will be replaced with metal rods soon. The Department observed several flags near points 13 and 15.
