RE: Compliance Assistance Offer  
North Florida Rock  
FL0980722  
Jackson County

**FLORIDA DEPARTMENT OF ENVIRONMENTAL PROTECTION**  
**WASTEWATER COMPLIANCE INSPECTION REPORT**

| <b>Facility Name and Physical Address</b><br>North Florida Rock, LLC<br>5160 Vermont Rd.<br>Marianna FL., 32448 | <b>WAFR ID</b><br>FL0980722 | <b>County</b><br>Jackson | <b>Entry Date</b><br>3/26/2024 | <b>Entry Time</b><br>8:45 |

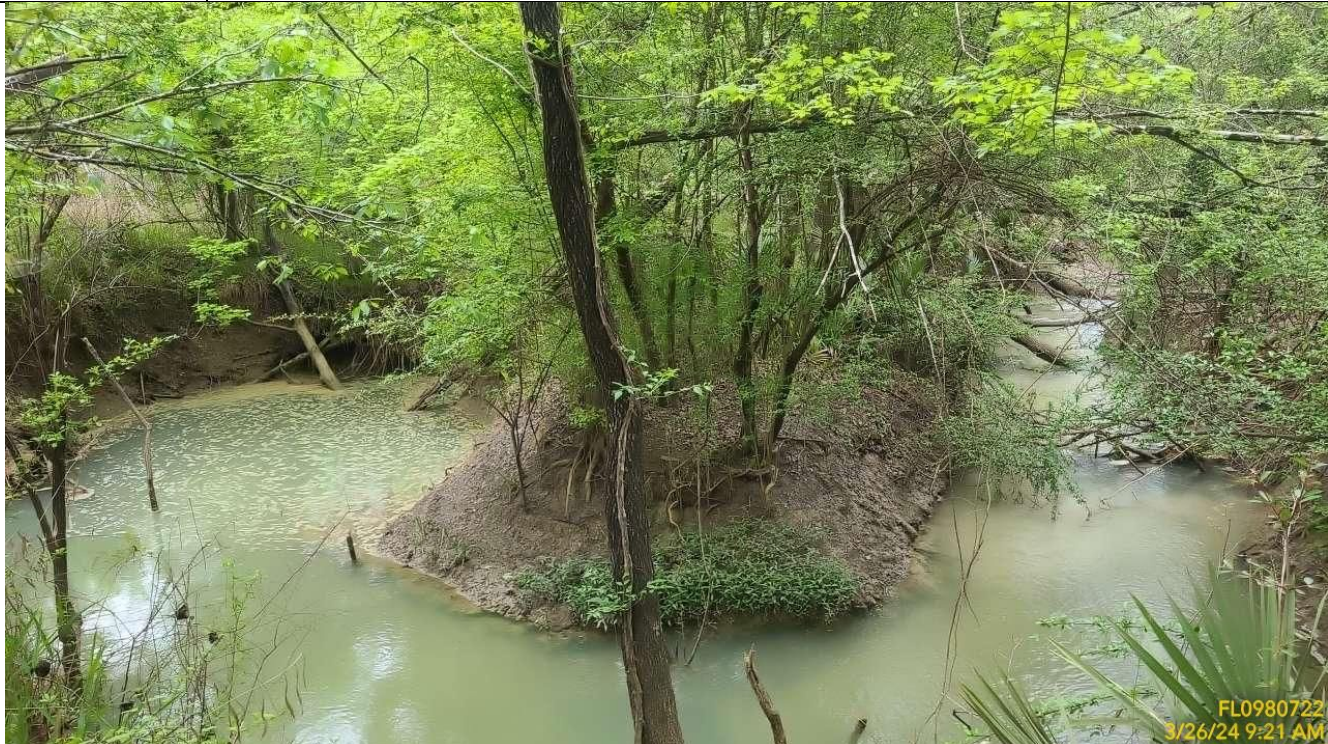
| <b>Photo Description:</b> | Swallet before discharging into Chipola River |

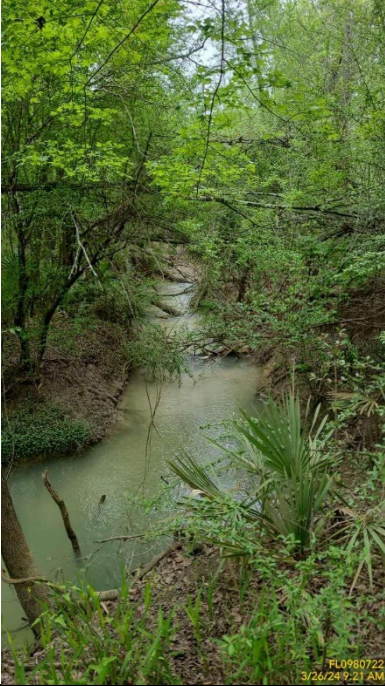
| <b>Photo Description:</b> | Unnamed tributary to discharge point into Chipola River |

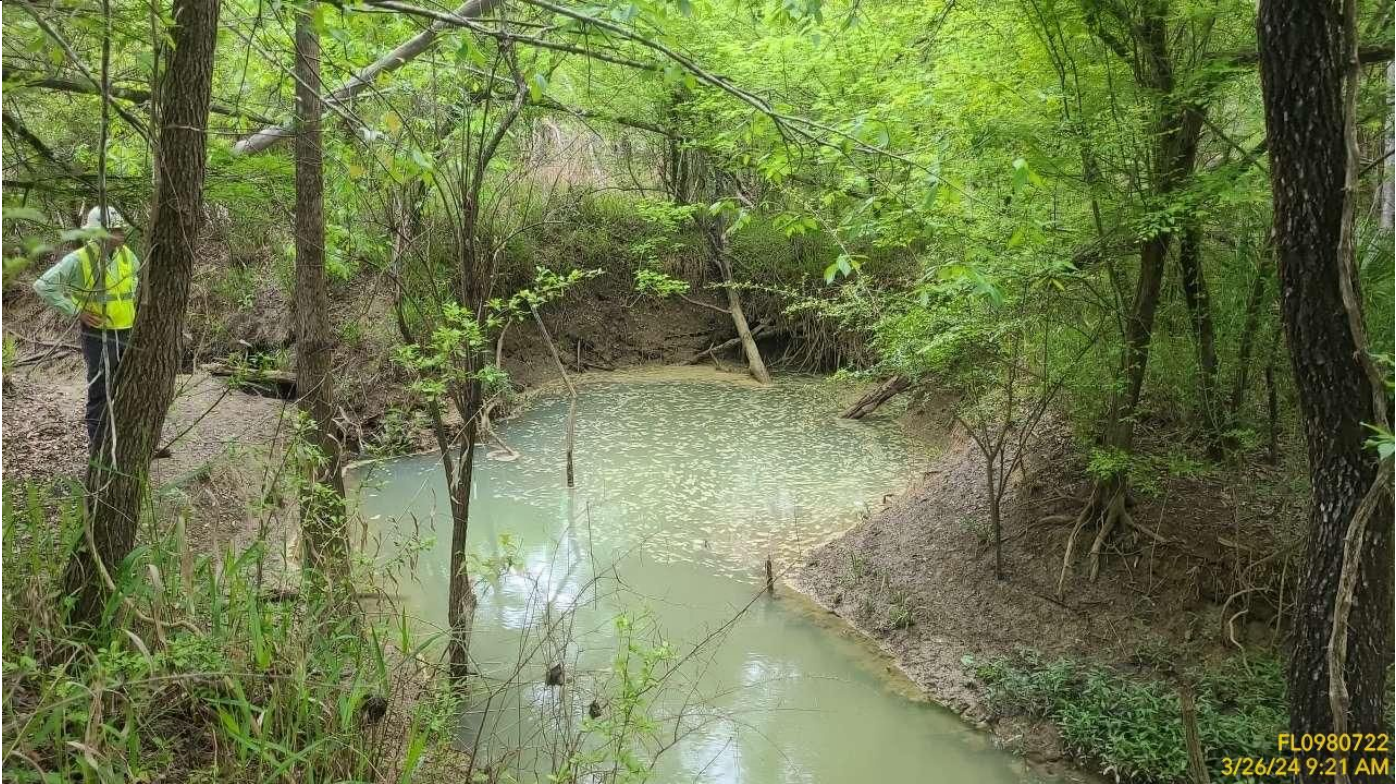
| <b>Image #:</b> | 3 |

| <b>Photo Description:</b> | Swallet with minimal organic film, this area was slowly circulating |

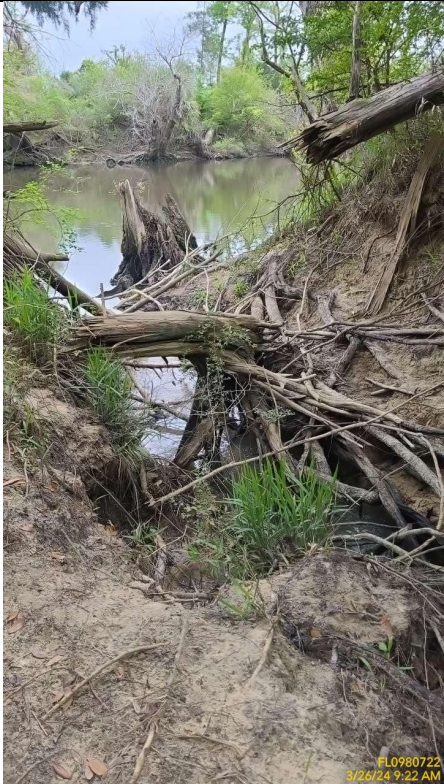
| Image #: | 4 |

| Photo Description: | Discharge point into Chipola River |

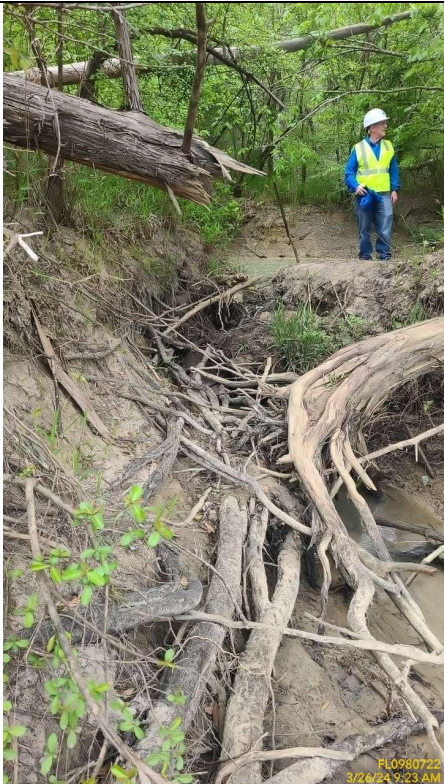
| Image #: | 5 |

| Photo Description: | Discharge point from edge of Chipola River |

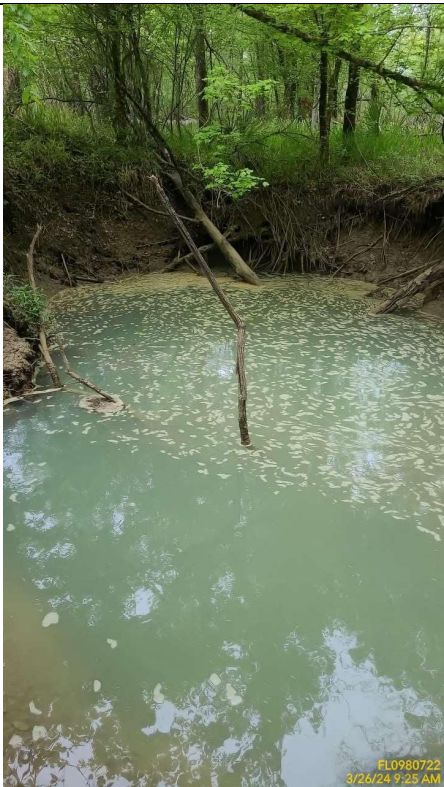
| Image #: | 6 |

| Photo Description: | Swallet with minor organic film |

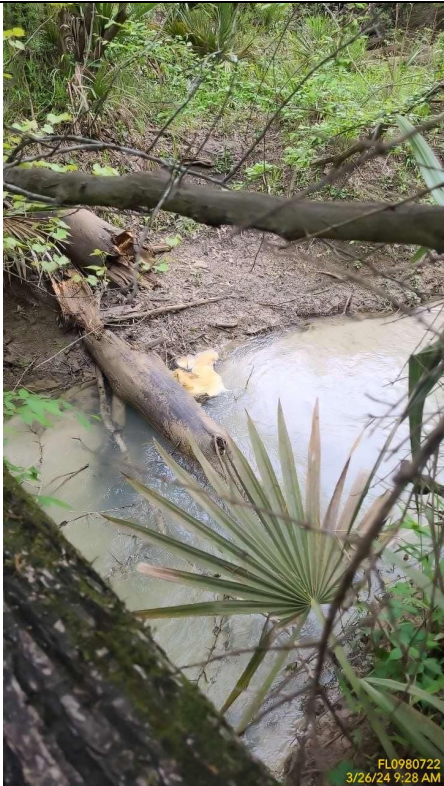
| Image #: | 7 |

| Photo Description: | Organic film upriver from discharge point |

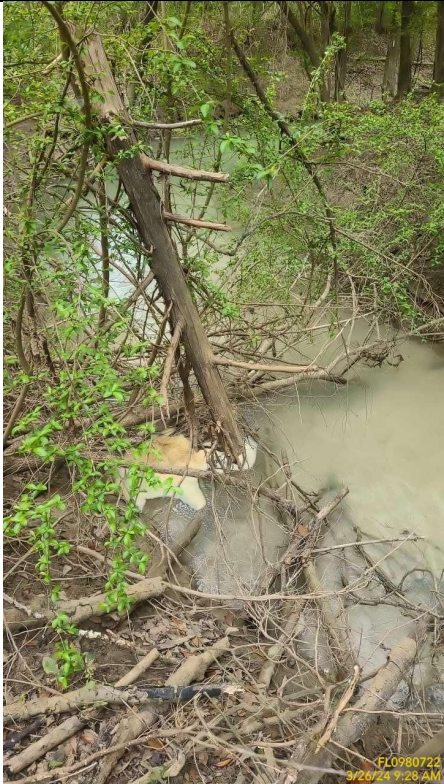
| Image #: | 8 |

| Photo Description: | Organic Film upriver from discharge point |

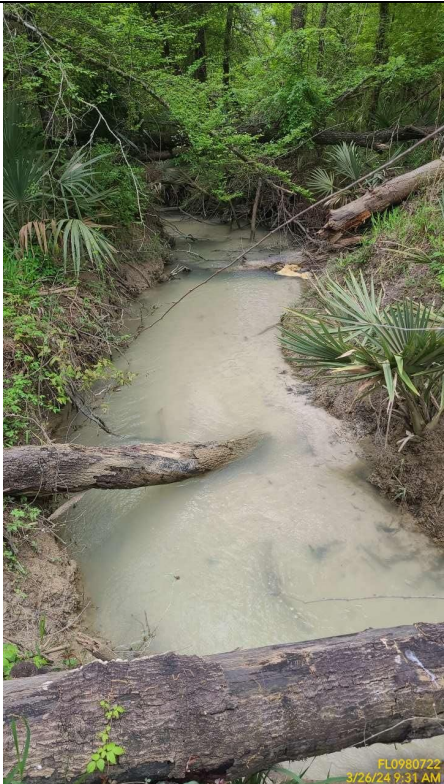
| Photo Description: | Approx. 100 ft. from discharge point |

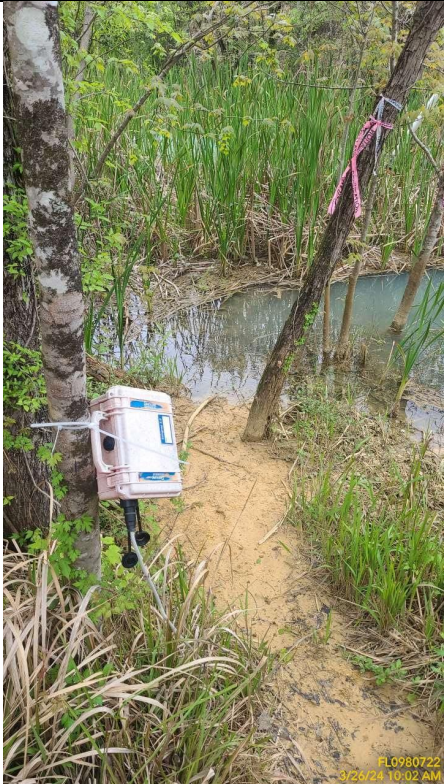
| Image #: | 10 |

| Photo Description: | Flow Meter box |

Recommendations: Maintain sampling area for ease of use. Cut back excessive weeds and brush within the flow measurement and sampling area. (See photos #10 and 12).

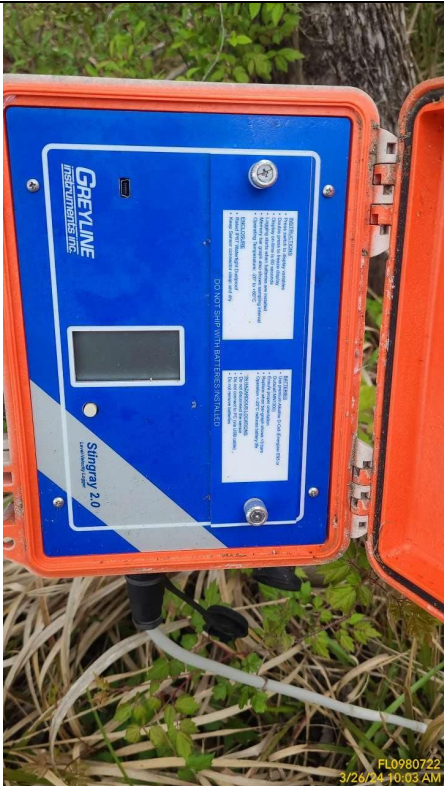
| Photo Description: | Flow meter box, open |

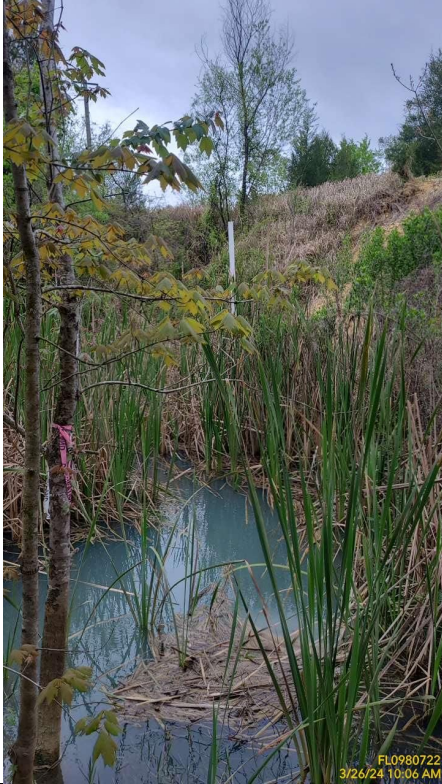
| Image #: | 12 |

| Photo Description: | Effluent sampling point |

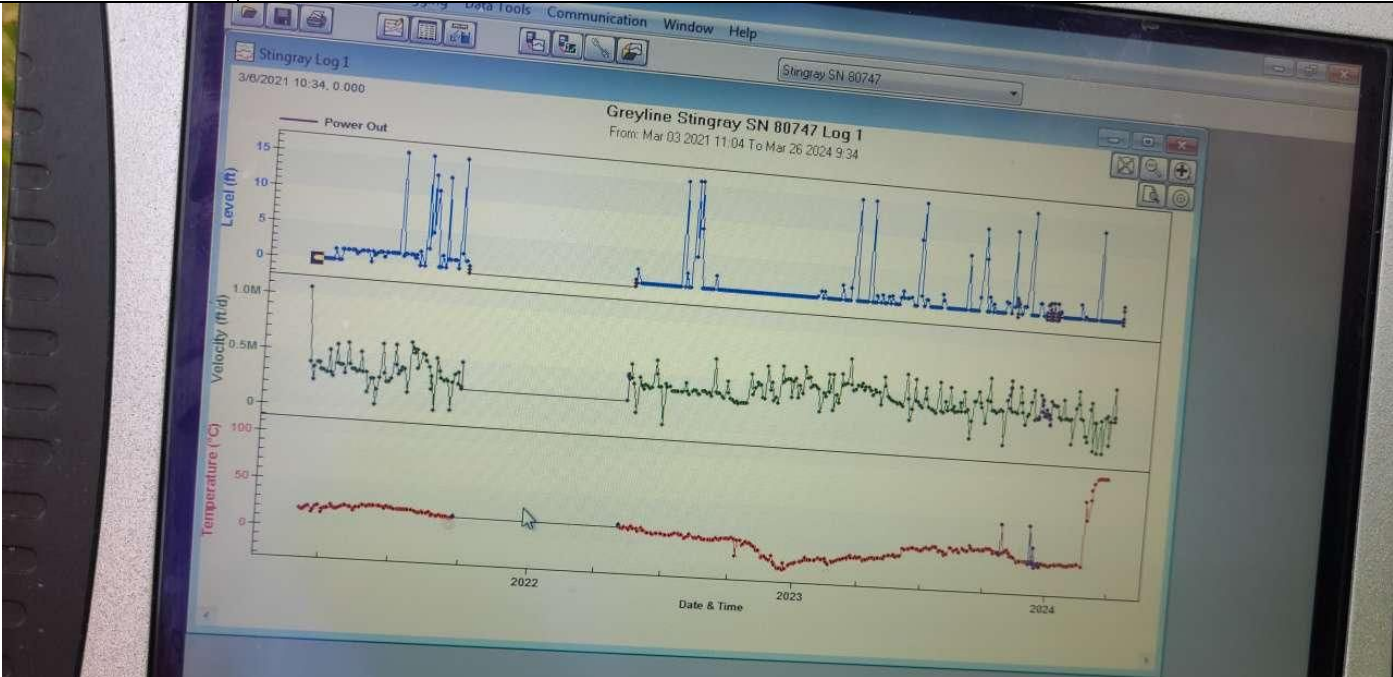
| Photo Description: | Flow meter results |

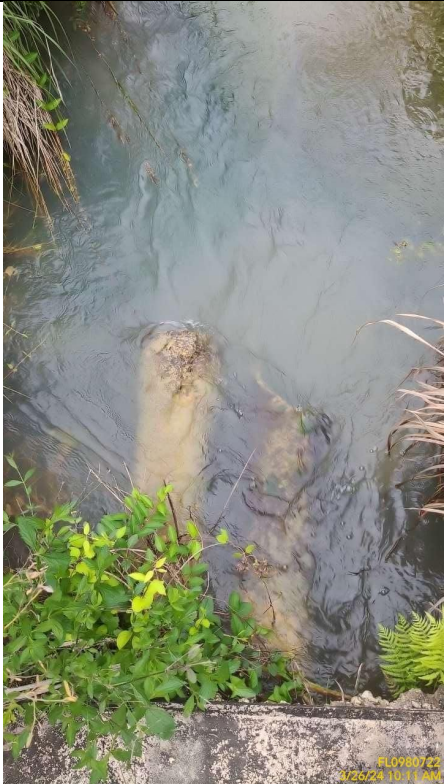
| Image #: | 14 |

- 10.1 Deficiency:** Weir not functioning as per permit requirements. (See photos # 14 & 15)  
**Rule/Permit Reference:** Phase 1 Language currently states that the settling pond outfall consists of an 8-foot broad-crested weir with concrete block agitators on discharge slope of weir with overland flow to discharge point at surface level.  
**Corrective Action:** Please provide reasonable assurance that the pending permit modification will resolve this deficiency.
- 10.2 Deficiency:** Sinking stream "swallet" is not currently 45 feet from the Chipola River

| Photo Description: | Effluent pipes running under weir, inflow |

**Corrective Action:** Please provide reasonable assurance that the pending permit modification will resolve this deficiency.

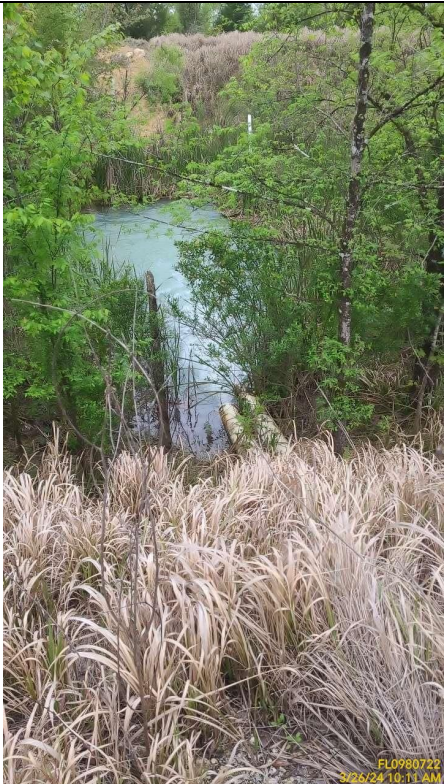
| Image #: | 15 |

| Photo Description: | Effluent pipes flowing into sampling area, outflow |

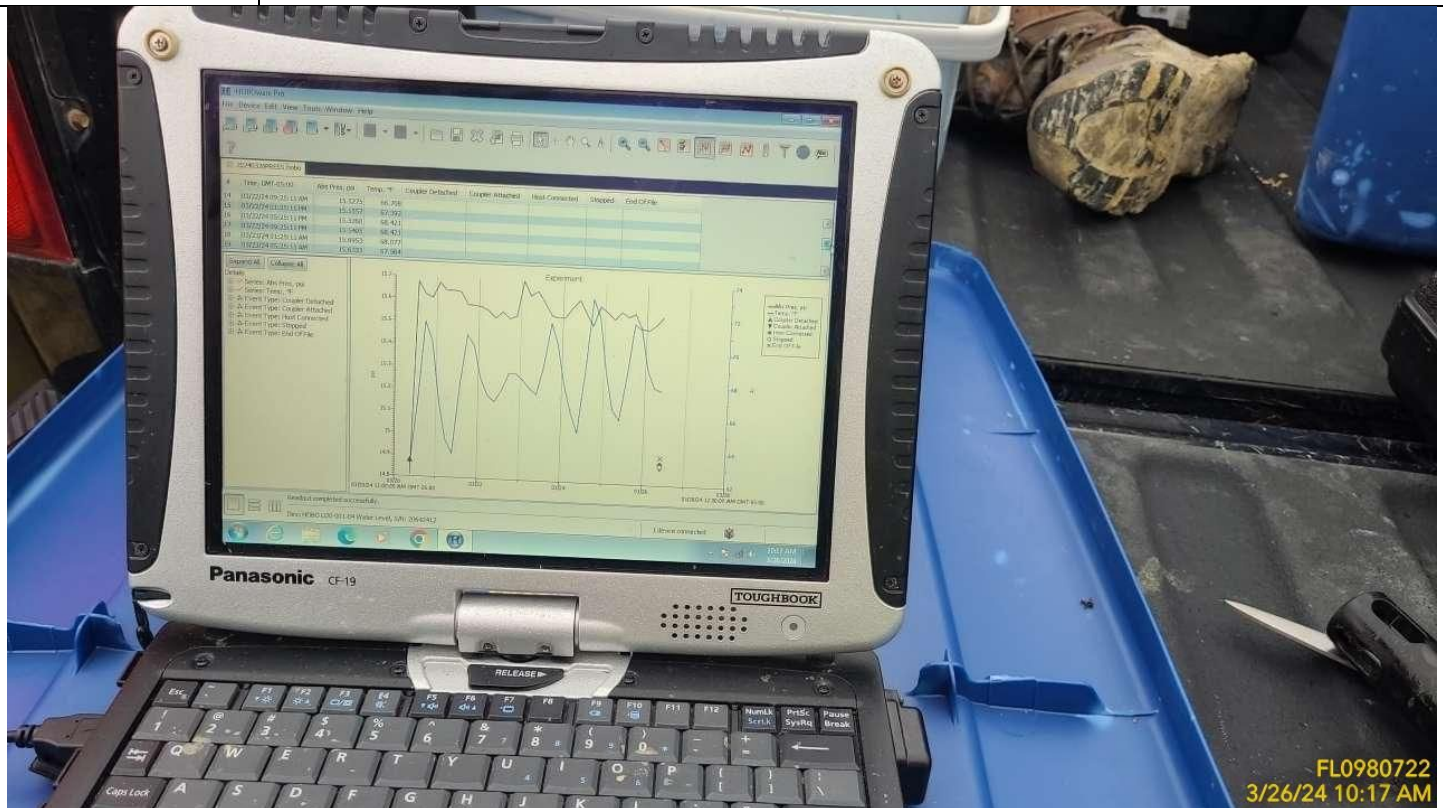
| Image #: | 16 |

- 9.1 Deficiency:** DO from EFF-01 exceeded the percent saturation limit during 09/2023.

| Photo Description: | DO Results |

**Corrective Action:** In response to this report, please explain why these 04 outlying days (under the 67% DO saturation value) noted on the DMR/part B occurred. Also, what steps were taken to identify and control the source that caused these exceedances.

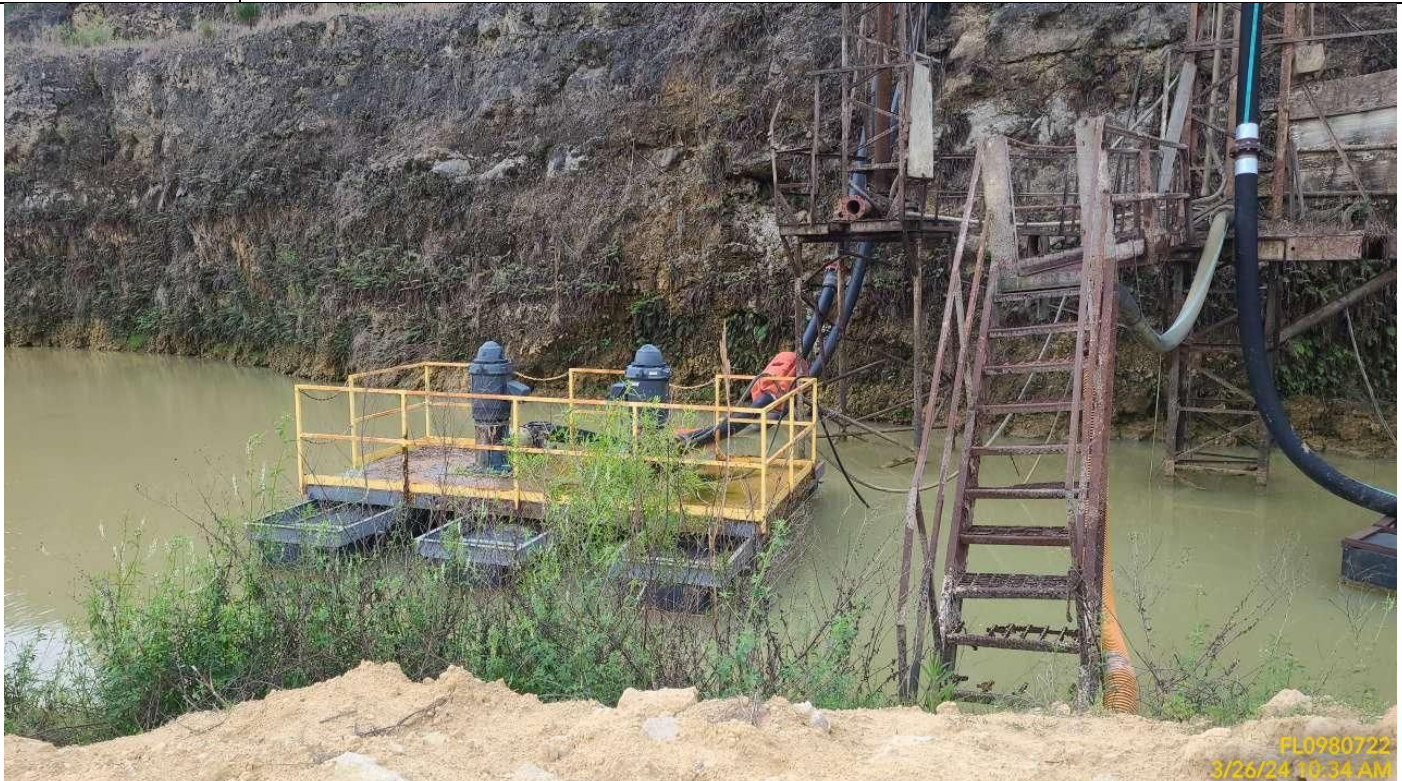
| Photo Description: | Float Pumps #1 |

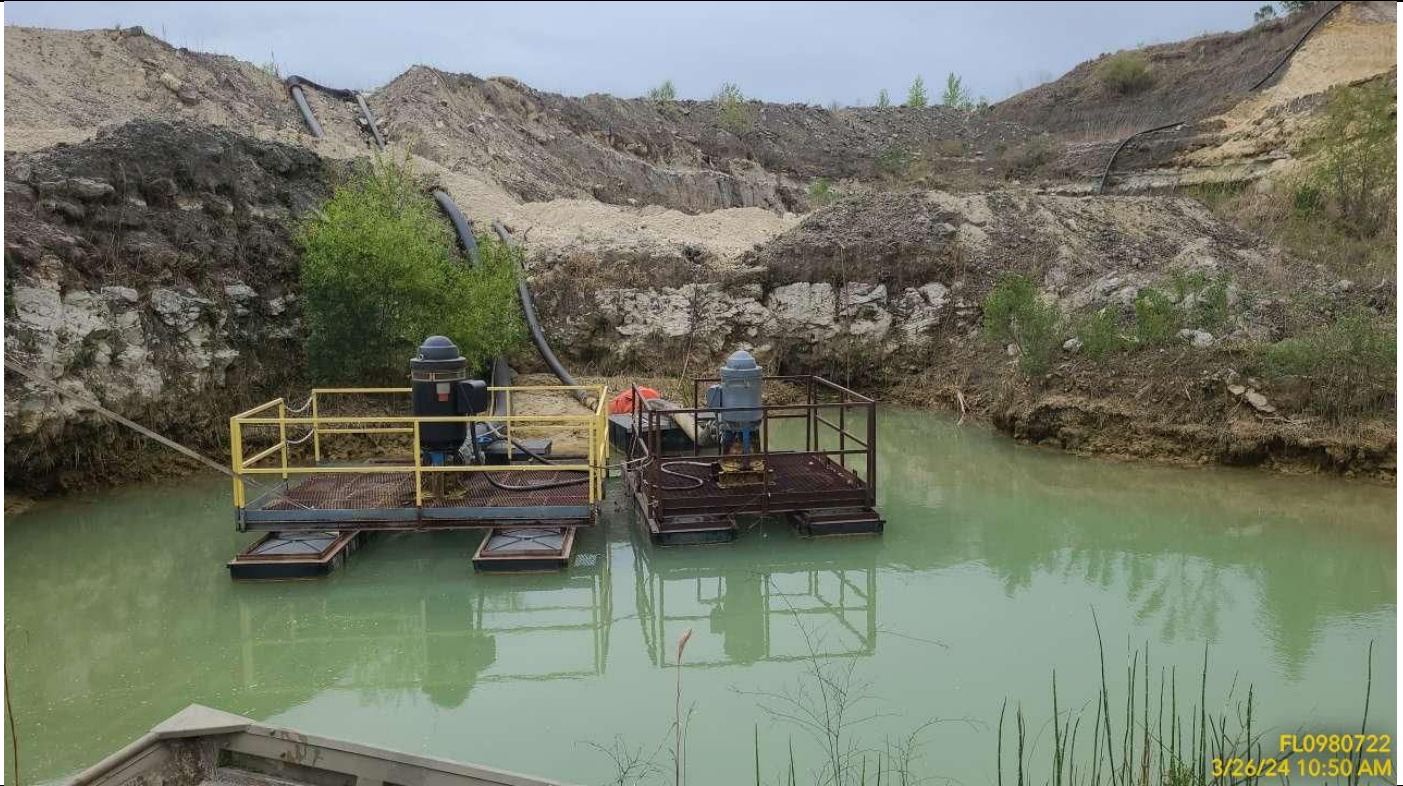
| <b>Photo Description:</b> | Floating Pumps #2 |

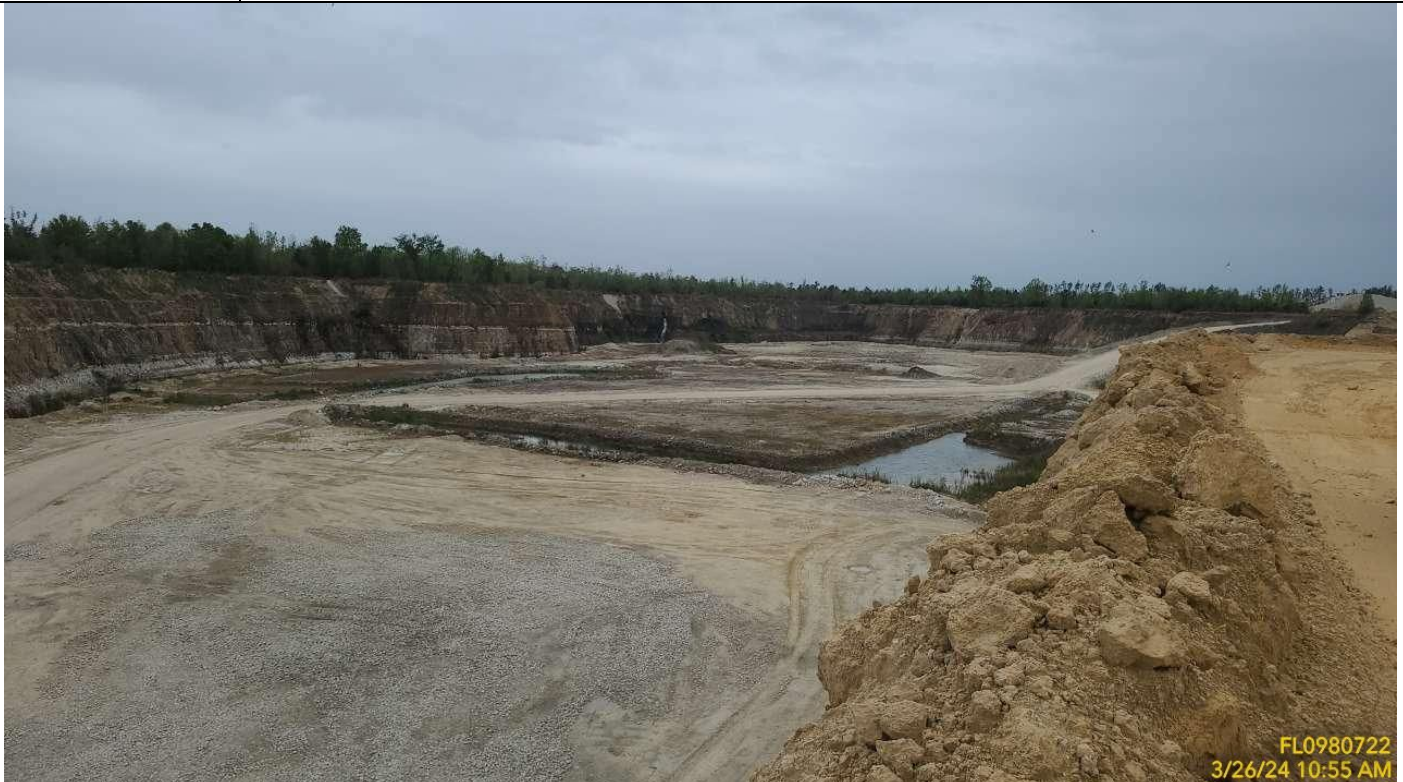
| <b>Image #:</b> | 19 |

| <b>Photo Description:</b> | Mine with partial wetland area in center |

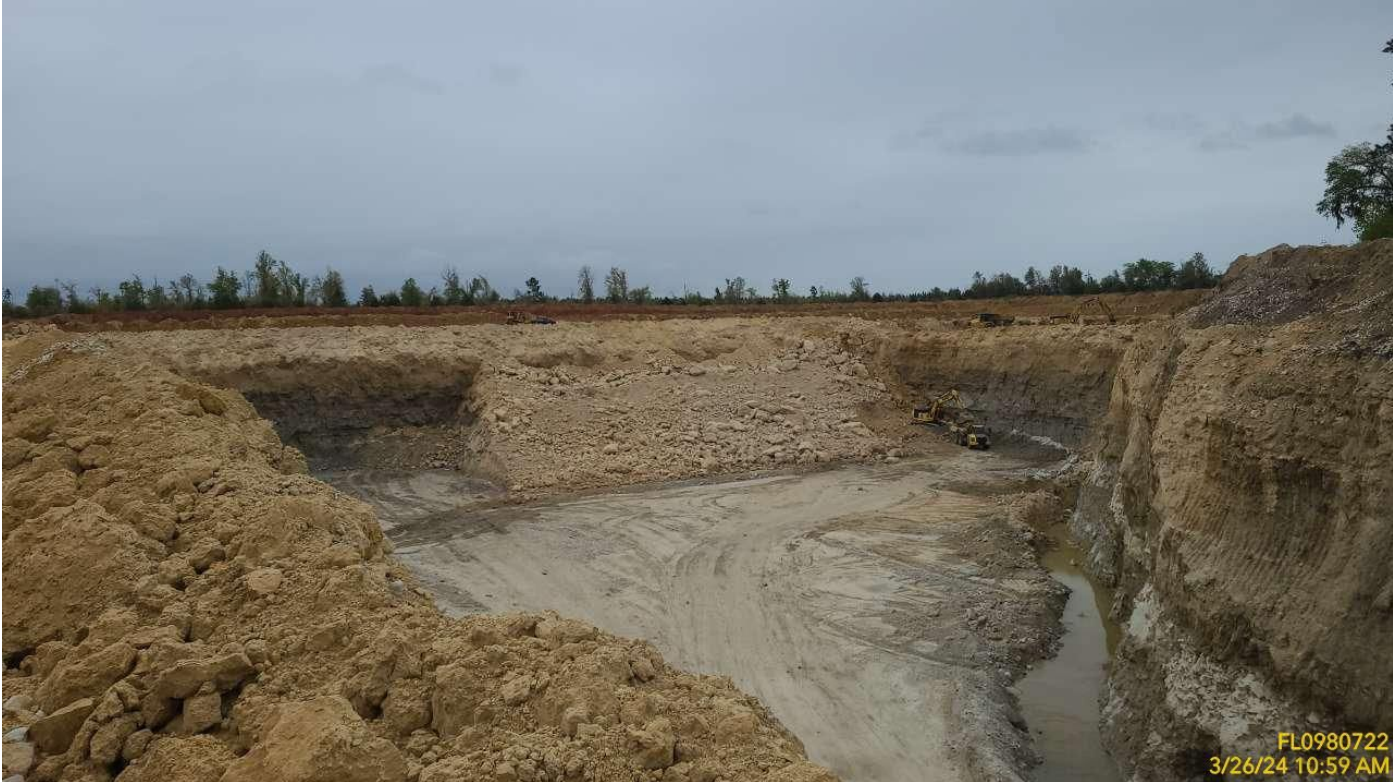
| Image #: | 20 |

| Photo Description: | Mine approx. 75 ft. depth with trucks for reference |

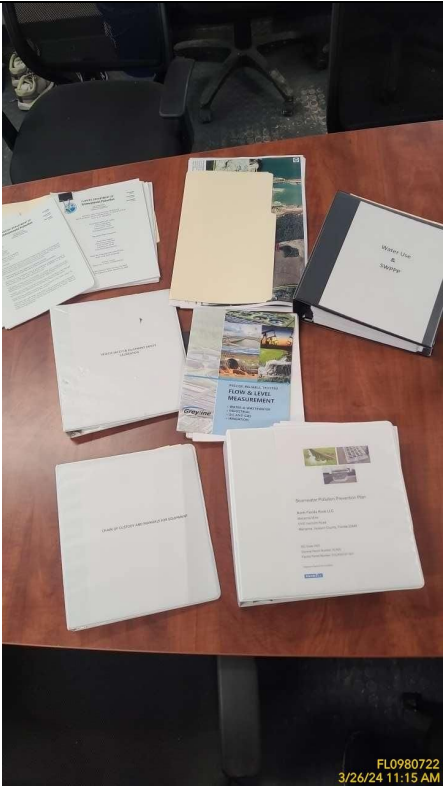
| Image #: | 21 |

| Photo Description: | Permit, O & M manual, SWPP with BMP |

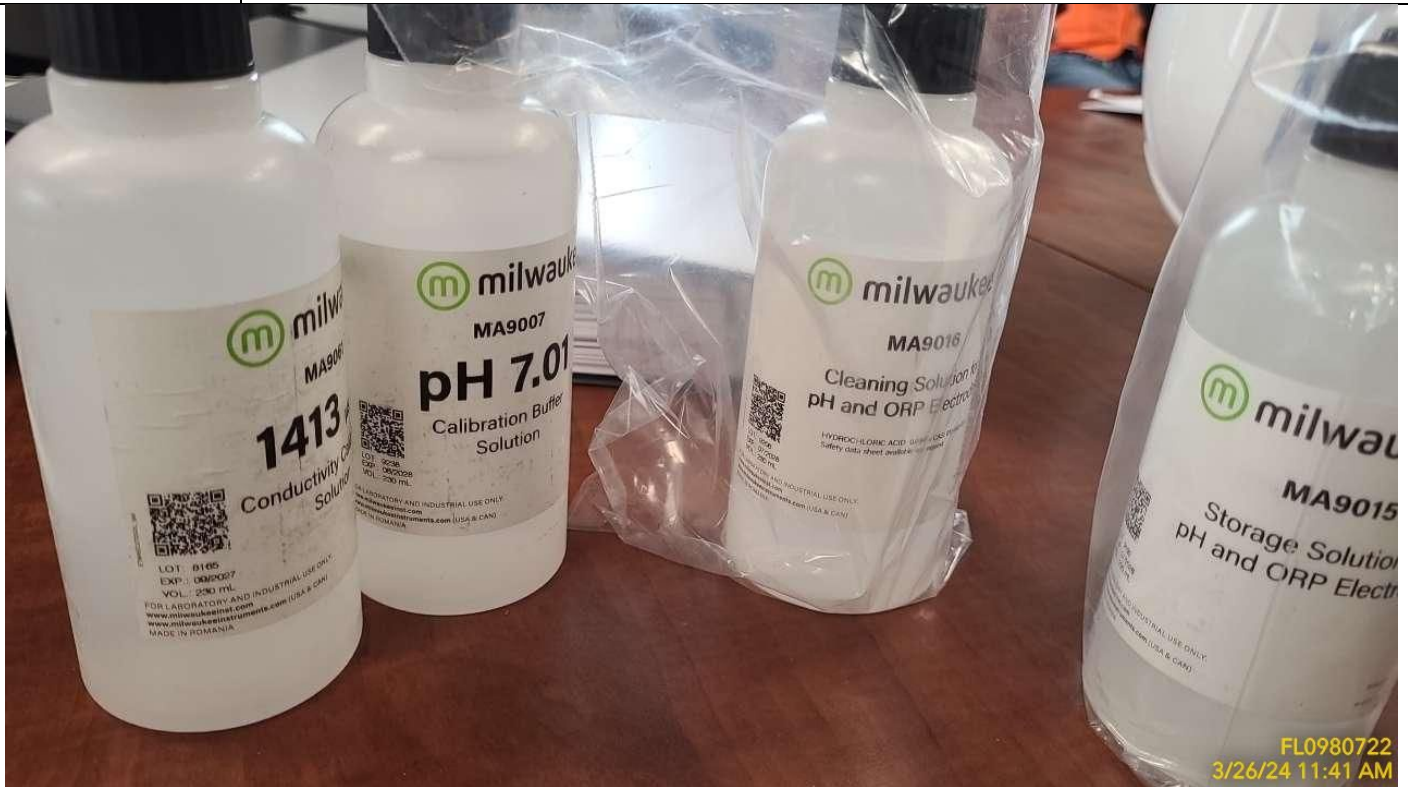
| <b>Image #:</b> | 22 |

| <b>Photo Description:</b> | Reagents and buffers all within date |

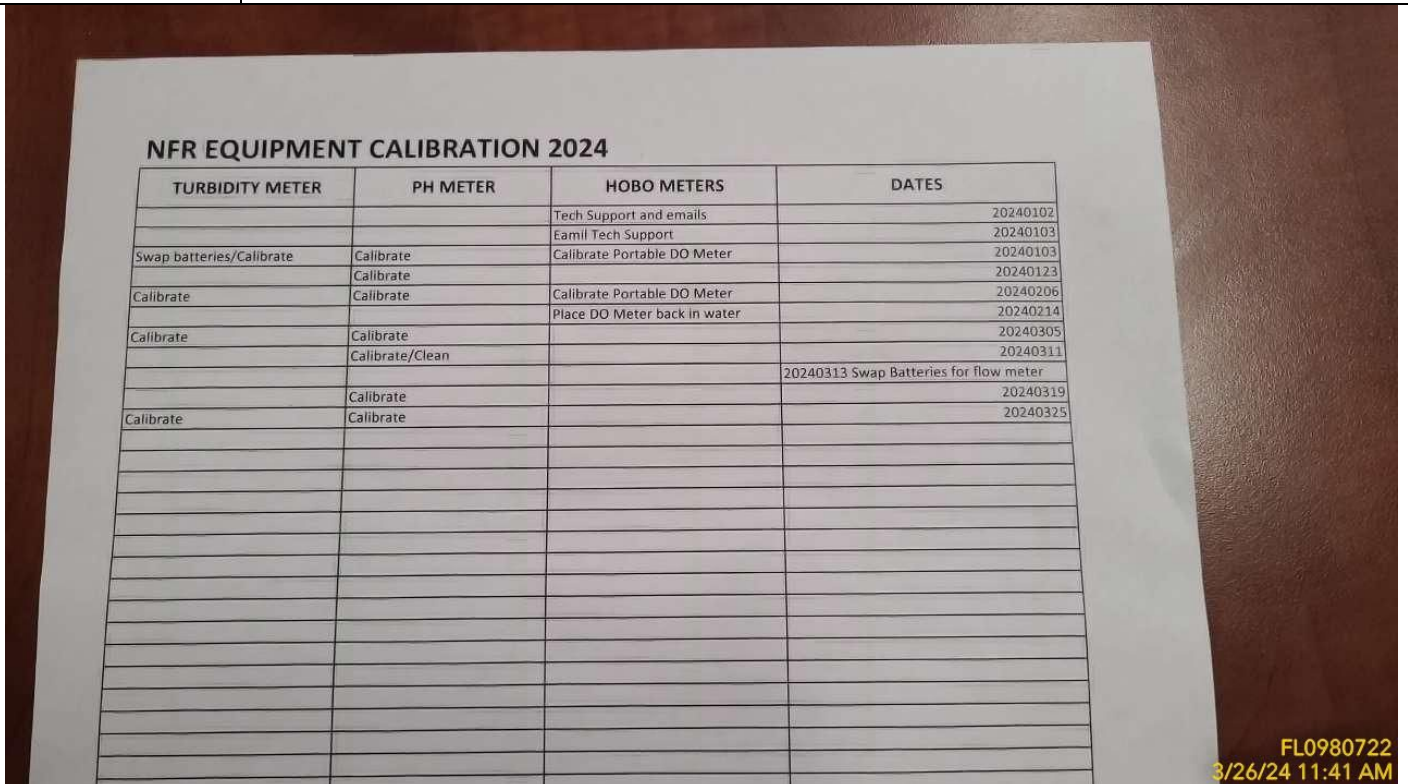
| <b>Image #:</b> | 23 |

| <b>Photo Description:</b> | Calibration log |

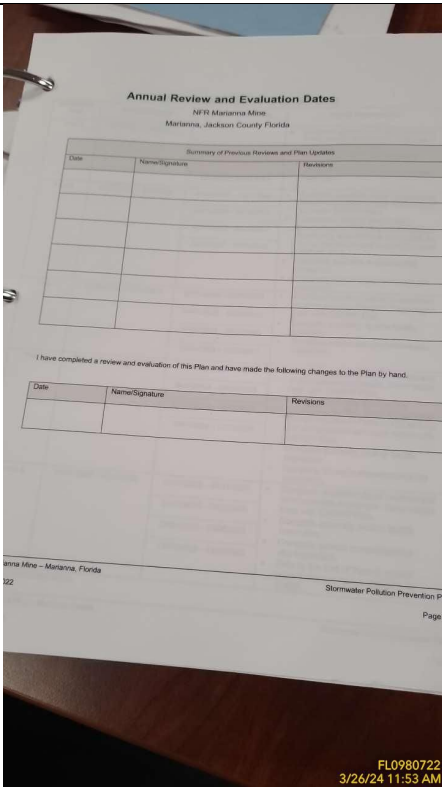
| <b>Image #:</b> | 24 |

- 8.1 Deficiency:** Need annual review of O&M manual, including operational updates and training plans for employees. (See photos #24 &25)

| <b>Photo Description:</b> | Unsigned annual review/evaluation of O&M manual |

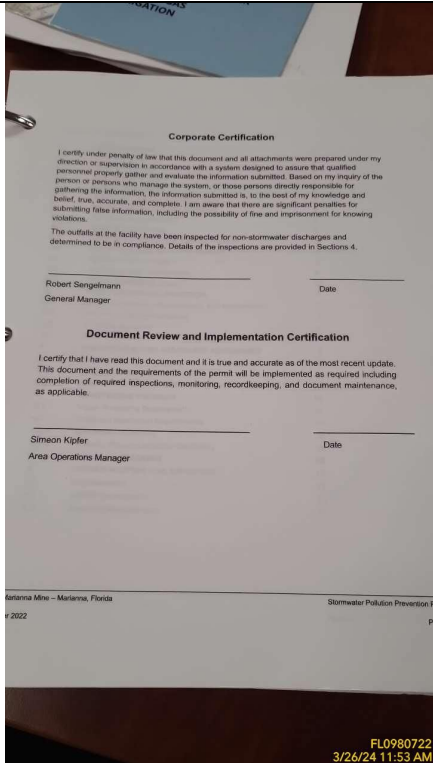
| <b>Image #:</b> | 25 |

| <b>Photo Description:</b> | Unsigned O&M manual, document review and implementation |
