Route VT15

Bridge #00020 (Routine)

VT 00015 ML over LAMOILLE RIVER

Team Lead: Stephen Piro, Inspection Date: September 07, 2021

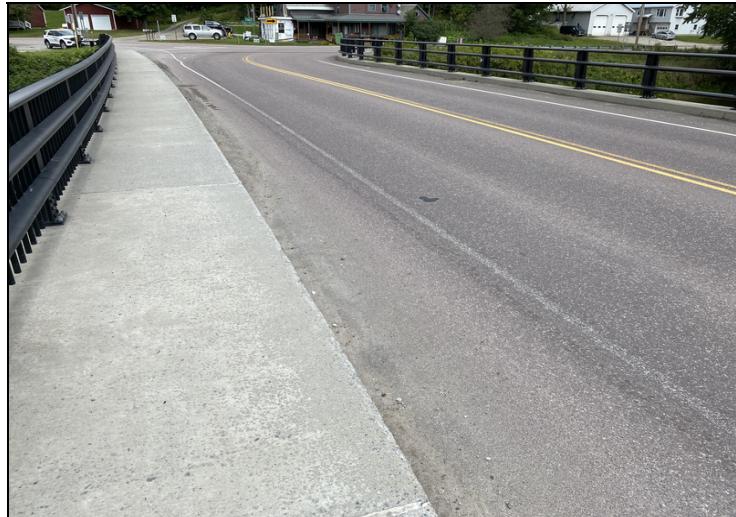
Deck Surface

Comment: Asphalt is in fairly good condition having some light wearing in the wheel paths.

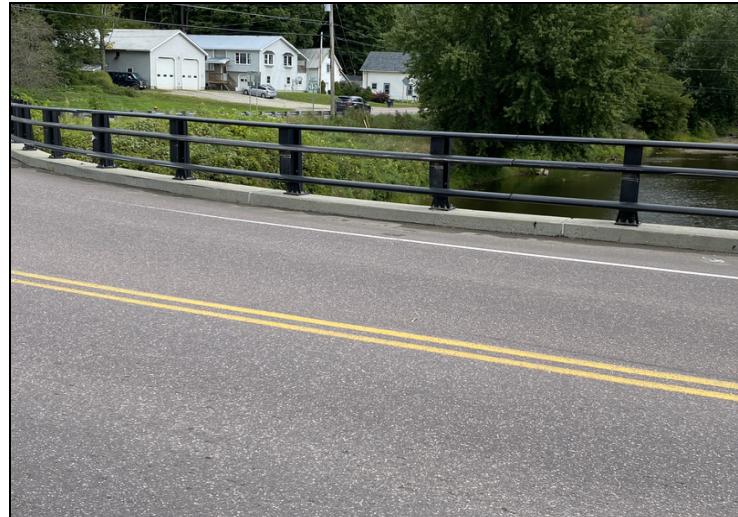
Comment: Pedestal mounted painted aluminum posts with aluminum offsets are in fairly good condition. The upstream bridge rail posts near the eastern end of the structure have impact damage present.

Damaged Bridge Rail Upstream near Eastern End
if Structure

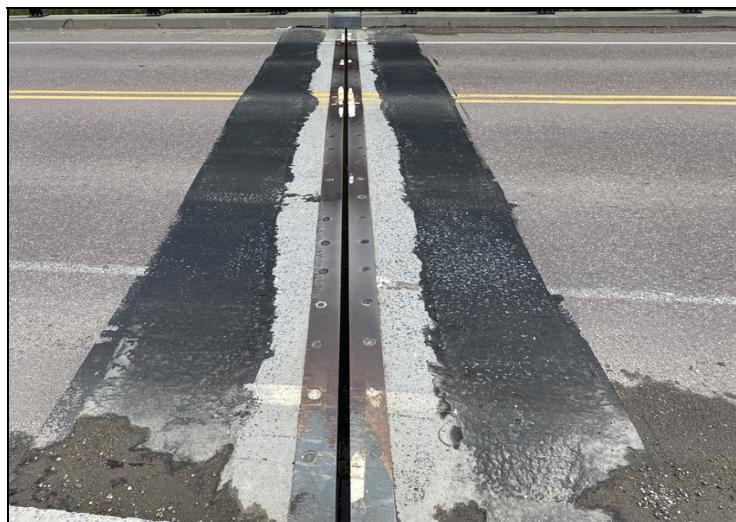
Comment: Asphaltic plug joints are present over both abutments are in fairly good condition having some light wearing. Vermont type joints are present over pier #1 and pier #2 are in fairly good condition. Concrete headers have some light wearing along the top surface with asphaltic plug joints present along both sides of the steel plates.

Vermont Type Joint over Pier #2

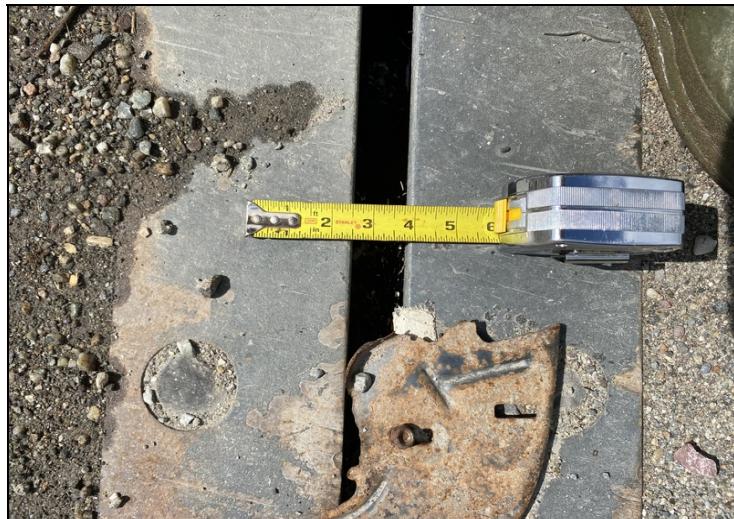
Separation Measurement at Pier #1

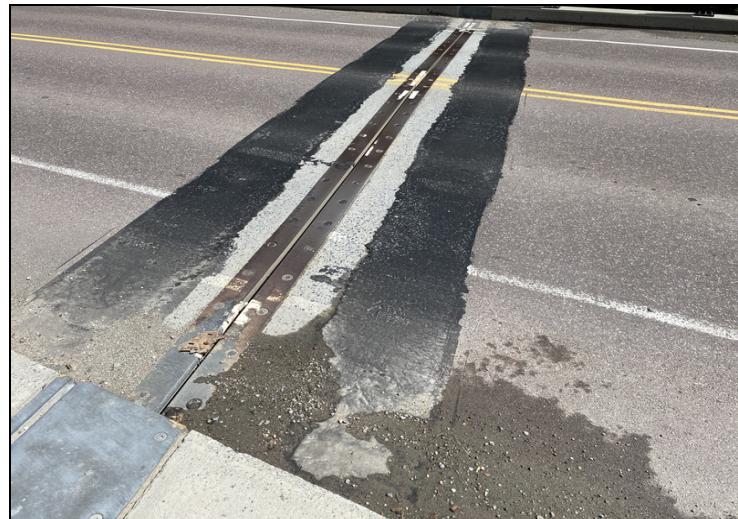
Vermont Type Joint over Pier #1

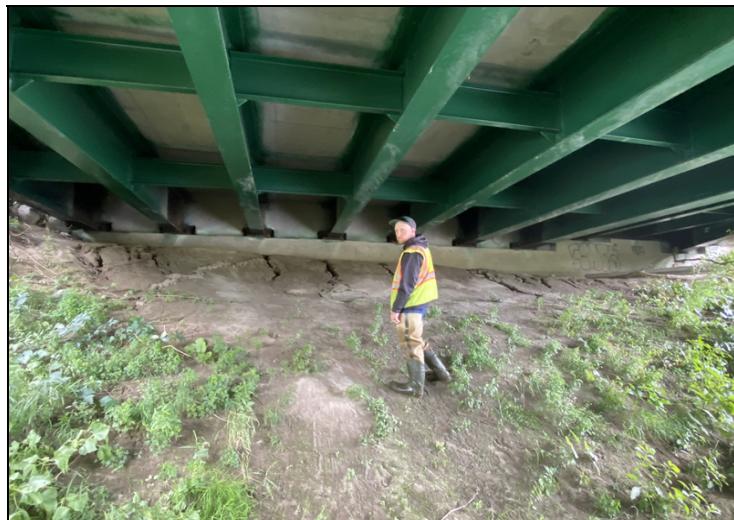
Comment: Lamoille River flows mainly through span #4 with remaining spans having smaller portions of flow due to elevation. Channel bottom is gravel and silty. Channel banks are well vegetated with good brush and tree growth. Abutment #2 has stone riprap and sandy material in front for protection while abutment #1 has sand build up in front.

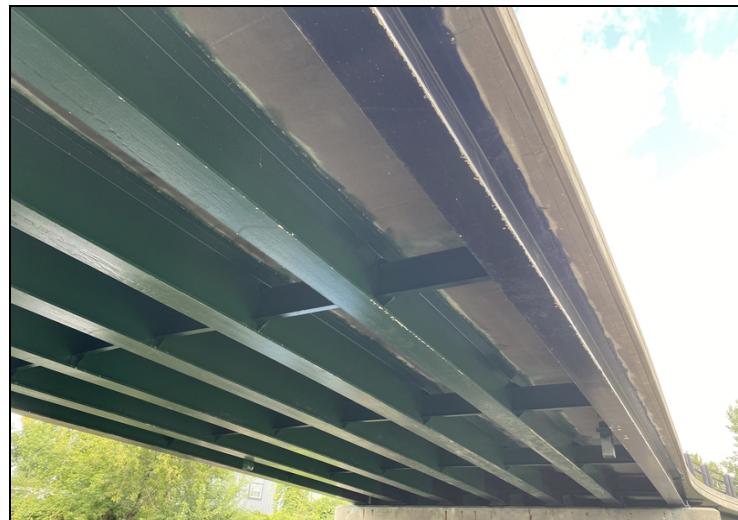
Span #4 Superstructure

Comment: Seven (7) painted steel rolled beams are in satisfactory condition having scattered minor to moderate previous pitting along the flanges and webs throughout. Superstructure was painted in 2008 and is holding up fairly well.

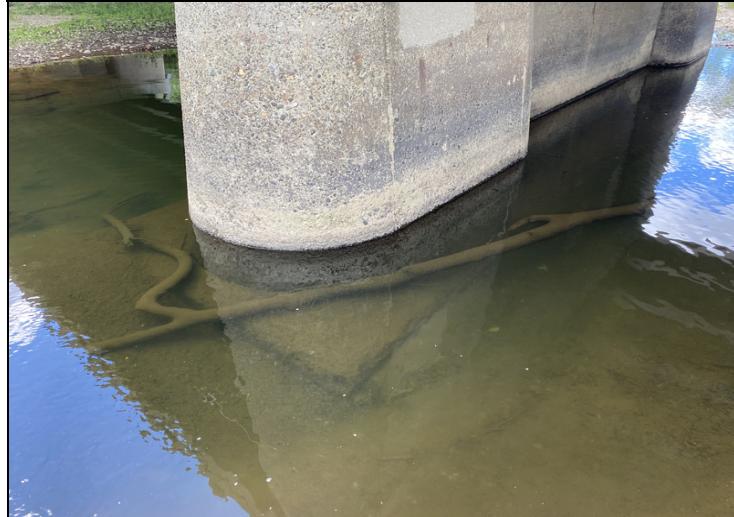
Comment: Pier #3 footing is exposed along the upstream side and is in fairly good condition.

Upstream Pier #3 Nose / Footing

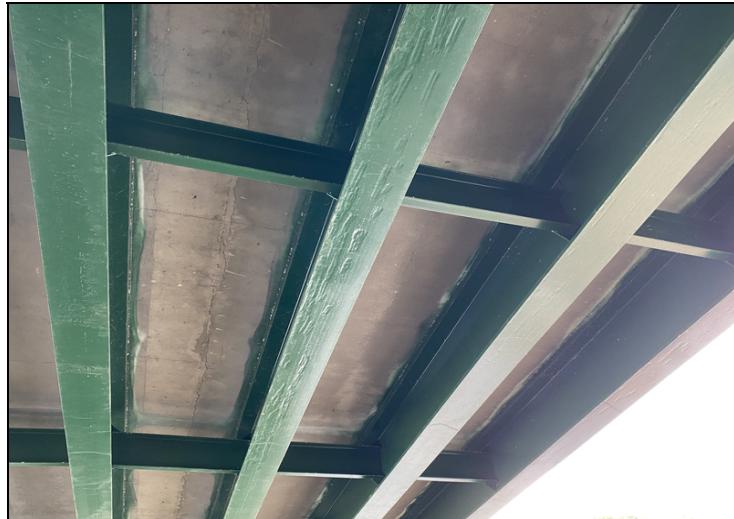
Beam #5 in Span #4 Previous Pitting

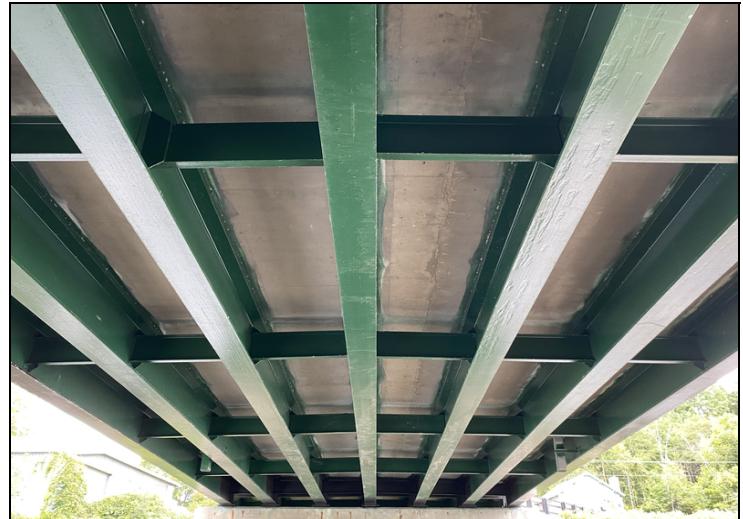
Span #4 Deck Soffit

Comment: Reinforced concrete deck is in fairly good condition. Deck soffit has multiple hairline transverse shrinkage cracks present.

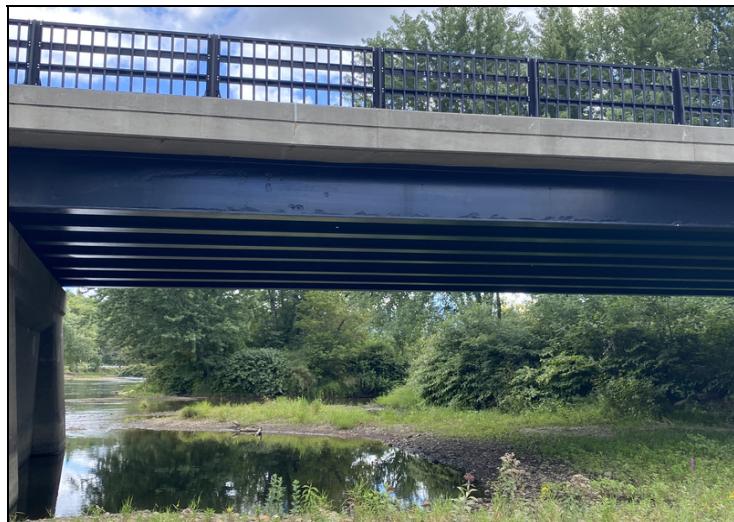
Beam #1 Span #3 Previous Pitting

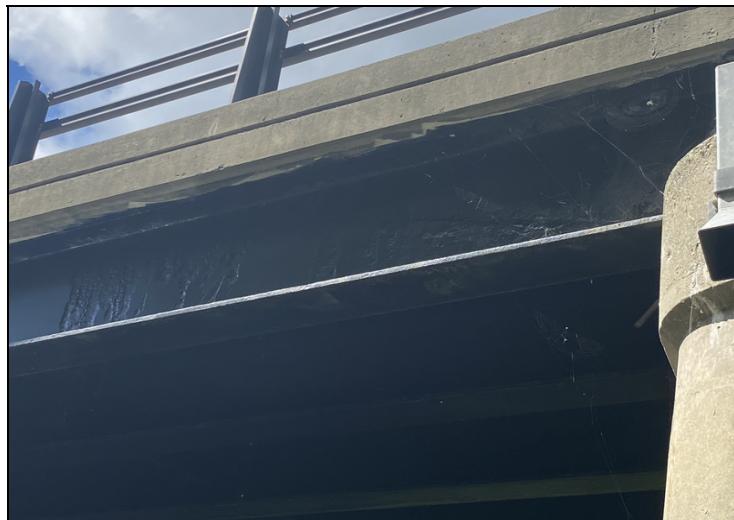
Beam #7 in Span #1 Previous Pitting

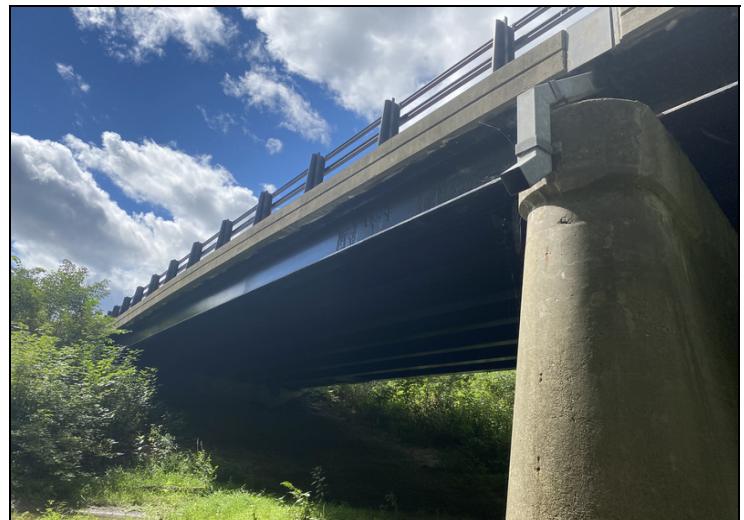
Comment: Reinforced concrete fascia's are in fairly good condition having multiple vertical hairline cracks.

Span #1 Upstream Fascia / Beam #7 Previous
Pitting

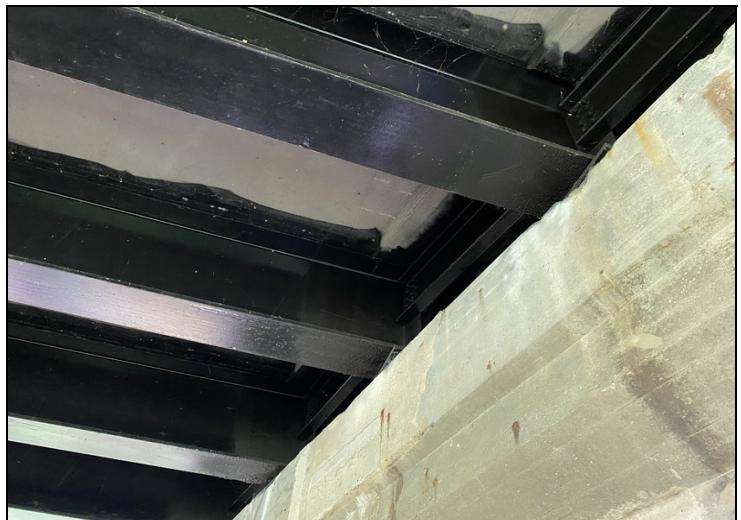
Beams #3 through #5 at Pier #1 in Span #2
Previous Pitting

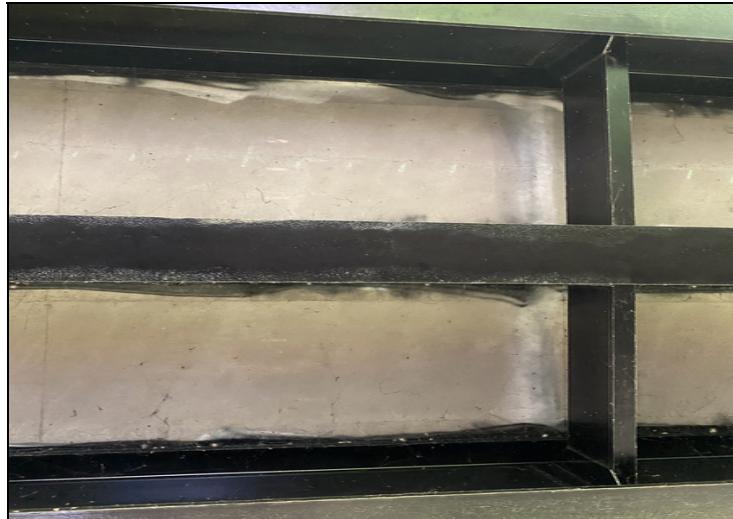
Beam #3 Span #1 Previous Pitting

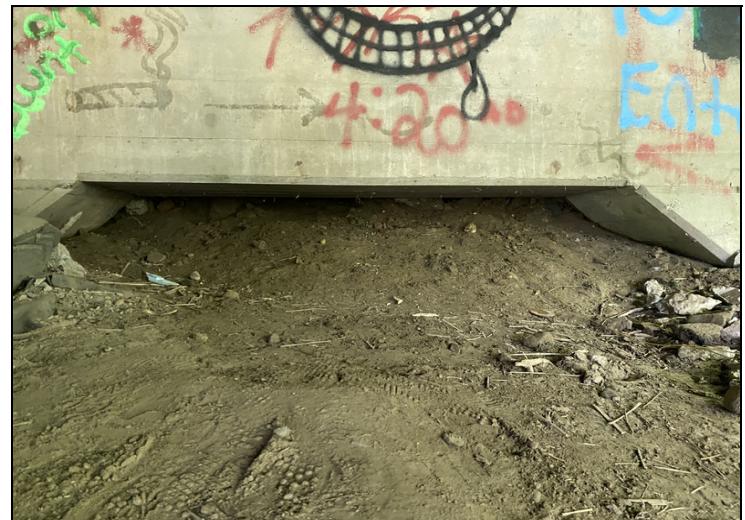
Comment: Reinforced concrete abutment #1 is in fairly good condition having some slight undermining between the columns that penetrates to the backside along the downstream side and less along the upstream side. Reinforced concrete abutment #2 is in fairly good condition.

Undermining at Abutment #1
