Aviation Investigation Final Report

Location:	Climax, North Carolina	Accident Number:	ERA23FA188
Date & Time:	April 11, 2023, 11:32 Local	Registration:	N543GM
Aircraft:	MILLER GLENN F RV-12	Aircraft Damage:	Destroyed
Defining Event:	Loss of engine power (partial)	Injuries:	1 Fatal, 1 Serious
Flight Conducted Under:	Part 91: General aviation - Flight test

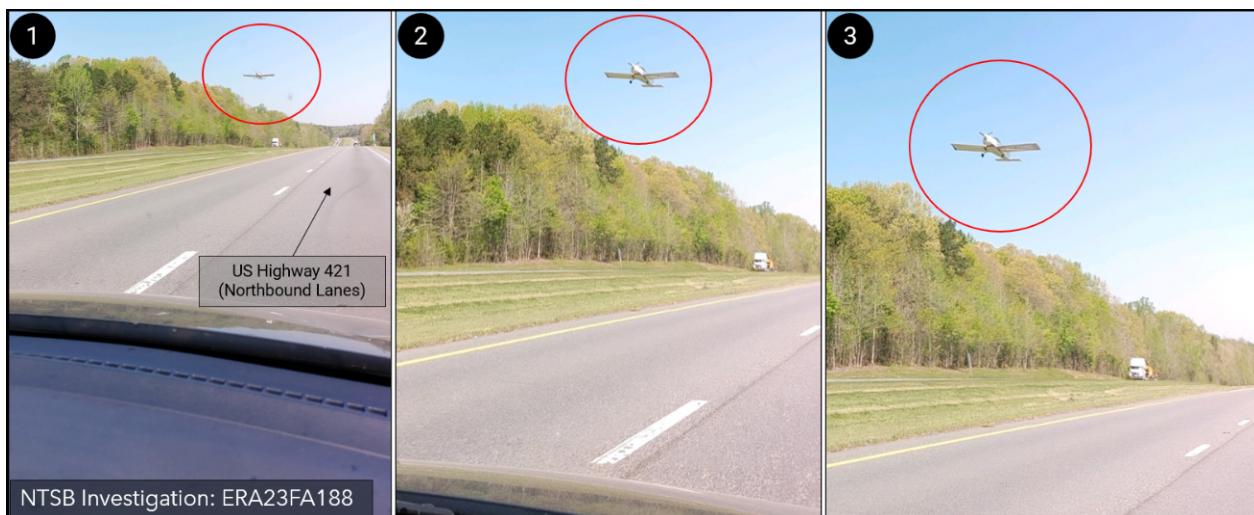
The witness provided three photographs from her position on the northbound lanes of the highway, which shows the airplane low over the highway about 500 ft from the overpass (see figure 1).

Figure 1 - Witness provided photographs of the airplane flying low over the highway about 500 ft from the overpass bridge.

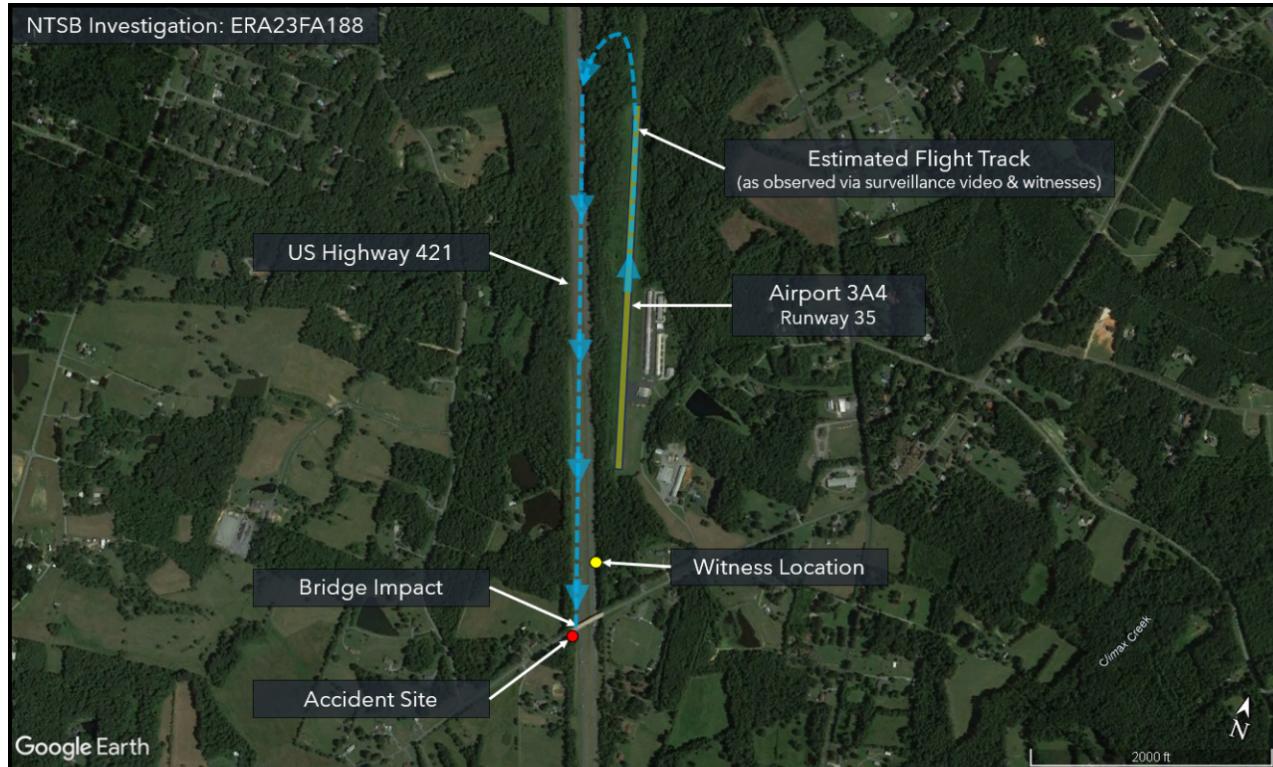
Figure 2 below provides an overview of the estimated flight track of the airplane as reported by the surviving pilot, surveillance video, and witnesses. The total distance the airplane traveled over the highway, from abeam the north end of runway 35 to the overpass, was about 4,300 ft. US Highway 421 was a 4-lane highway with a sloping grass median that was about 60 ft wide. Photographs reviewed at the time of the accident and witness reports found that the traffic was not heavy in either direction.

Figure 2 - Overview of the airplane's estimated flight track, witness location, and accident site.

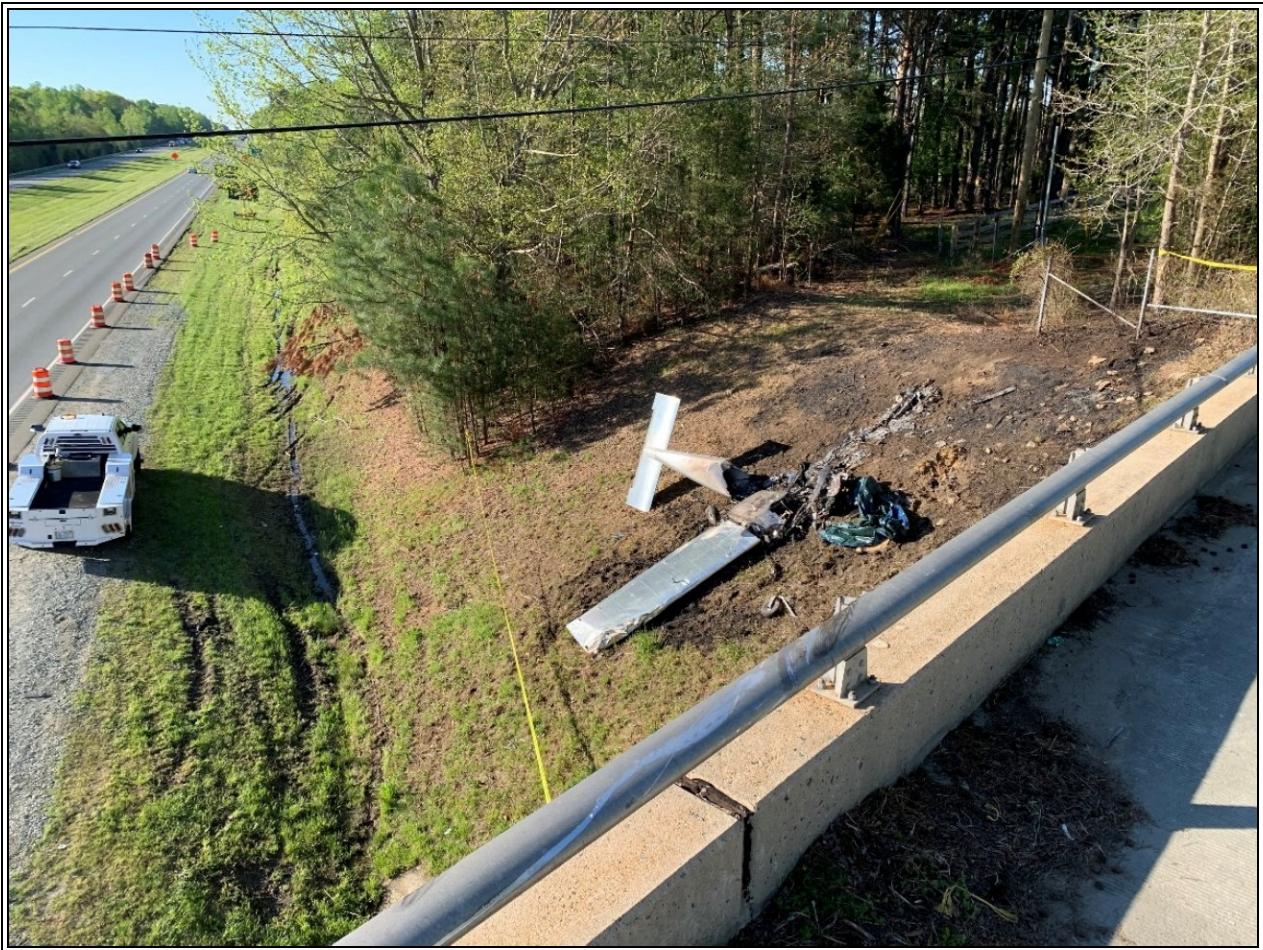
The airplane came to rest inverted, the wreckage was fragmented, and was located in a compact area. All major portions of the airframe were located at the accident site. The engine was co-located with the cockpit and firewall debris. A postcrash fire consumed significant portions of the fuselage, cockpit, and left wing.

Flight control continuity was confirmed from the cockpit to the rudder and elevator surfaces. Multiple breaks consistent with impact-related forces and severe thermal damage were observed within the aileron control push-pull rods. All cockpit switches, instrumentation, the center fuel tank, and non-volatile memory were destroyed by the postimpact fire (see figure 3).

Figure 3 - Overview of the accident site as viewed from the overpass the airplane impacted. Note the powerlines above the overpass, which spanned across the entire highway from east to west.

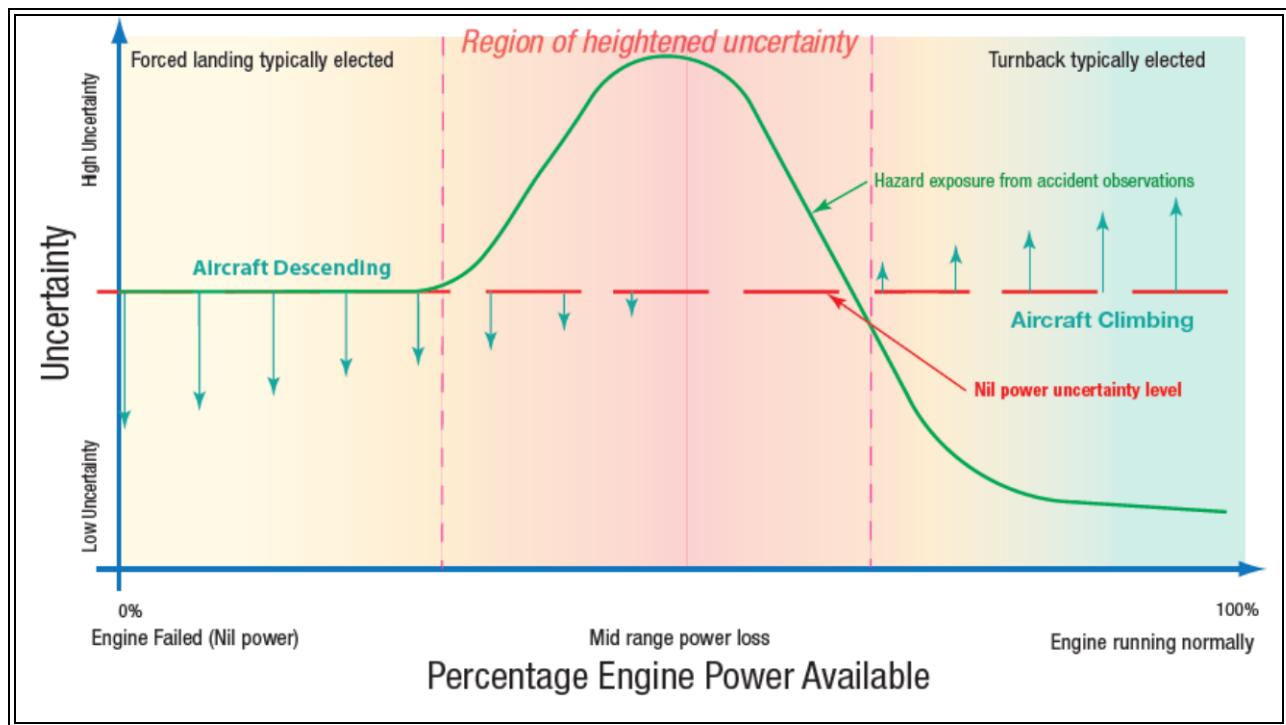
The research also provided a figure that shows the conceptual hazard following a partial loss of engine power after takeoff, drawn from the findings of ATSB fatal accident investigations. When the amount of power lost is close to that experienced with a complete loss, the pilot is likely to identify the severity of the situation readily and take action similar to that expected for a total power loss. At the other end of the spectrum, where the remaining engine power allows the aircraft to climb, more options are available to the pilot, such as climbing slowly into the airport traffic pattern or carefully turning back to the airport, while maintaining glide-speed and height. The region of heightened uncertainty is most prevalent with a mid-range power loss.

Figure 5 - Partial Loss of Engine Power Regions of Uncertainty Chart (ATSB Research, Canberra, 2013)
