Aviation Investigation Final Report

Location:	Boston, Massachusetts	Accident Number:	DCA24LA092
Date & Time:	February 8, 2024, 11:37 UTC	Registration:	N956JT (A1); N2157J (A2)
Aircraft:	Airbus A321-231 (A1); Airbus A321 (A2)	Aircraft Damage:	Substantial (A1); Minor (A2)
Defining Event:	Ground collision	Injuries:	210 None (A1); 154 None (A2)
Flight Conducted Under:	Part 121: Air carrier - Scheduled (A1); Part 121: Air carrier - Scheduled (A2)

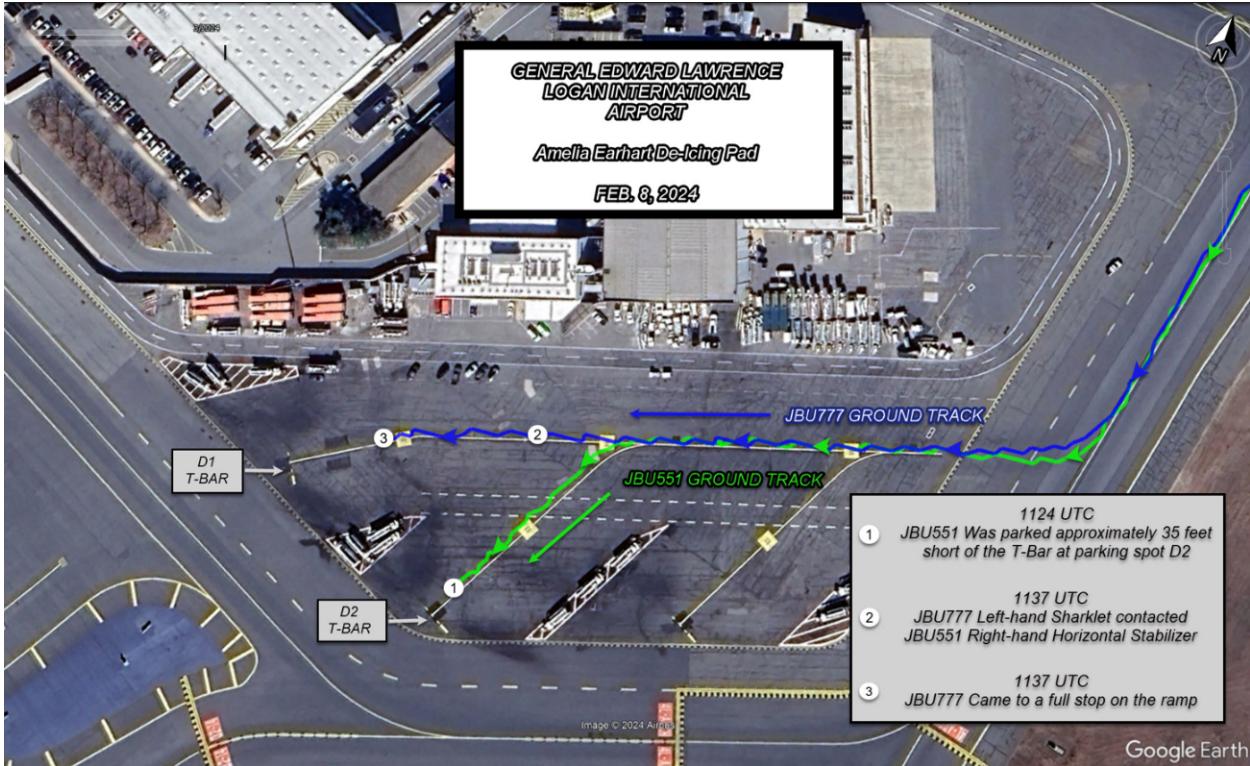
The flight crew of flight 551 stated that, following a normal preflight and uneventful taxi from the gate to the de-icing pad, they were guided by a "follow me" vehicle operated by JetBlue contractor, Aeromag (see figure 1). The flight crew proceeded to follow the vehicle to the D2 parking spot. A yellow painted "T" inside a black square marked the proper stopping point location for the airplane's nose tires when parked. Nearing the stopping point, the "follow me" vehicle turned to the right and stopped with its headlights facing toward the back of the airplane. The driver of the "follow me" vehicle communicated with the flight crew via radio and began a "countdown" for when the captain should stop the airplane.

Figure 1. Google Earth image showing the ground position tracks of both airplanes.

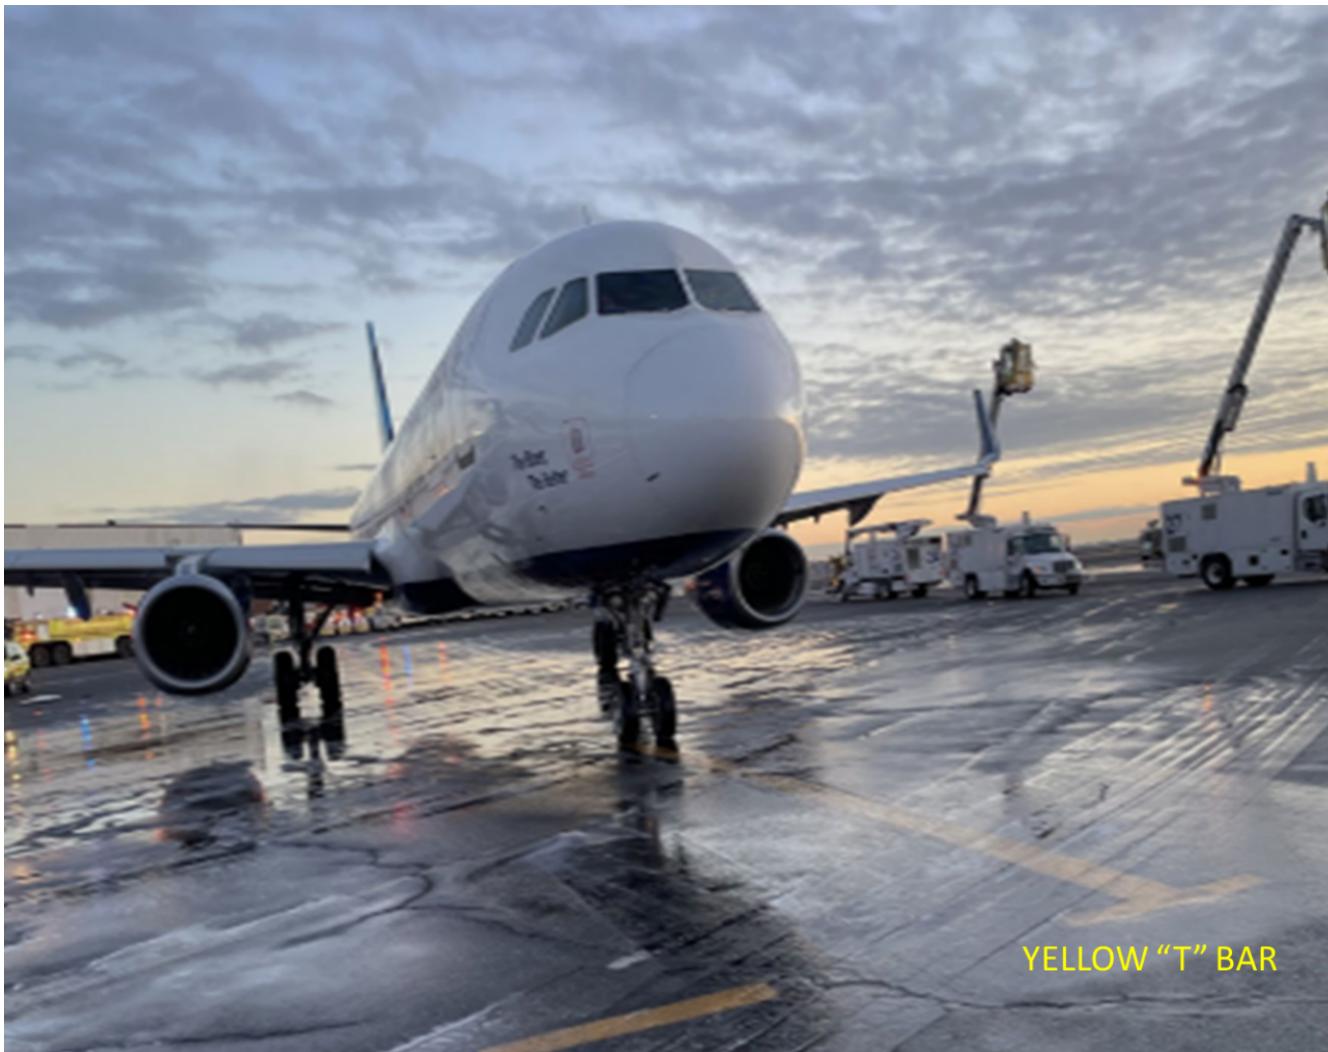
YELLOW "T" BAR

In a post-accident statement, the driver of the “follow me” vehicle indicated that he stopped the airplane (flight 551) at what he thought was the normal stopping point. He had difficulty seeing the yellow “T” -bar due to the dark night conditions and the de-icing fluid that was present on the ground (figure 2). A post-accident inspection found that the airplane was about 35 ft short of the normal stopping point.

Figure 2. Photograph showing N956JT (JetBlue flight 551) about 35 feet from the yellow "T" bar. (Source: JetBlue)

The “follow me” driver stopping the airplane (flight 551) about 35 feet from the normal stopping point due to a difficulty in seeing the yellow “T”-bar because of the dark night conditions and the presence of de-icing fluid on the ground.

- o “Follow me” truck is now required to verbally confirm with the flight crew that the aircraft is correctly stopped on the deicing “T”-Bar.
- o JetBlue will add to the Airport Briefing Guide (ABG) that the pilot will not configure the aircraft until confirmation that the aircraft is correctly stopped on the deicing “T”-Bar.
- o The “follow me” truck is required to check the rear of the aircraft to ensure that it is within the bay and clear of the zipper line before confirming brake set.
- o Safety Lead will perform a secondary check, reconfirming with the CTM that the aircraft has stopped on the deicing “T”-Bar. Safety Lead will also verify that the rear of the aircraft is clear of the zipper line and within the bay.
- o Truck positioning and aircraft deicing will commence after these checks have been completed.

1. Guide the aircraft into the assigned bay.
2. Ensure the aircraft is properly stopped on the deicing “T”-Bar.
3. Confirm that the rear of the aircraft is within the bay, clear of the zipper line, before bringing any other aircraft in.

1. Inspect and confirm with CTM that the aircraft is properly stopped on the deicing “T”-Bar.
2. Inspect that the rear of the aircraft is well within the bay and clear of the zipper line.

- o Repainting and reviewing the color format of the delineated markings using high-visibility paint and/or reflective inset markers.
- o Investigating the feasibility of adding high mast lighting for the Earhart facility.
- o Operational audits to focus on the correct positioning of aircraft while maintaining the safety buffer zones.
- o Explore opportunities to locate Aeromag tower personnel in elevated positions.
