Aviation Investigation Final Report

Location:	Chicago, Illinois	Incident Number:	DCA24LA043
Date & Time:	October 18, 2023, 23:55 Local	Registration:	N30913
Aircraft:	Boeing 787	Aircraft Damage:	Minor
Defining Event:	Ground collision	Injuries:	2 None
Flight Conducted Under:	Part 91: General aviation - Ferry

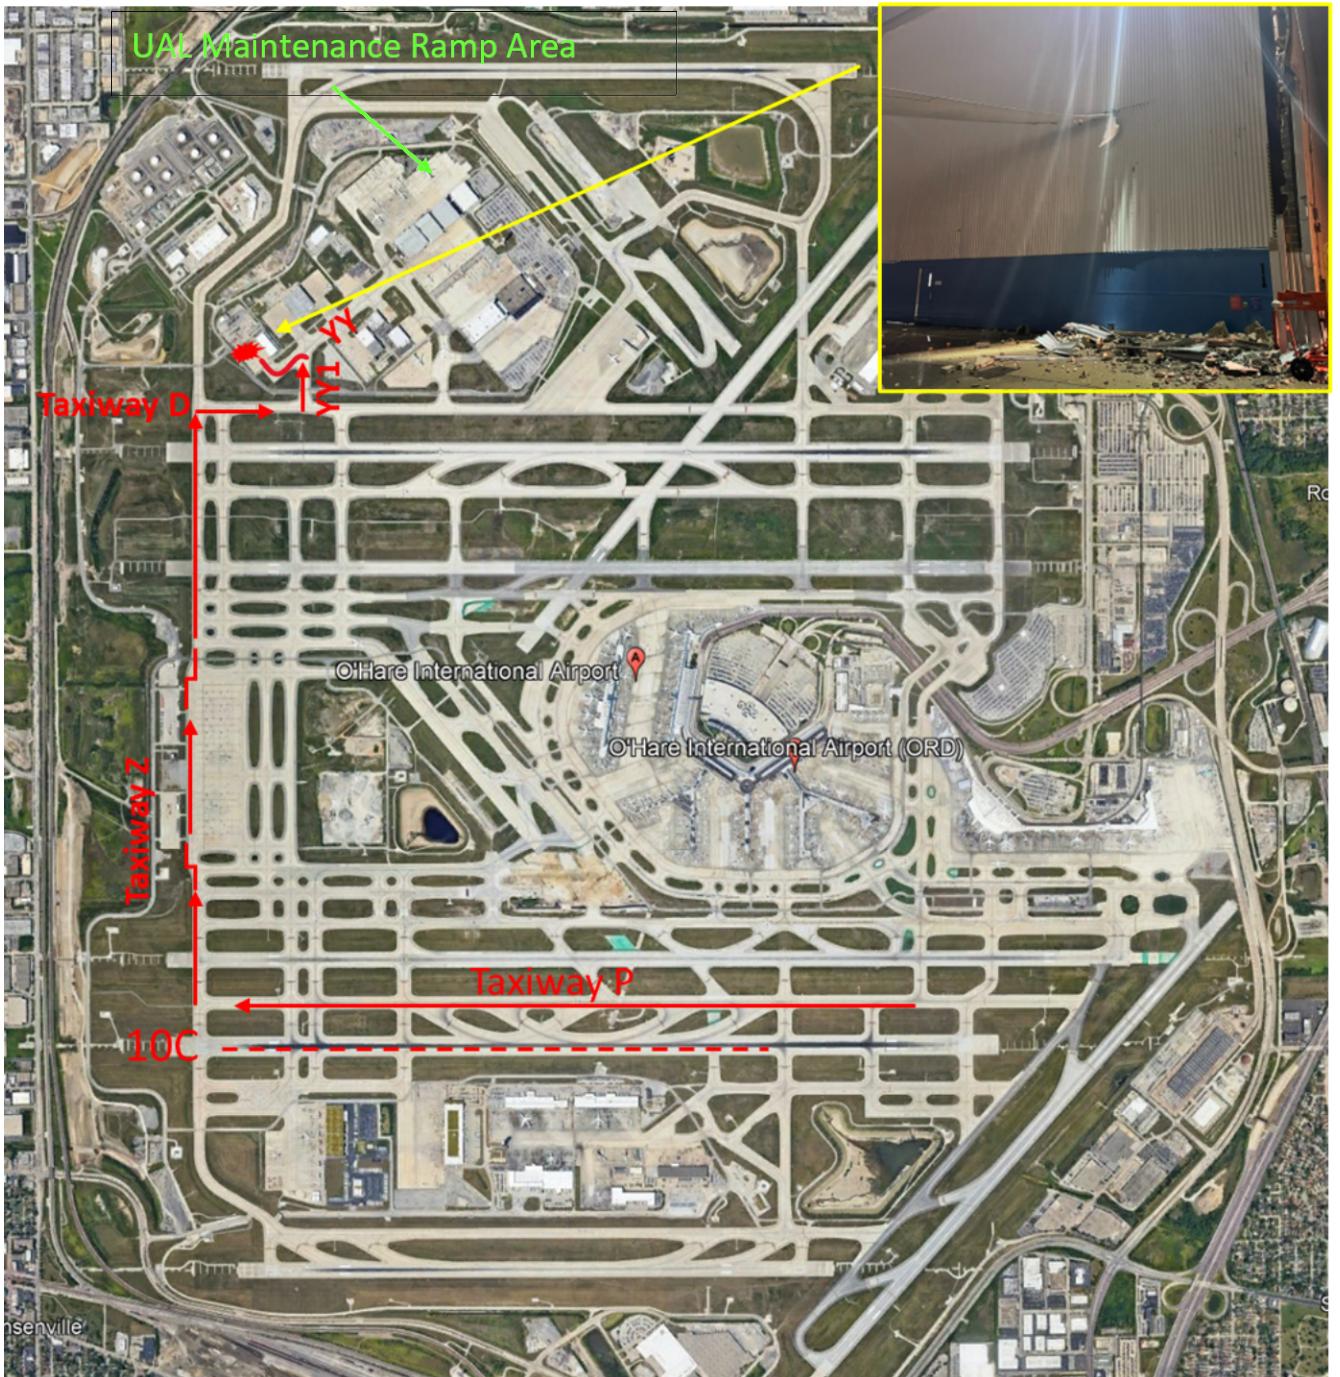
Figure 1 - Google Earth image with taxi route in red. The inset photo of accident site was provided by United Airlines. Green arrow indicates the location of United Airlines maintenance ramp area.

The right-wing tip of the airplane struck a hanger resulting in minor damage to the wing. The damage to the hanger was estimated at about \$236,000. A B787 has a wingspan of 197 feet 3

inches. The distance from the taxiway centerline to the hangar was about 98 ft accommodating a wingspan of about 196 ft.

Had the marshallers met the airplane at American Eagle ramp and provided obstruction clearance guidance and/or the flight crew requested additional ground handling support before attempting to turn around in an unfamiliar area it is likely that the collision would not have occurred.

The flight crew's misperception of the distance required to safely pass the hangar and failure to request additional ground handling support while taxiing, which resulted in a collision with a hangar. Contributing to the accident was United Airlines Maintenance Ramp personnel's ambiguous taxi instructions and lack of obstruction clearance guidance.
