# Aviation Investigation Final Report

<b>Location:</b>	Oshkosh, Wisconsin	<b>Accident Number:</b>	CEN23FA333
<b>Date &amp; Time:</b>	July 29, 2023, 12:27 Local	<b>Registration:</b>	N193AZ (A1); N221EL (A2)
<b>Aircraft:</b>	Rotorway 162F (A1); ELA ECLIPSE 10 (A2)	<b>Aircraft Damage:</b>	Destroyed (A1); Destroyed (A2)
<b>Defining Event:</b>	Midair collision	<b>Injuries:</b>	2 Fatal (A1); 2 Serious (A2)
<b>Flight Conducted Under:</b>	Part 91: General aviation - Personal (A1); Part 91: General aviation - Personal (A2)

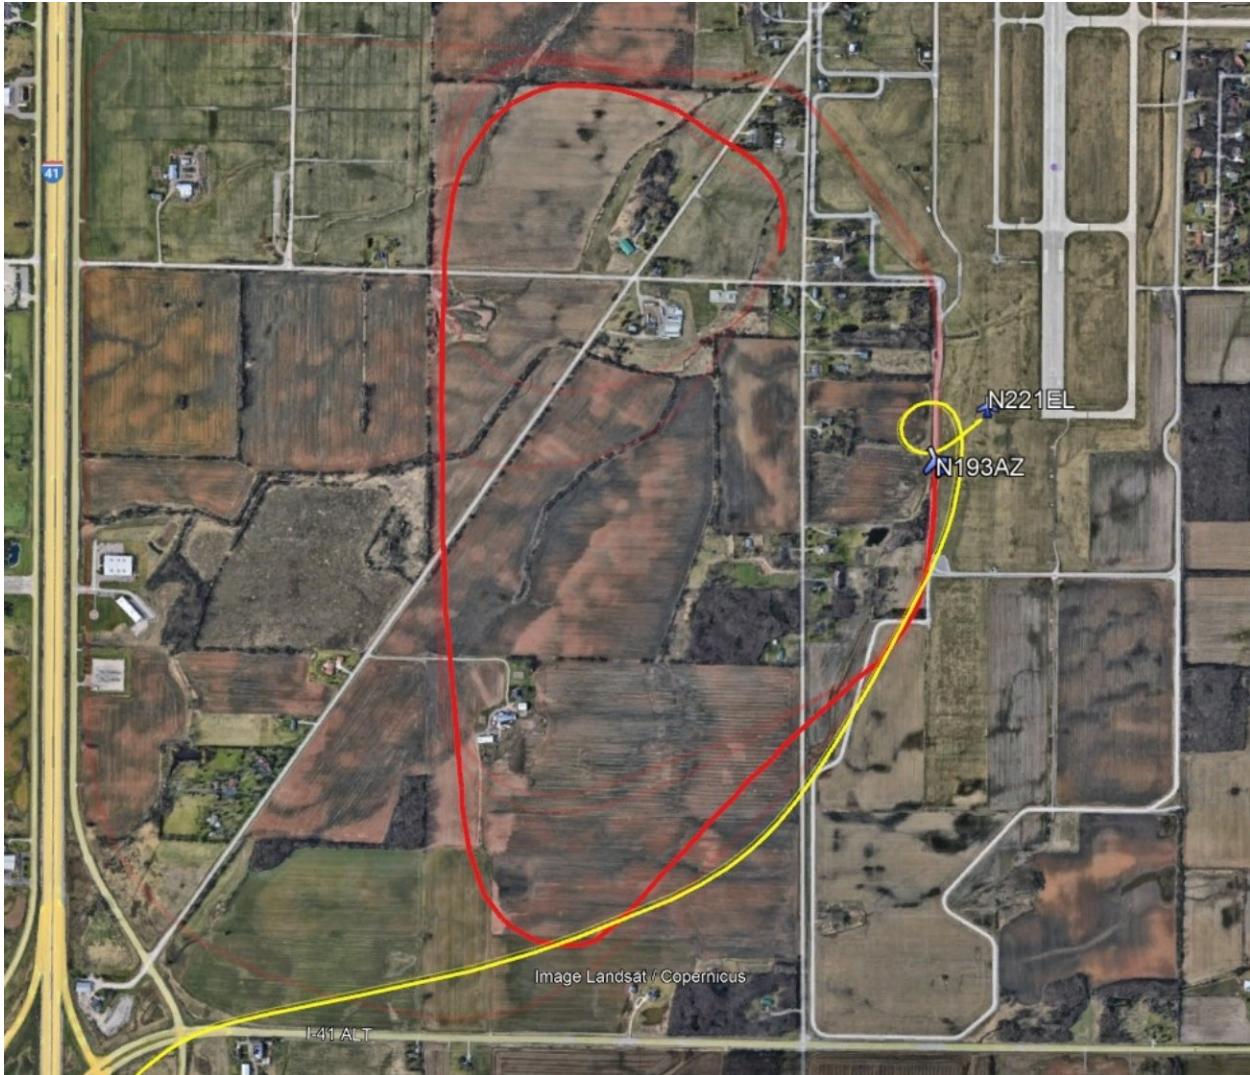
About 35 seconds before the collision, the rear seat passenger in the gyroplane began taking a video with his cellular phone camera. At this time, the gyroplane was on the base leg from the south and began a 360° left turn. The helicopter, which was positioned behind the gyroplane in the traffic pattern, was also approaching the runway on the base leg from the south, following the north/south paved road (see figure 1).

Figure 1. Flight tracks of the helicopter (red) and gyroplane (yellow).

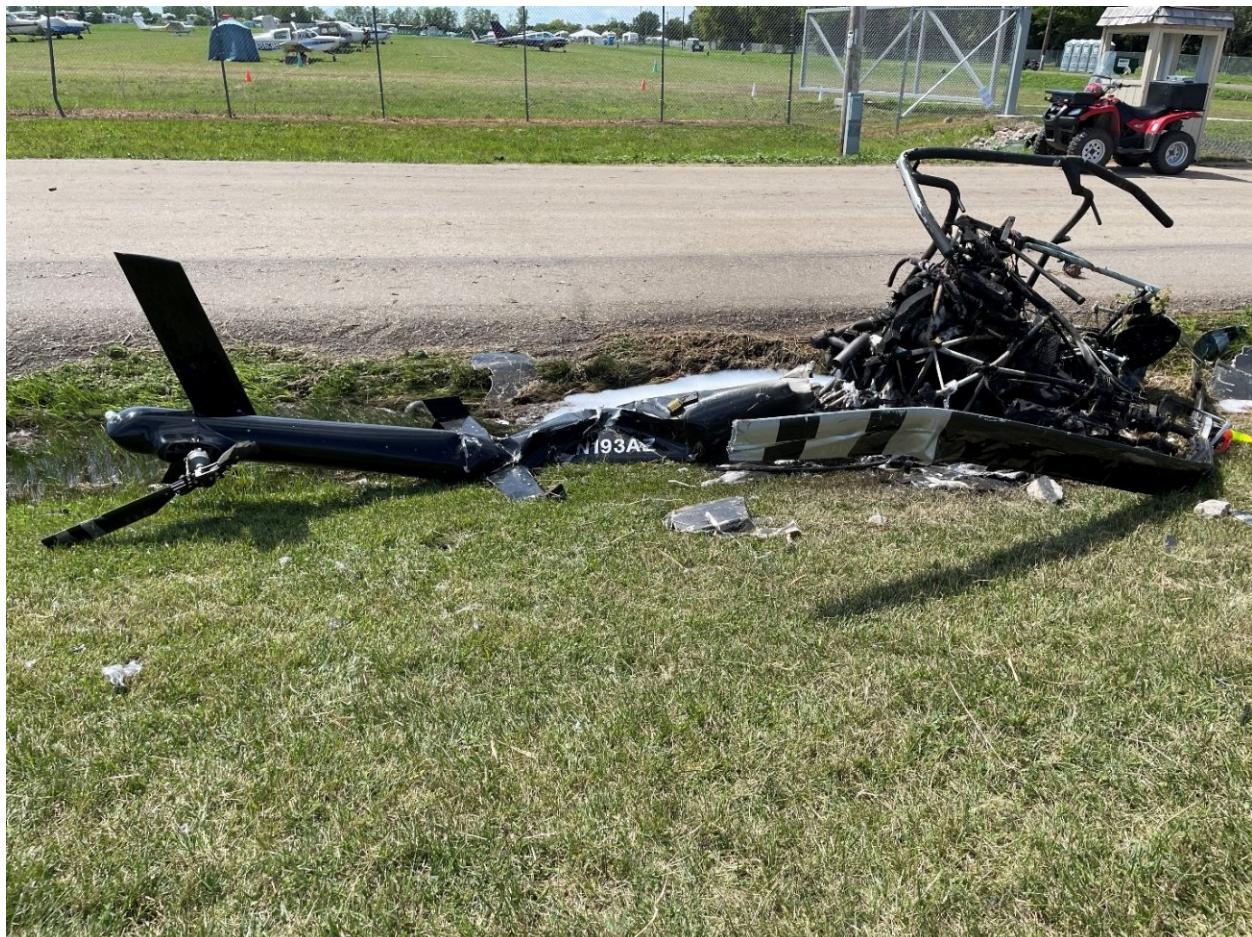
Both aircraft descended in a near-vertical attitude with debris separating from both aircraft. The helicopter impacted terrain, came to rest inverted, and a postaccident fire ensued (see figure 2). The gyroplane impacted an unoccupied airplane that was parked between the north/south paved road and runway 36L (see figure 3). No ground injuries were reported.

Figure 2. Helicopter as it came to rest

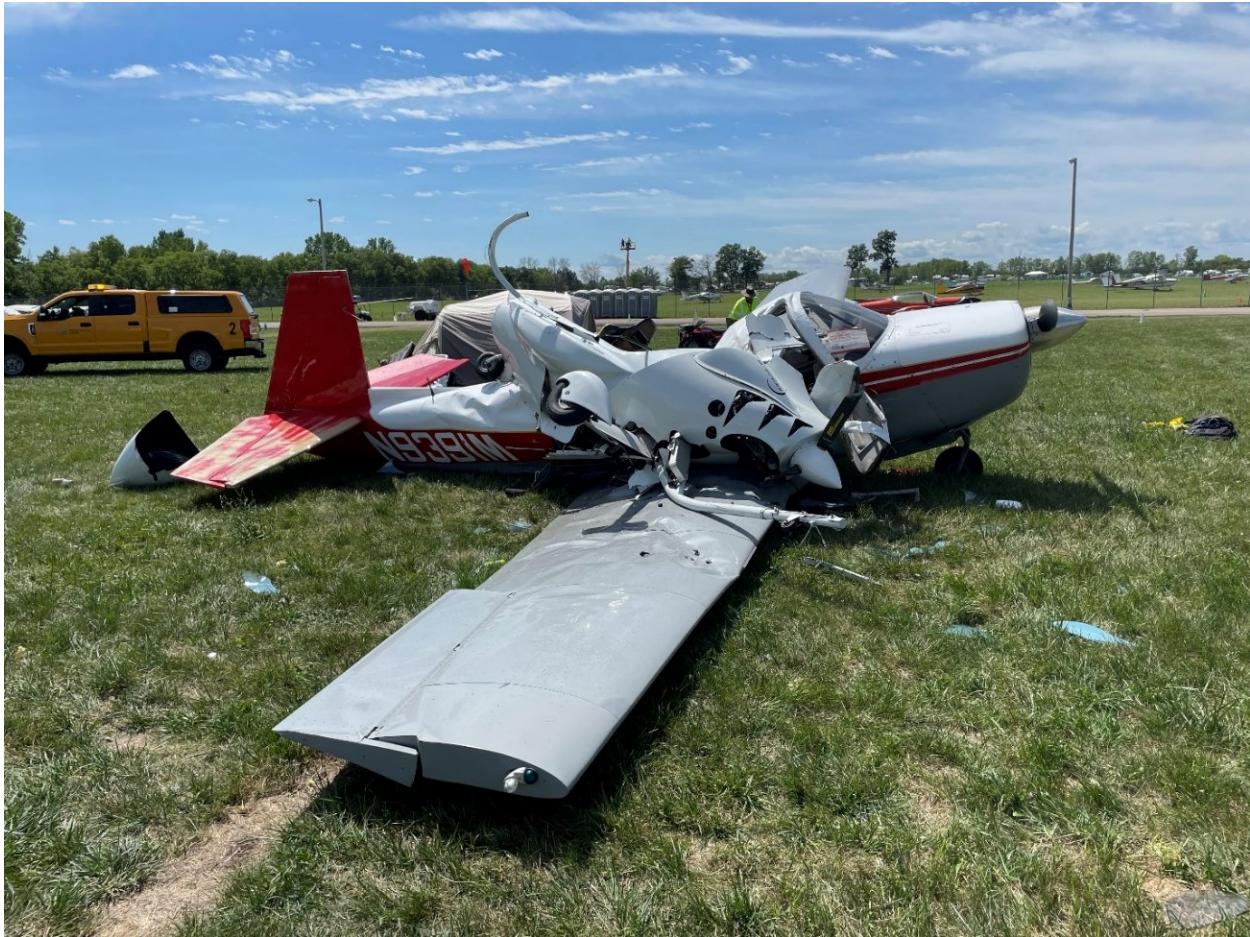
Figure 3. Gyroplane and unoccupied parked airplane

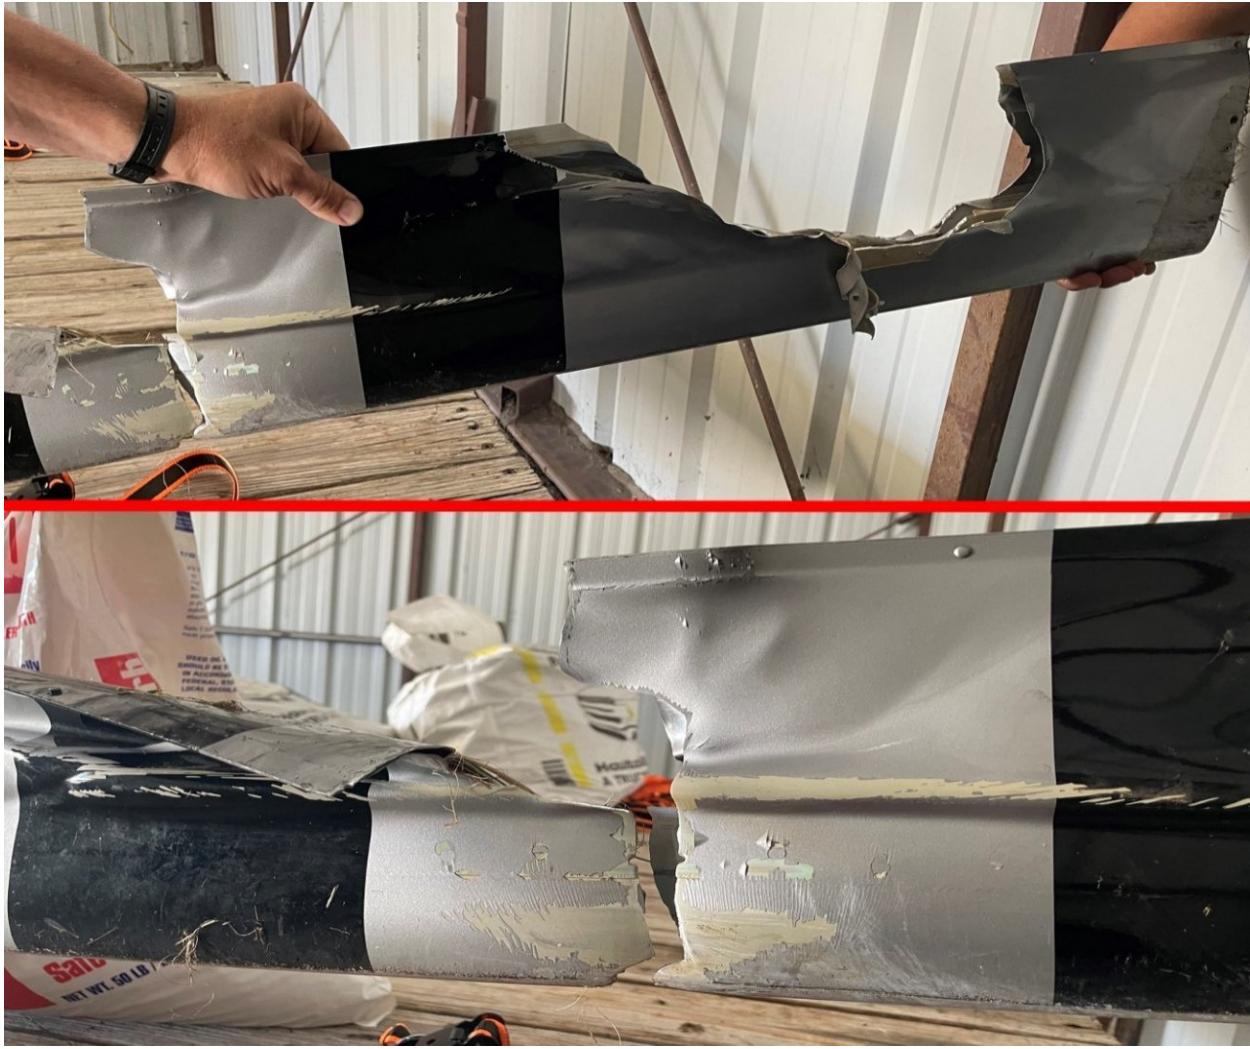
Postaccident examination of the helicopter revealed that both outboard sections of the main rotor blades were separated and came to rest in the debris field (see figure 4). The main rotor blade's structure displayed impact marks and white paint transfers, consistent with the gyroplane's structure and paint color.

Figure 4. Separated outboard sections of the helicopter's main rotor blades.

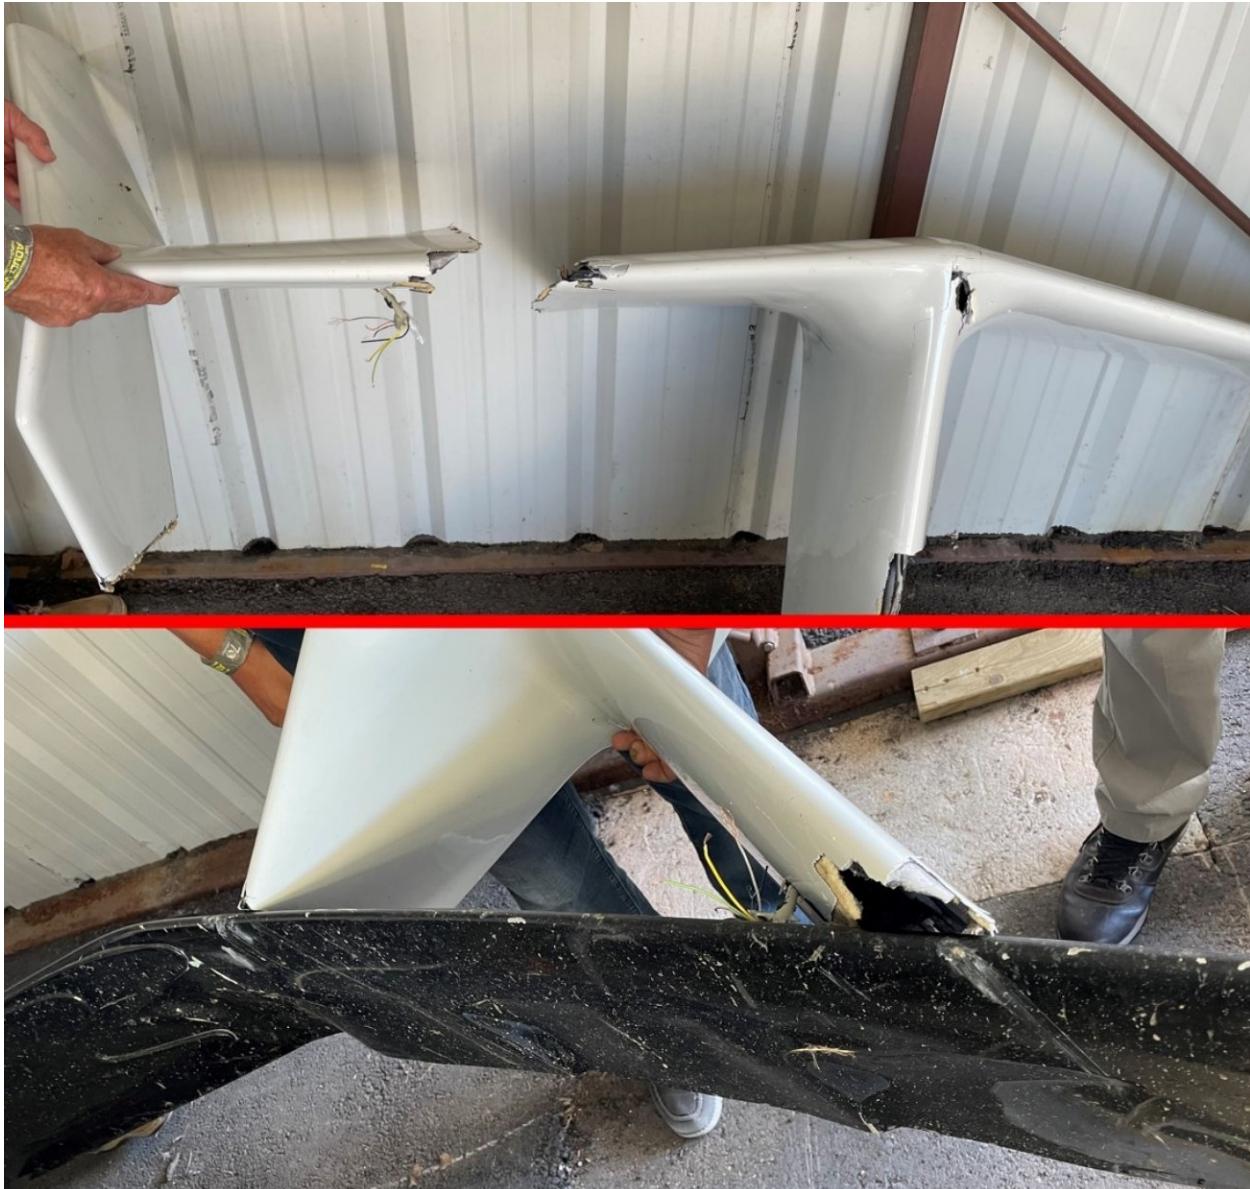
The gyroplane's right horizontal and vertical stabilizers displayed shear cuts and separated structure consistent with helicopter main rotor blade contact (see figure 5). The gyroplane's main rotor mast was separated about mid-length with an impact signature consistent with the helicopter's main rotor blade (see figure 6).

Figure 5. The upper photograph depicts the gyroplane's separated right horizontal stabilizer and lower vertical stabilizer. The lower photograph depicts the separated stabilizer section in comparison with the helicopter main rotor blade contact witness marks and white paint transfer.

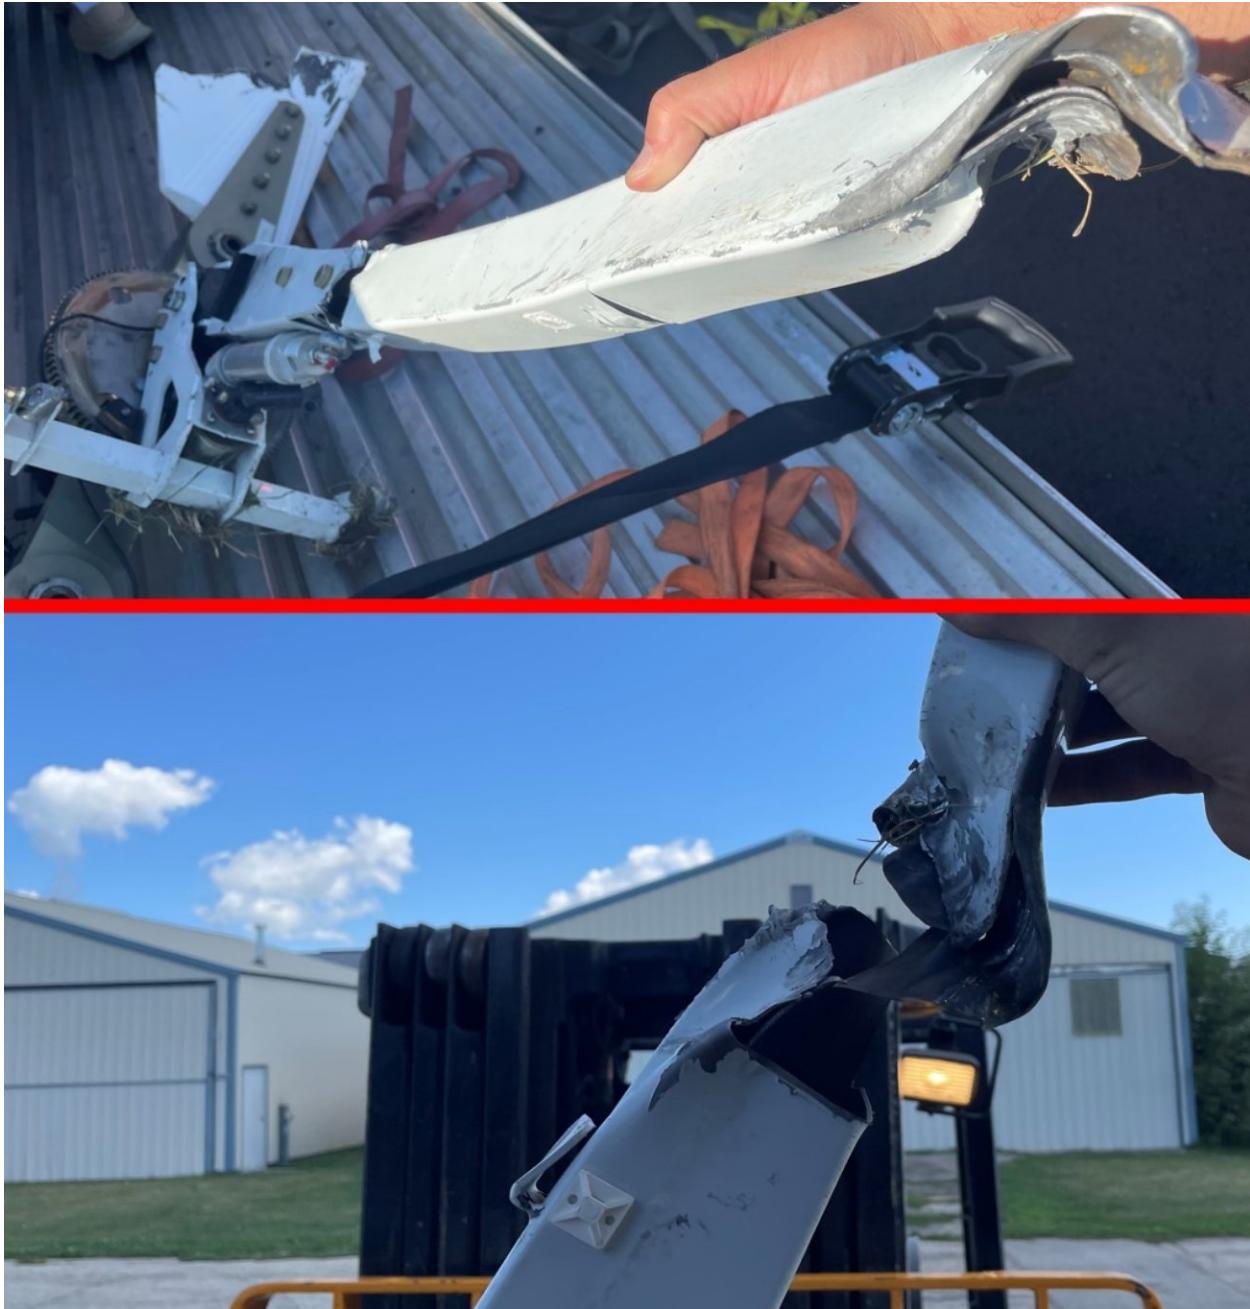
Figure 6. Gyroplane's separated rotor mast section and the helicopter's main rotor blade contact witness mark.
