Aviation Investigation Final Report

Location:	Creswell, Oregon	Accident Number:	WPR23LA184
Date & Time:	May 9, 2023, 17:50 Local	Registration:	N468MM
Aircraft:	RANS S-21	Aircraft Damage:	Substantial
Defining Event:	Loss of engine power (total)	Injuries:	1 None
Flight Conducted Under:	Part 91: General aviation - Personal

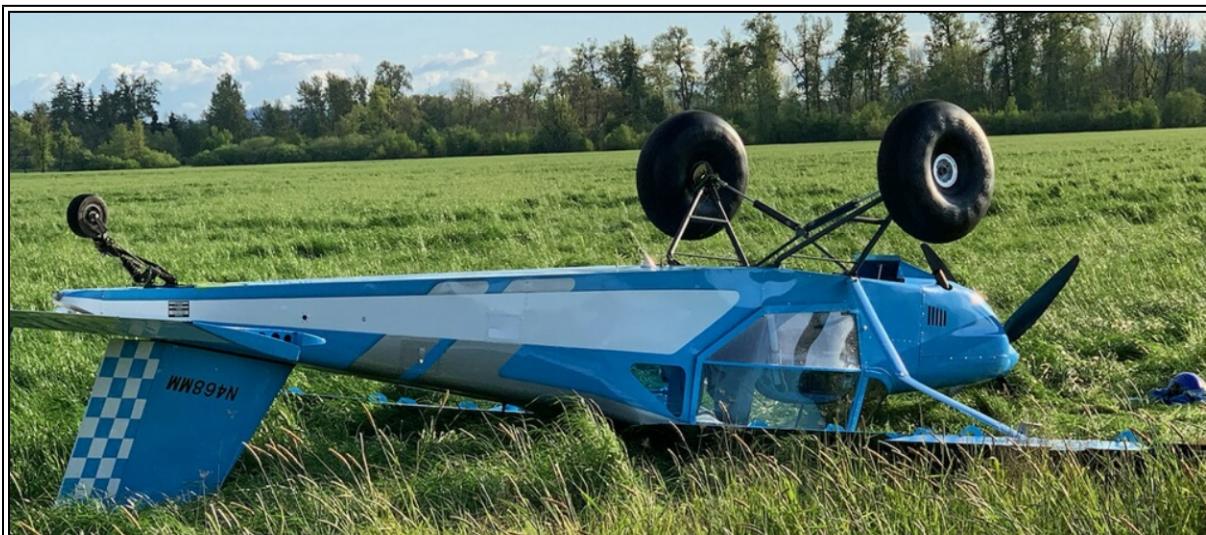
Figure 1: Wreckage

The pilot and his son had recently finished building the airplane. The accident flight was one of a series of test flights the pilot was performing after making cowling modifications. After a normal departure, the pilot flew to a test area and was in flight for about 20 minutes. While the pilot was maneuvering at about 700-900 feet above ground level (agl), the engine made "rough" sounds and vibrated. About 20 seconds later, the propeller seized, and the pilot made a forced landing in the field below. During landing roll out, the airplane flipped over and came to rest inverted, damaging the vertical stabilizer (see Figure 1 below).

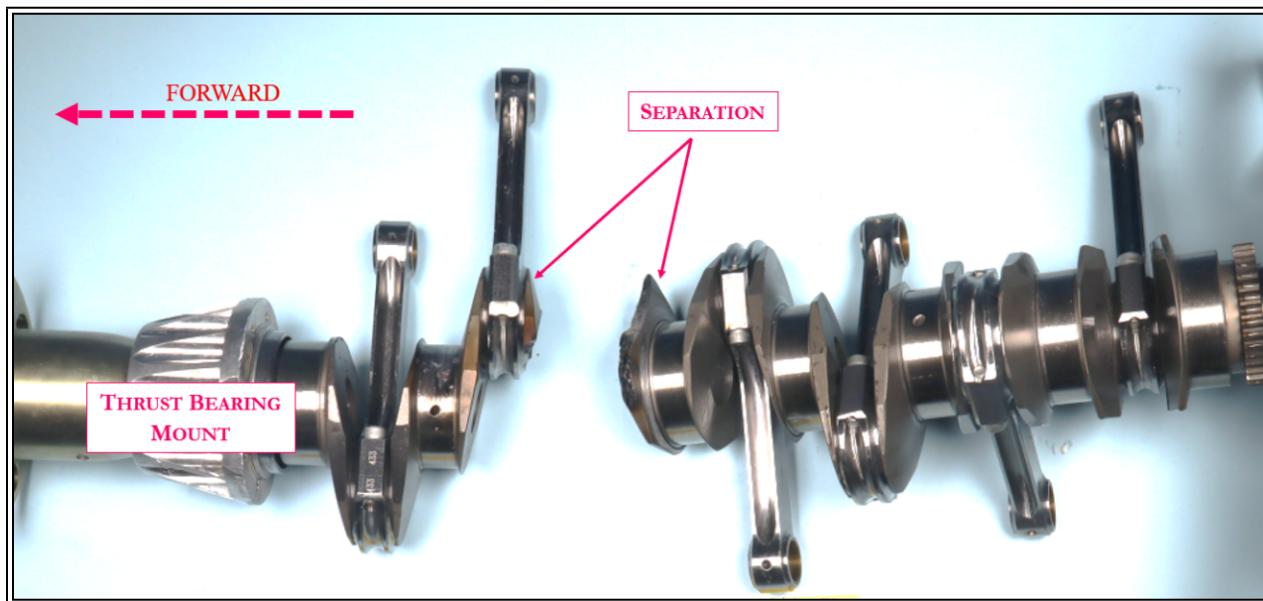
Figure 2: Crankshaft

Upon applying force to the propeller, the engine would not rotate through. Removal of the pistons revealed that the crankshaft was fractured at a web (crank cheek), just aft of the No. 2 connecting rod journal. The thrust bearing mount was able to move forward and aft.

Disassembly of the crankcase revealed that the six connecting rod journals still had their respective rods and caps attached; all were able to be easily rotated about their respective journals (see Figure 2 below).

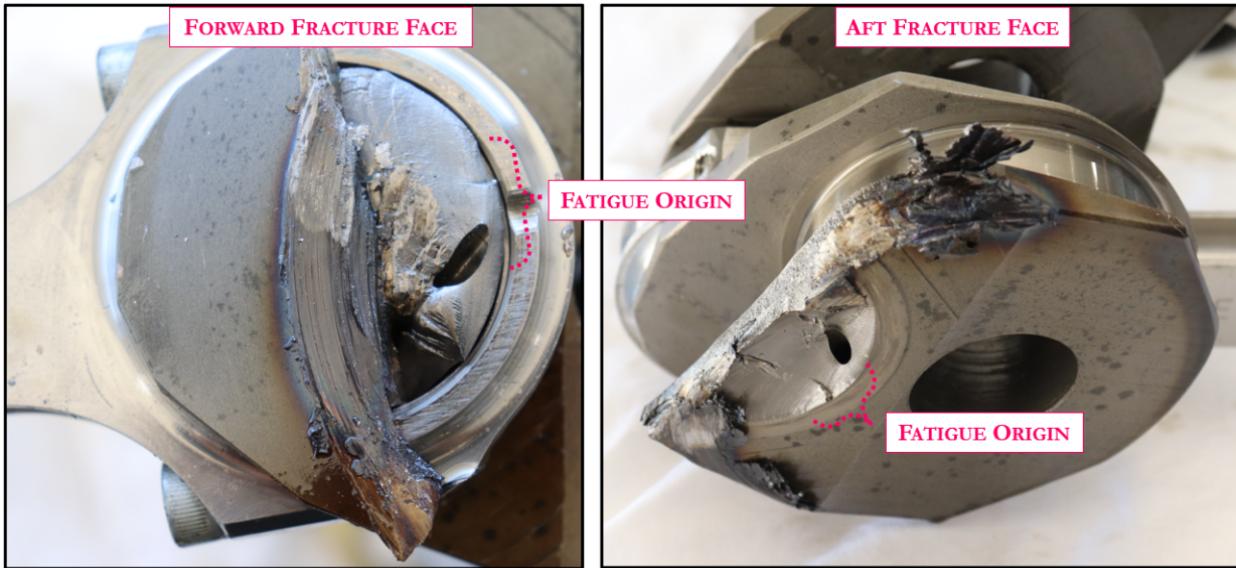
Figure 3: Mating Fracture Faces

A total loss of engine power caused by fatigue cracking and fracture of the crankshaft due to severe wear of the bearings.

The fracture extended through the crank cheek in the area between the No. 2 rod journal and the No. 3 main journal. The fracture surface was relatively shiny and reflective, with a portion of the cheek showing severe deformation damage and heat tinting on the forward face. The preliminary assessment of the fracture surfaces was consistent with a fatigue fracture at the aft radius of the No. 2 rod journal (see Figure 3 below).

The No. 2 rod journal's aft fracture face displayed crack arrest marks consistent with fatigue cracking, originating from multiple points at the surface of the aft radius. Circumferential scoring marks were present on the surface of the aft radius, intersecting the fatigue origin area, with the fatigue crack measuring about 1.6 inches. The crack propagated through 30% of the rod journal cross section. The remaining fracture extended axially through the crank cheek between the No. 2 rod journal and the No. 3 main journal. The major portion of the crank cheek fracture exhibited damage consistent with post-fracture mechanical damage. The mating fracture exhibited similar fracture features.
