Aviation Investigation Final Report

Location:	Lampasas, Texas	Accident Number:	WPR23LA117
Date & Time:	March 4, 2023, 11:00 Local	Registration:	N6532M
Aircraft:	Stinson 108	Aircraft Damage:	Substantial
Defining Event:	Loss of engine power (partial)	Injuries:	1 None
Flight Conducted Under:	Part 91: General aviation - Personal

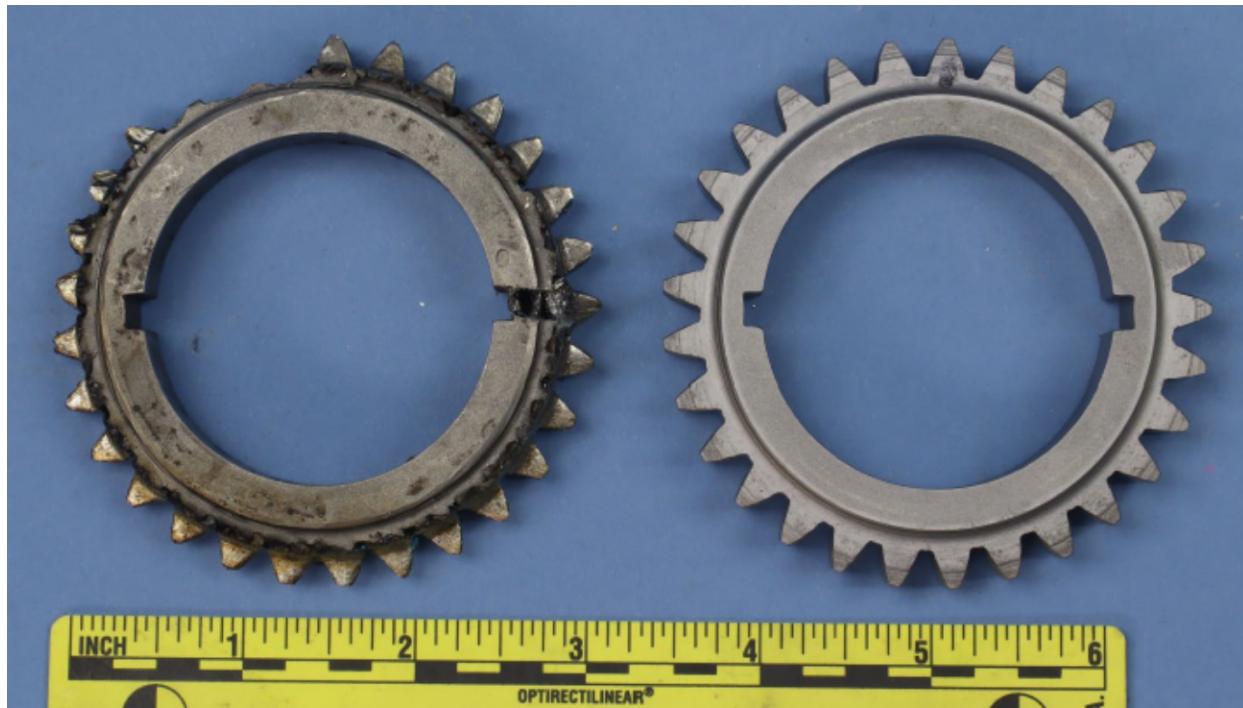
Three liberated gear teeth were recovered from the oil sump. The teeth and crankshaft timing gear were sent to the National Transportation Safety Board Materials Laboratory for examination. Figures 1 and 2 show the accident gear alongside an exemplar gear.

Figure 2. The accident gear (left) and an exemplar gear (right).
