# Aviation Investigation Final Report

<b>Location:</b>	Sioux City, Iowa	<b>Incident Number:</b>	ENG23LA030
<b>Date &amp; Time:</b>	June 17, 2023, 10:59 Local	<b>Registration:</b>	N926TT
<b>Aircraft:</b>	GULFSTREAM AEROSPACE G-IV	<b>Aircraft Damage:</b>	Minor
<b>Defining Event:</b>	Powerplant sys/comp malf/fail	<b>Injuries:</b>	9 None
<b>Flight Conducted Under:</b>	Part 135: Air taxi & commuter - Non-scheduled

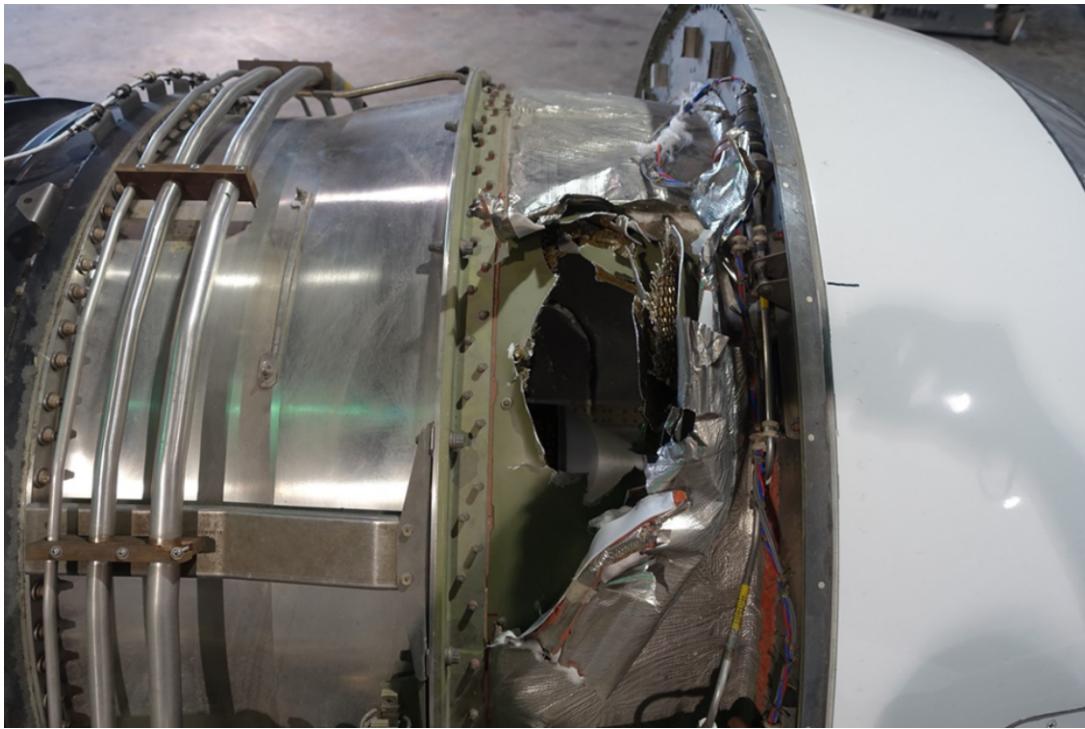
The No. 2 engine inlet cowl had multiple acoustic liner impact gouges into the honeycomb structure, 360 degrees around the circumference. The impact damage was most severe from the fan blade path leading edge to approximately 12 inches forward of the fan blades. There was a rounded slice at the 8 o'clock position that had an arc length of approximately 15 inches. The inlet cowl had a penetration at the 1 o'clock position that measured approximately 12 inches circumferentially by 7 inches axially at the widest points. The penetration extended axially from the inlet cowl bulkhead to approximately 2 inches forward of the inlet cowl-to-fan case flange (Photo 1). The inlet cowl composite and metal material around the hole was petaled radially outward. There were two additional small inlet cowl penetrations at the 3 o'clock and 10 o'clock positions. The penetration at the 3 o'clock position measured approximately 0.5 inch axially by 2 inches circumferentially and extended forward from the inlet cowl-to-fan case flange. The fan cowl metal and thermal blanket insulation around the hole were displaced radially outward. The

small penetration at the 10 o'clock position was located on the inlet cowl-to-fan case flange. Light was barely visible through the impact and there was no evidence of material escape.

Photo 1- Inlet Cowl Penetration, 10 o'clock Position

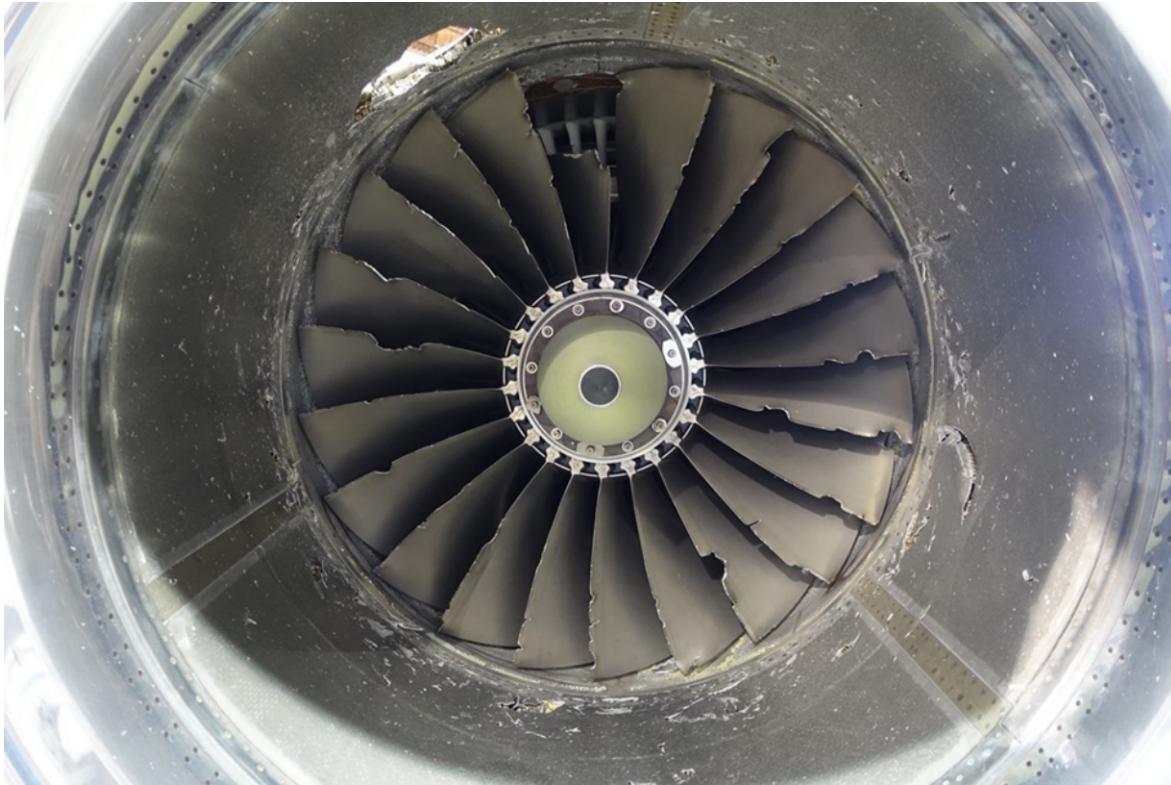
Photo 3- Fan Blade Damage, Fan Blade Position 7 Midspan Separation

The fracture surfaces of fan blade position 7 were approximately 7.56 inches-8.66 inches (192mm-220mm) above the platform. The fracture surfaces were consistent with forced rupture (overload) originating from a leading edge impact. SEM/EDS analysis confirmed the fan blade material was consistent with Ti 6/4 as specified on the part drawing.
