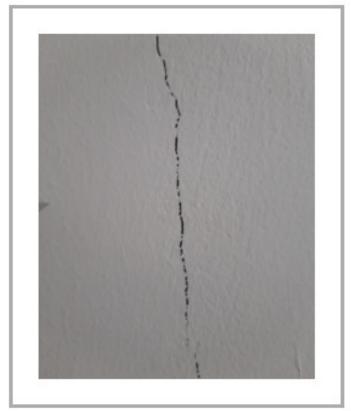
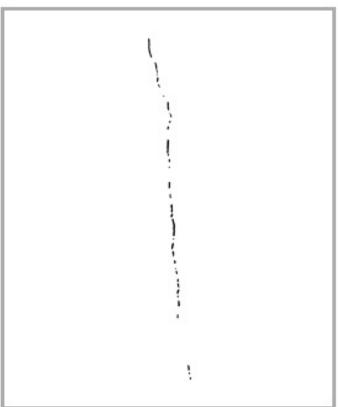
The image characterized as: **Contains Crack**

Length: **25.09 cm**

Width: **3.59 mm**

Positive Crack Probability: **72.89%**

Negative Crack Probability: 27.11%

Location of Crack: Column
