# Investigation into the Internal Erosion and Local Settlement of Esfarayen Earth-Fill Dam

Seyyed Kazem Razavi<sup>1</sup>; Masoud Hajialilue Bonab<sup>2</sup>; and Ahmad Dabaghian<sup>3</sup>

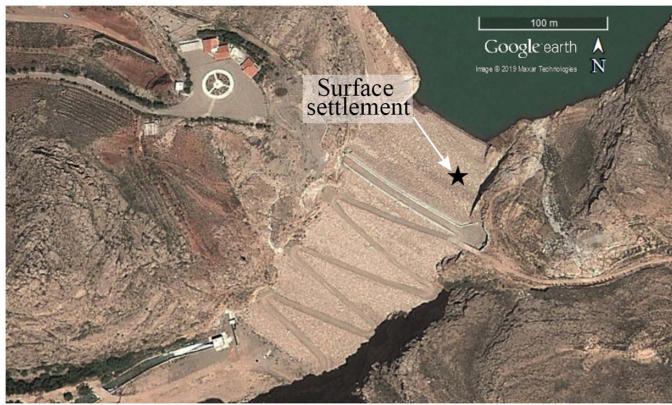
**Abstract:** A considerable sudden settlement was discovered on the Esfarayen Earth-fill Dam surface near to the left abutment when the reservoir level rose to 51 m from the riverbed in April 2013. As a result, a detection process was prepared to comprehend the problem and relevant challenges required to consider devising an appropriate remedial work. For this purpose, the work was divided into three main parts: (1) analyzing the information gathered from the monitoring and surveillance plan, (2) performing a geotechnical site investigation to test the subsurface condition and the extent of the problem, and (3) finding the cause of the problem initiation by considering three aspects—the bedrock geological condition, material susceptibility, and three-dimensional numerical modeling. The outcomes from the different parts of the study categorized the problem as an internal erosion incident. The existence of an inadequate sealed crushed zone of a fault passing through the reservoir on the contact surface with the clay core was the major cause of the internal erosion initiation. The water, appearing through this narrow crushed zone, applied additional hydrostatic pressure on the clay core, which depended on the reservoir level and had no influence on the stress distribution inside the dam. With the water pressure exceeding the minor principal total stress, a crack formed and extended with time, turning to a large void. Because of the high quality of the clay core material and its well-designed downstream filter, the internal erosion progression was concentrated on the core and directed to the upstream. When it reached the upstream filter, the filter entered into the core, and the material from the overlying part of the dam repeatedly dropped, resulting in a final settlement on the dam surface. The numerical modeling was successful in the determination of the approximate time of the internal erosion initiation by considering the past loading history of the dam and the influence of the existing defect. DOI: [10.1061/\(ASCE\)GT.1943-5606.0002216](https://doi.org/10.1061/(ASCE)GT.1943-5606.0002216). © 2020 American Society of Civil Engineers.

**Fig. 2.** Observed surface settlement near to the left abutment. (Map data © 2019 Google, Image © 2019 Maxar Technologies.)

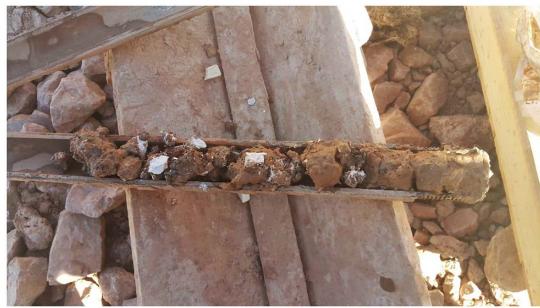
**Fig. 11.** Rock samples covered with the clay core obtained at elevation 1,475 m.
