Geotechnical aspects and seismic damage of the 156-m-high Zipingpu concrete-faced rockfill dam following the Ms 8.0 Wenchuan earthquake

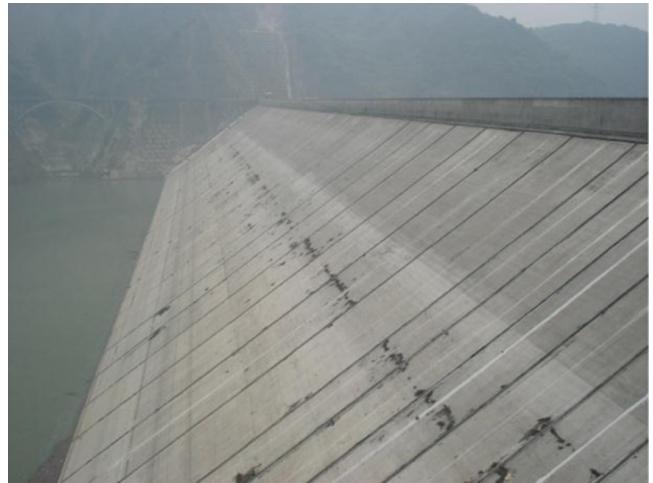
Fig. 10 shows the upstream surface of the Zipingpu CFRD after the Wenchuan earthquake. The surface features indicating the nature of damage to concrete face slabs include arching, bulging, detaching and cracking with several penetrating cracks on the upstream face slab nos. 3–8, 10–12, 15, 17–25, 27, 28 and 36. The horizontal construction joints defining the second and third stages experienced extensive dislocations (Fig. 11), which were resulted from excessive residual shear strain or permanent deformation of the rockfill ([29,30]) and affected by water elevation in the reservoir [18]. The total length of dislocation was up to 340 m and the maximum dislocation was 170 mm. The steel rebar was bent due to relative movement of the slabs. For example, dislocations of 150–170 mm were observed on slab nos. 5–12; 120–150 mm on slab nos. 14–23; and 20–90 mm on slab nos. 30–42. Moreover, cracks developed at the construction joints on slab nos. 30–34 and 39–42 at El. 845.0 m.

Fig. 10. Upstream surface of the Zipingpu dam after earthquake [12].

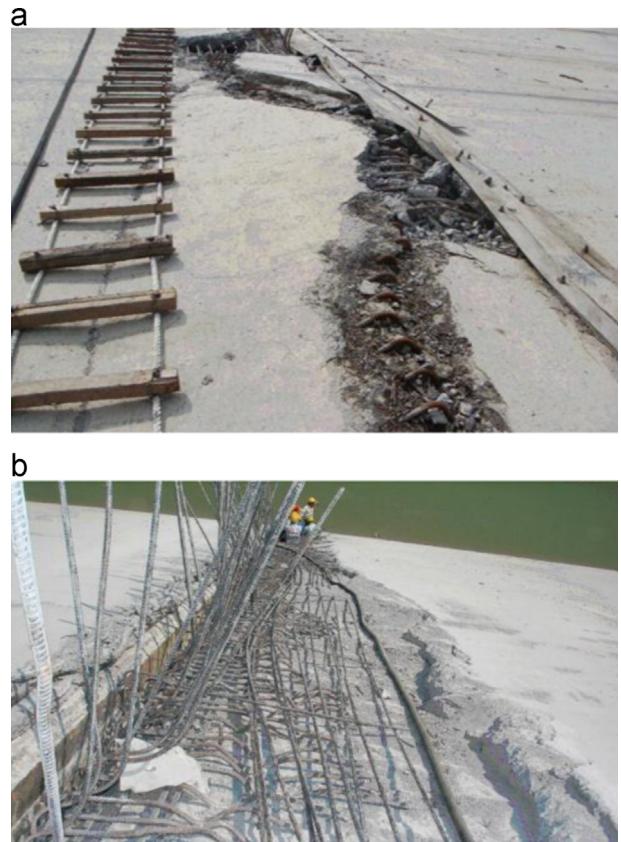
In addition to the dislocations along the construction joints as previously described, severe dislocations also developed along the vertical joints. For instance, the dislocation between face slab nos. 5 and 6 reached 350 mm and the concrete on both sides of these slabs suffered from compression damage from El. 880.4 m to El. 845.0 m. The dislocation between face slab nos. 23 and 24 extended

from the top to the underwater elevation of 791.0 m with a maximum dislocation of 150 mm and damaged length accounting for 60% of the total length of the slabs. As shown in Fig. 12, the concrete of slab no. 23 was compressed with a damage width of 0.5–1.7 m. A borehole inspection of slab no. 23 at El. 843.0 m also indicated that the damaged depth of the concrete was 320 mm and that a cavity of 50 mm in dimension had formed. The mesh reinforcement that had been installed within the edges of the slabs was detached from its protective concrete layer.

Fig. 12. Damages to No. 23 slab: (a) squeezing damage to concrete and (b) excavation of the damaged concrete [12].

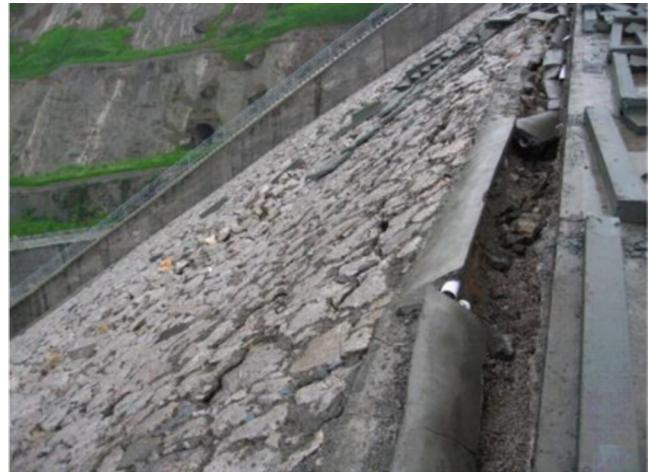
The masonry stones on the downstream slope below the crest curb stone slid downstream, leaving a gap between them with a maximum width of 650 mm. A close-up view of this area is shown in Fig. 13. Large areas of masonry stones near the right abutment were uplifted. Those adjacent to the berms at El. 840.0 m and 796.0 m were loosened and displaced. Those within El. 780.0–790.0 m and below the berm of El. 796.0 m were uplifted and loosened. Some scattered stones below the berm of EL. 840.0 m fell off.

Fig. 13. Gaps between dam crest and downstream stone masonry [12].
