**Asbestos Survey Report –**  
**Management Survey**

**Lyngarth, Old House Lane,  
Marton, Blackpool, FY4 5LD**

**Our Reference: PG152/15PR**  
**Surveyor(s): P.Rawcliffe**  
**Date of Survey: 17<sup>th</sup> April 2015**

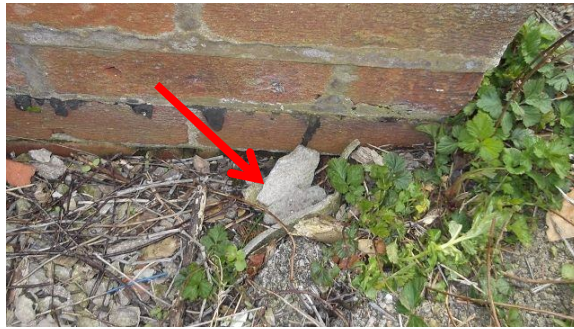
- Asbestos cement debris to the grounds of the Lyngarth property. The debris was located adjacent to the front door. The debris was found to be in a poor condition and partially buried in the ground. The total area affected was approximately 1m<sup>2</sup>.

| Room Number | Location | Product Type | Extent | Accessibility | Condition | Surface Treatment | Asbestos Type | Sample Number / Presumed | Material Assessment Score | Priority Assessment Score | Action |
|---|---|---|---|---|---|---|---|---|---|---|---|
| External | Grounds | Asbestos Cement debris | 1m <sup>2</sup> | Easy | Poor | Partially buried | Chrysotile | PH14855B | 6 | 6 | Remove – HSE licensed asbestos contractor |

| Reference: | Premises Name and Address: | | | | | | | Client | | | Survey Date(s) | | Surveyor(s) | |
|---|---|---|---|---|---|---|---|---|---|---|---|---|---|---|
| PH14855B | External | Grounds | Asbestos<br>Cement debris | 1 | 3 | 1 | 1 | 6 | 1 | 2 | 2 | 1 | 6 | 12 |

| Lab.Ref.No. | Your Ref.No. | Sampling Location | Date of submission to Laboratory | Type of Asbestos | |
|---|---|---|---|---|---|
| PH14855B | PG152/15PR-8 | CEMENT DEBRIS IN GROUNDS | 21.04.15 | CHRYSTOLE | S8 |

1. Asbestos cement debris within the grounds of the Lyngarth property – adjacent to front door.

- The identified asbestos cement debris within the grounds of the Lyngarth property must be removed by a licensed asbestos contractor (LCC approved) at the earliest opportunity.
- No access was gained to the external outbuildings as they had been secured to prevent access. Please contact LCC Design & Construction to arrange a further inspection once the security fittings have been removed and access can be gained.
- The grounds to the Lyngarth property were inspected during the survey. However, the plot was heavily overgrown with vegetation, which prevented a thorough visual inspection. Any work within the grounds must be undertaken with caution due to potential asbestos debris concealed by the vegetation (e.g. asbestos cement from a former outbuilding). Please contact LCC Design & Construction for further advice if any work is planned within the grounds of the Lyngarth property.

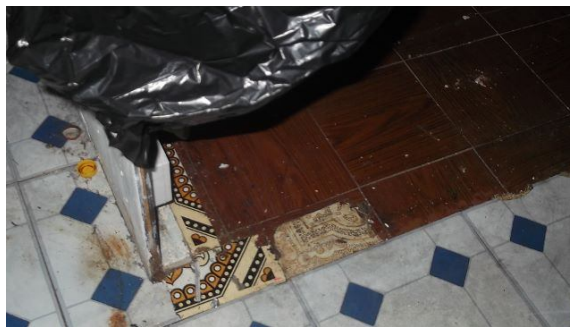
2. No asbestos detected in the floor tiles and lino – area 5.

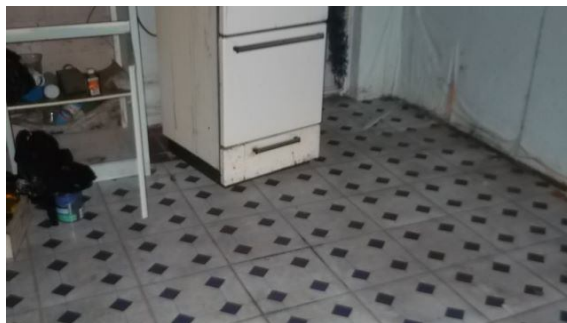
3. No asbestos detected in the floor tiles – areas 3, 5, & 10.

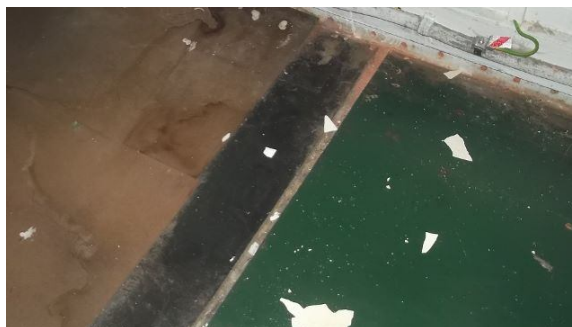
4. No asbestos detected in the flooring material – area 4.

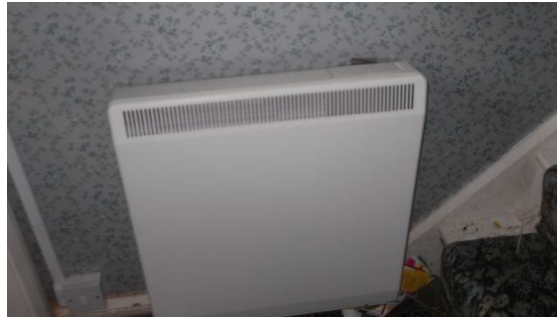
5. No asbestos containing materials to the Creda TSR12AW / TSR18AW & TSR24AW heaters – areas 1, 9 & 2.

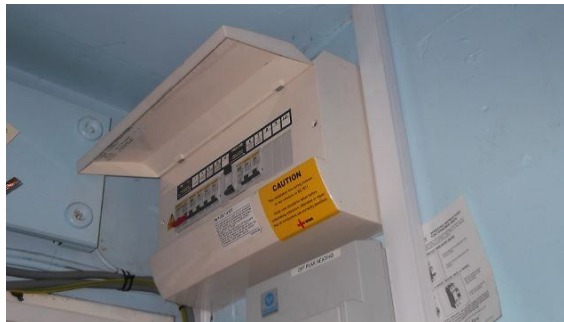
6. Modern distribution board – area 1.

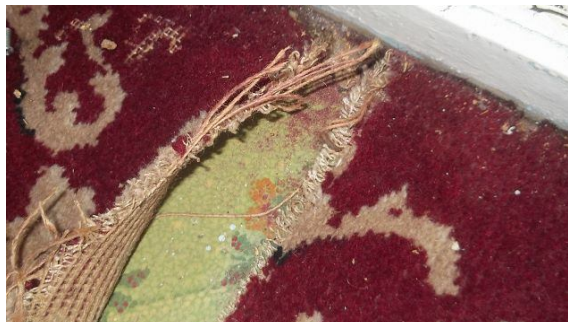
7. No asbestos detected in the lino flooring under the carpet – area 8.

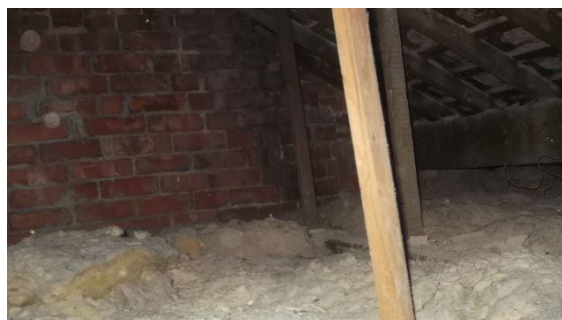
8. MMMF insulation in the roof space.

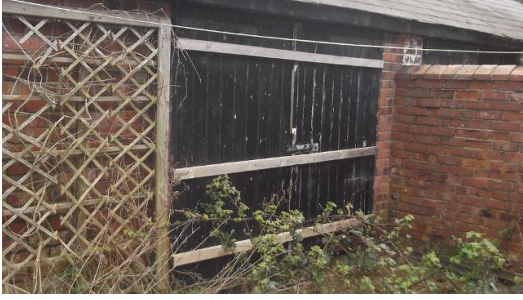
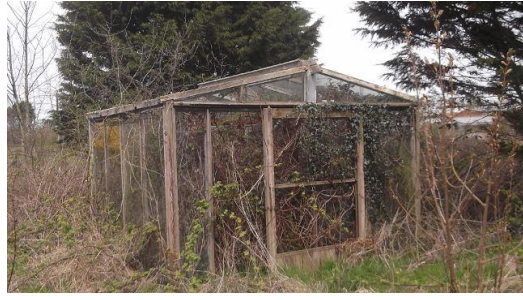
9. No access to the out buildings in the grounds of the Lyngarth property.
