Structure of the carbon layers deposited on the toroidal pump limiter of Tore Supra

Abstract

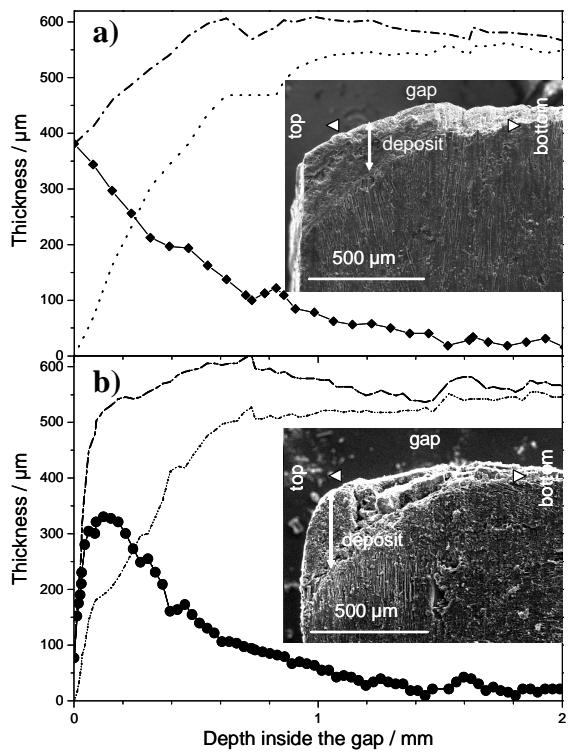
Figure 5

The deposit volume inside the gaps of the erosion zone is estimated at $\sim 100 \text{ cm}^3$ from the profile measurements of Fig. 5. This shows that, in the erosion zone, the deposit volume (and thus the D retention) is of the order of magnitude of that due to top surfaces of thin and thick deposits zones (table 1). This confirms that gaps play an important role in the total retention.

Figure 5: Deposit thickness profile inside the two poloidal gaps of tile F27T10 from the erosion zone with SEM images of each gap edge, (a) -◆- up-stream poloidal gap (b) -●- down-stream poloidal gap. The dotted (...) and dash-dotted (.-.-.) lines correspond to the positions of the tile and the deposit surfaces, respectively.
