# COOLING TOWER INSPECTION REPORT

Observed conditions and recommended services

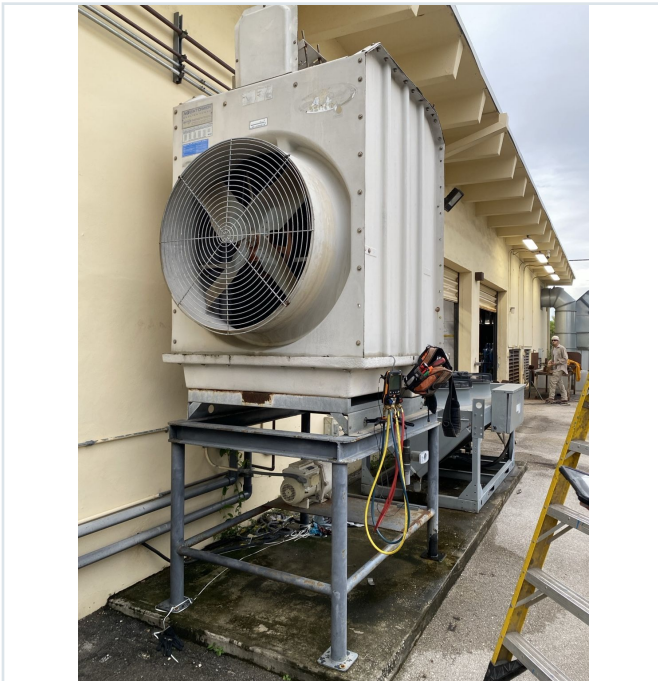
01 Fan and cooling tower exterior

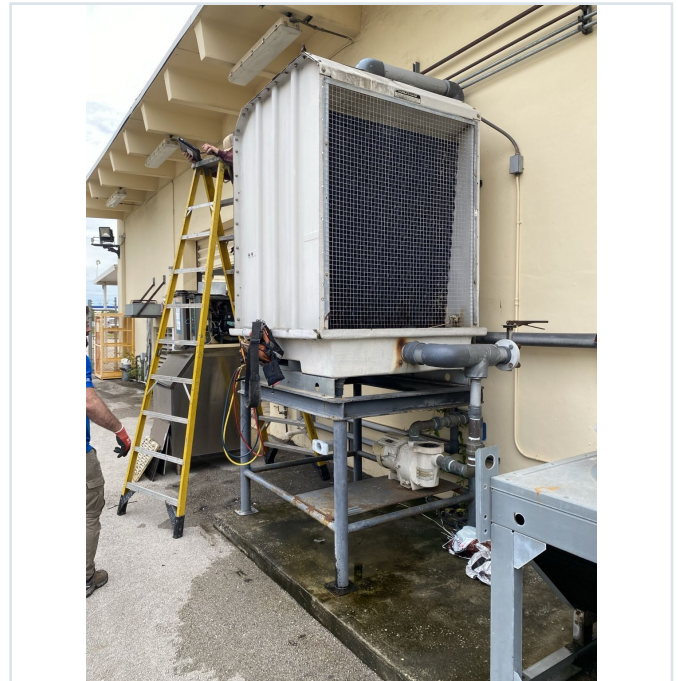
02 Grille, housing, and base

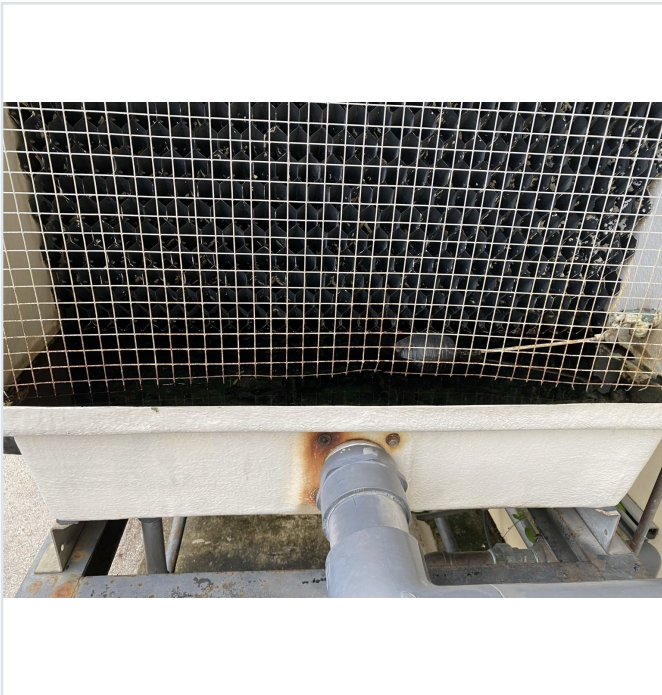
1. Suspected algae or other microbial growth was present at inspection.
2. Mineral buildup and scaling were observed on the cooling tower grille.

03 Grille and lower housing

1. Clean affected areas and request a water treatment assessment of growth and scaling.
2. Prepare and apply an anticorrosive coating to the unit base and exterior.
3. Install vibration absorbers and verify proper fit and operation.

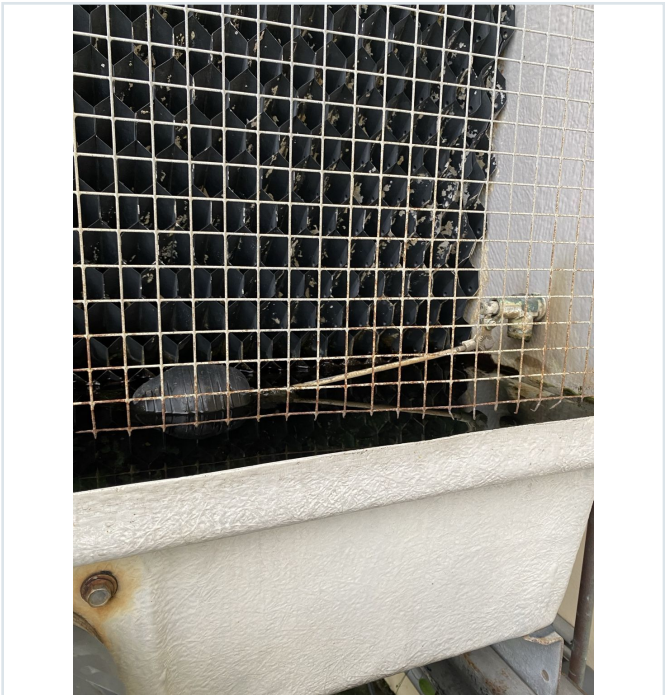
04 Grille close-up

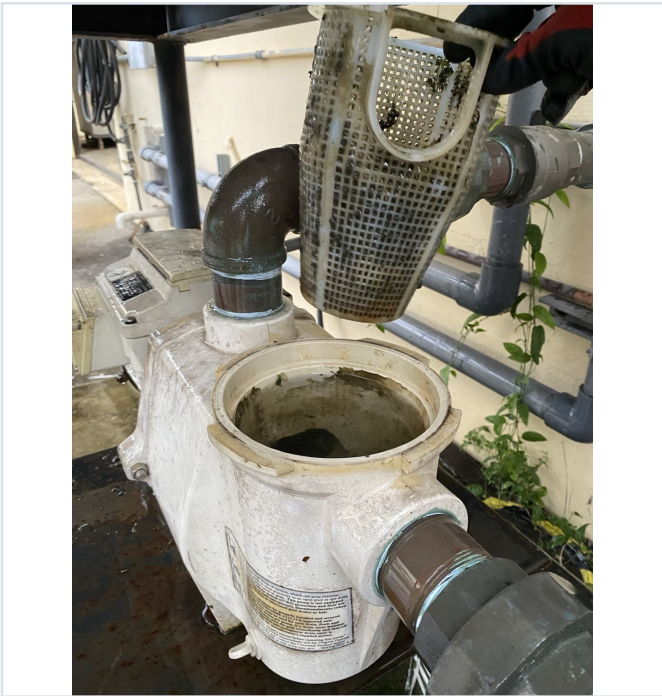
05 Water pump and strainer

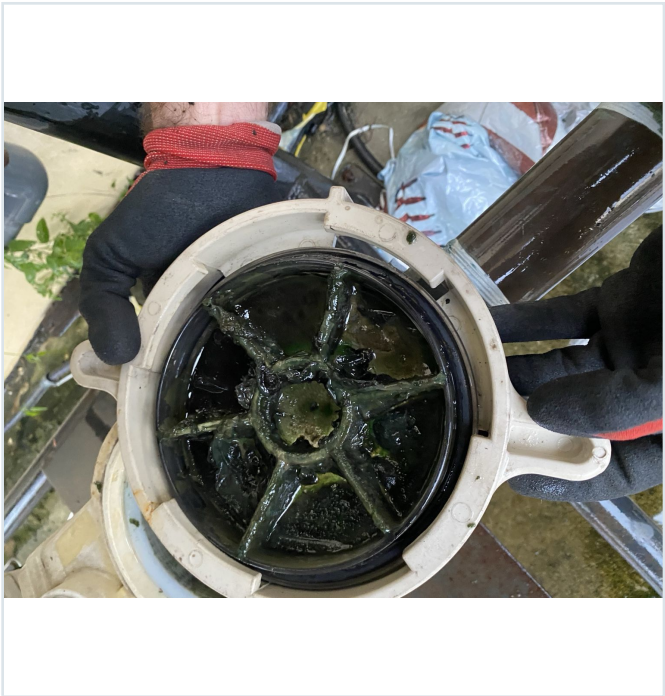
06 Internal pump component

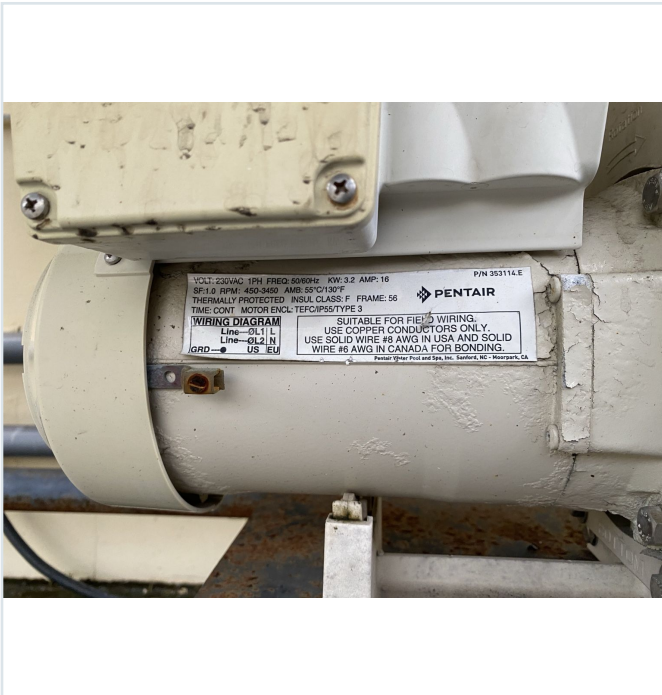
07 Pump motor identification plate

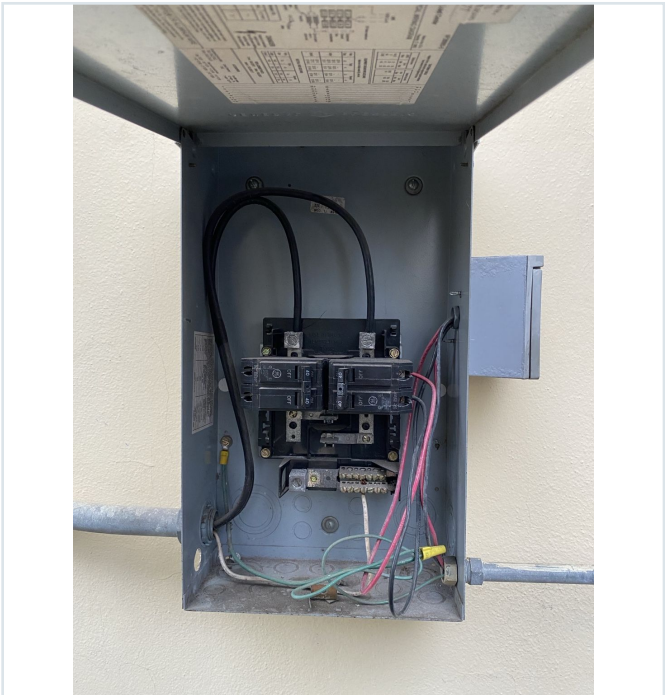
08 Electrical enclosure interior

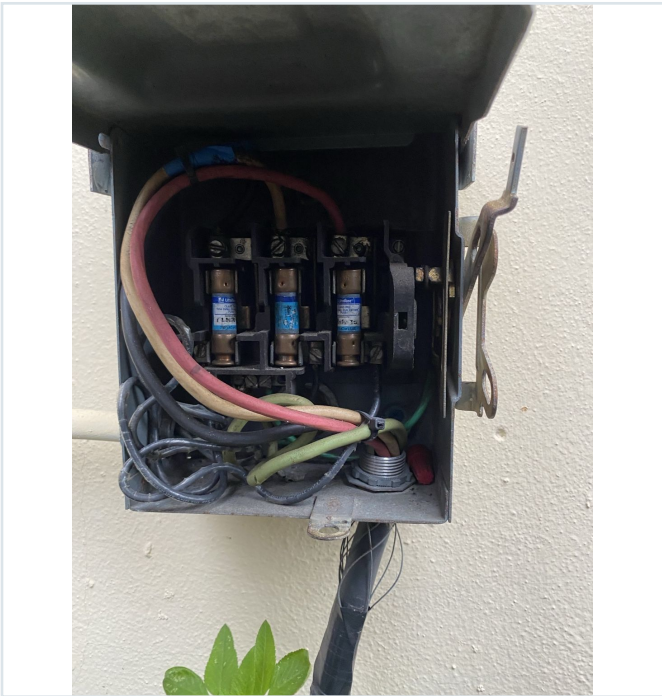
09 Electrical enclosure interior
