# PACKAGE HVAC UNIT INSPECTION REPORT

## Client-Facing Condition Assessment

| Equipment Type | Packaged HVAC Unit |

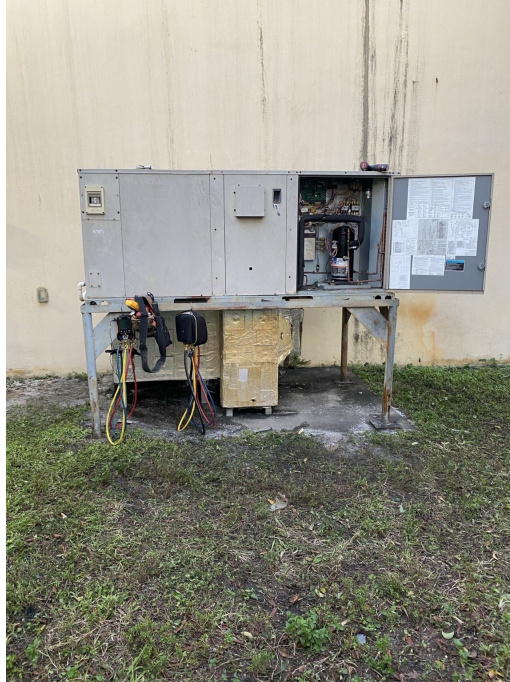
*Photo 1 - Overall view of packaged HVAC unit and service setup.*

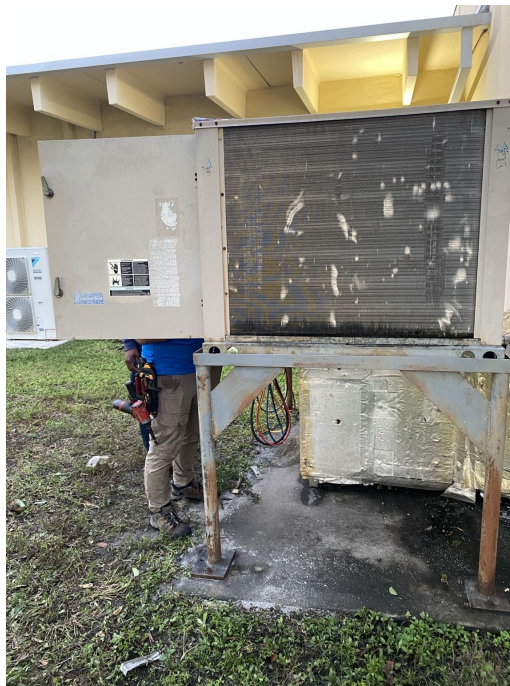
Visible corrosion is present at portions of the unit and supporting steel structure. Continued exposure to moisture may accelerate deterioration. Affected areas should be evaluated, cleaned and protected as appropriate.

The condenser coil exhibited visible dirt/debris accumulation and general deterioration consistent with extended service. Coil cleaning and inspection are recommended to maintain proper heat transfer and condenser airflow.

*Photo 2 - Condenser coil and equipment support frame; visible weathering/corrosion noted.*

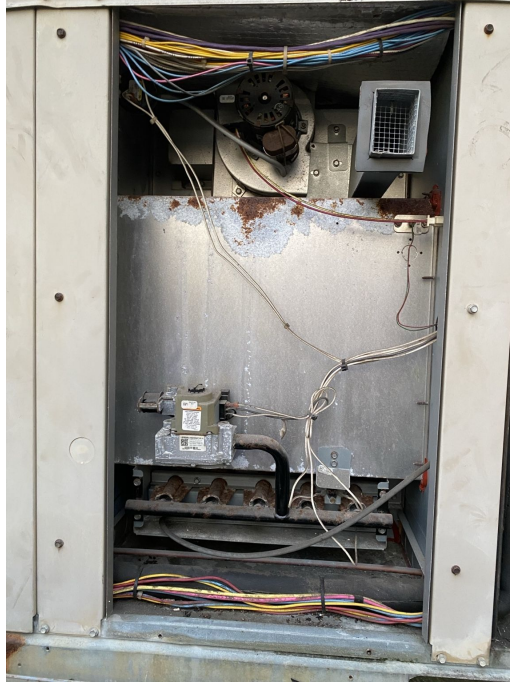
Visible corrosion and deterioration were observed within the heating section/heat exchanger area. Further evaluation by a qualified HVAC contractor is recommended to determine the extent of corrosion and whether repair or replacement is required.

*Photo 3 - Heating section/heat exchanger area showing visible corrosion.*

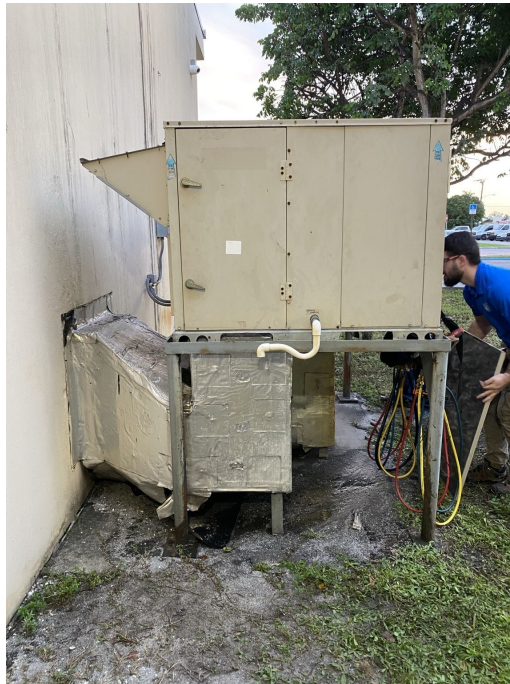
The condensate drain/P-trap configuration was found reversed or improperly oriented at the time of inspection. The configuration was corrected to establish proper drainage fall. The remaining condensate discharge piping should be evaluated and extended to discharge water away from the equipment and supporting structure.

*Photo 4 - Rear/side equipment view showing condensate drain arrangement and support frame.*

- Extend/reconfigure the condensate drain discharge to direct water away from the equipment base and eliminate recurring ponding.
- Confirm proper condensate trap configuration, slope and drainage after correction.

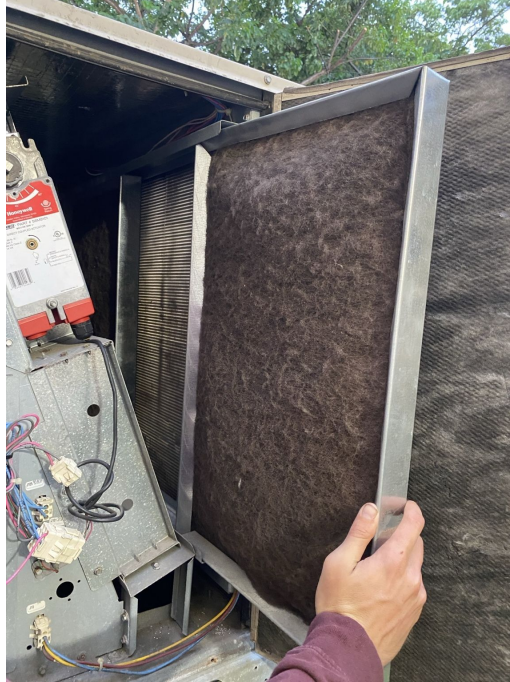
The filters showed substantial accumulation of dirt and debris. Restricted filters can reduce airflow, decrease cooling performance, increase energy consumption and place additional load on blower and refrigeration components. Filter replacement and routine preventive maintenance are recommended.

*Photo 5 - Air filter condition at time of inspection; significant dirt/debris accumulation visible.*

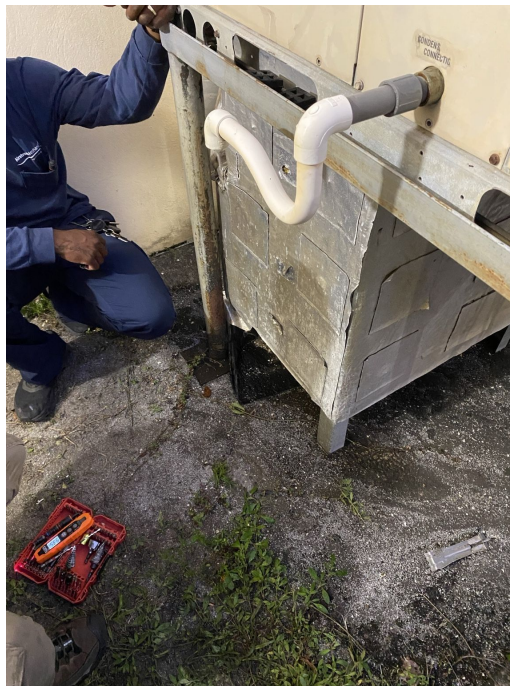
Standing water and evidence of condensate accumulation were observed beneath and around the unit. Continued ponding can contribute to corrosion of the equipment base, support frame and surrounding materials and may contribute to deterioration or settlement over time.

*Photo 6 - Condensate P-trap/drain piping and ponding beneath equipment.*
