# Algodon N Colors

**Style No:** 172706520

**Order No:** 17038

**Inspection  
Report**

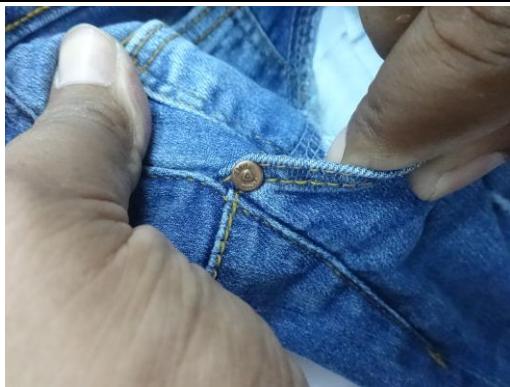
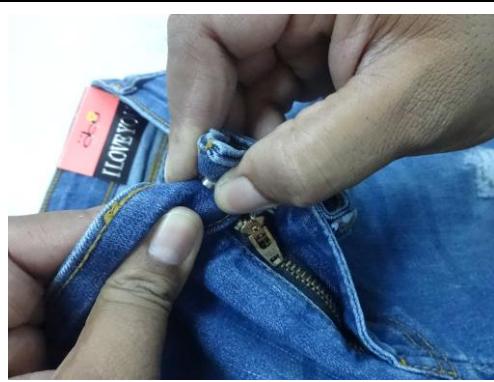
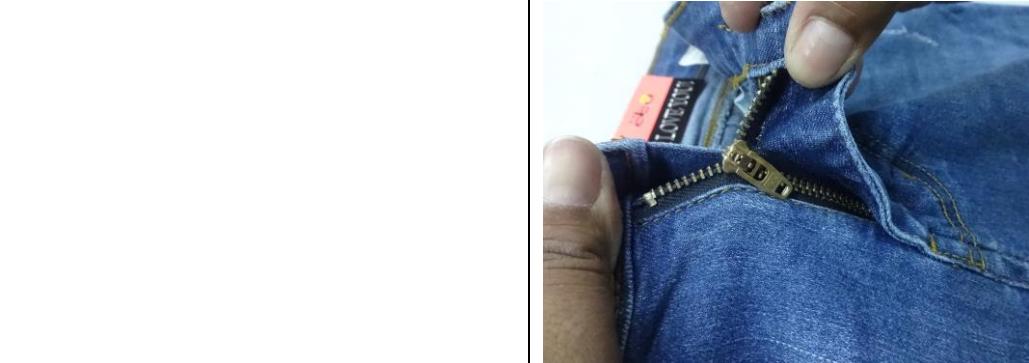
During Inspection		
Test Description	Comment for Inspector	Result
Fatigue test for all adjustable parts found on each sample, cannot skip (i.e., all zippers, velcro and snaps, and normal force to pull all the buttons).  Do  this 20 times for each sample.--20 pieces (      Pieces)	Did not found unsecured button, rivet and zipper	<b>Pass</b>

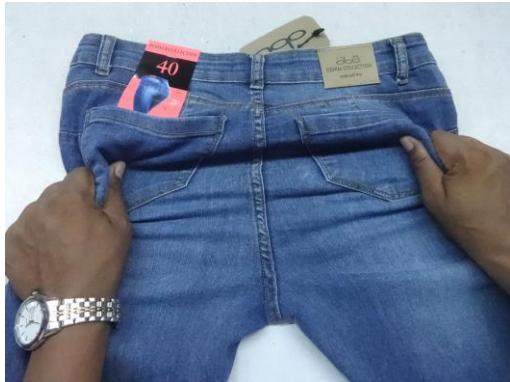
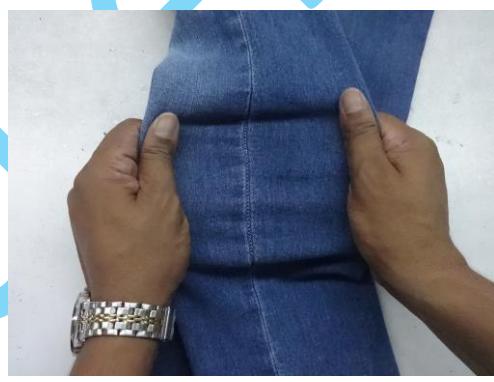
Seaming strength test-Test the strength along & cross the seams by hand. Especially on side seams and pockets

Seams were perfect

Pass

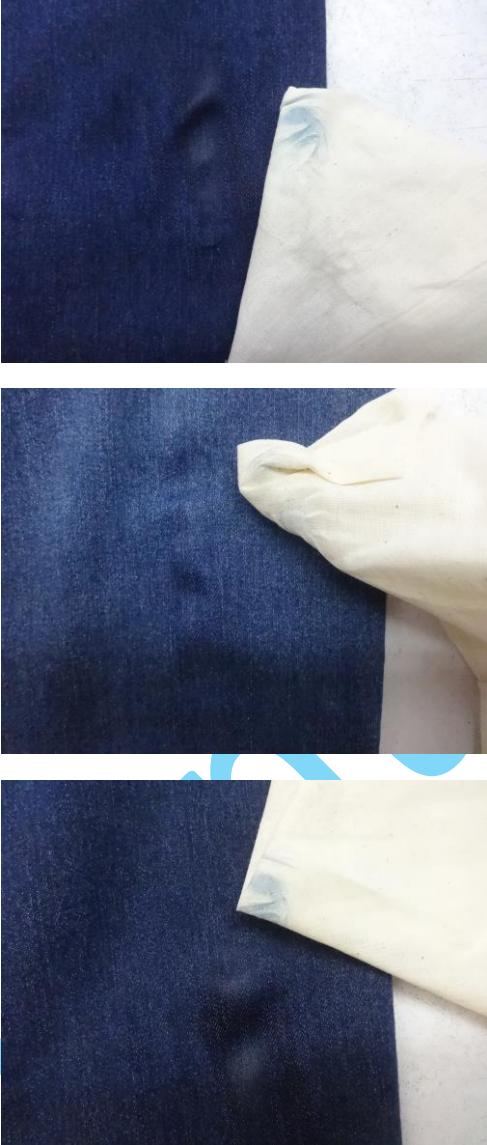
<p>Rub test to check the color fastness of the fabric (including the lining) and all the accessories (Labels must be rubbed for this test). Use a white cotton cloth to rub the material. Rub the item 10 times over a 10 cm distance with a force of 9N (1kg). Test 1 piece per color with both a dry and a wet cloth. Expected result: There should be no color transfer greater than 4 on a grey scale (between the original white cloth and the colored one) after the dry test. There should be no color transfer greater than 3-4 on a grey scale (between the original white cloth and the colored one) after the wet test</p> <p>Enc</p>	<p>As per sample</p>

<p>Pass</p>
--	--	-------------

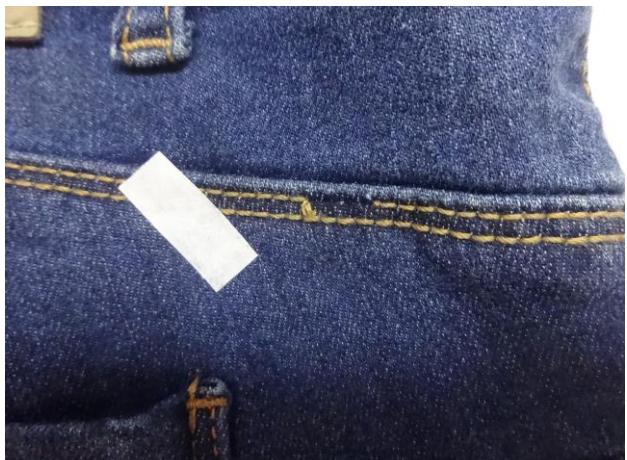
DEFECTIVES LIST					Picture
	Description	CRI	MAJ	MIN	
01	Broken stitch		01

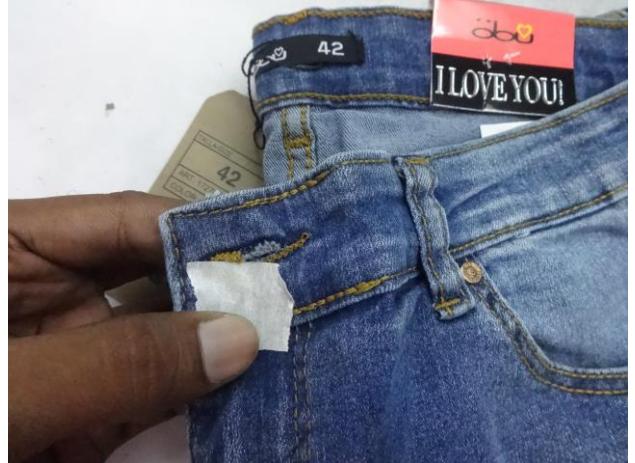
04	Broken eyelet kaj	01

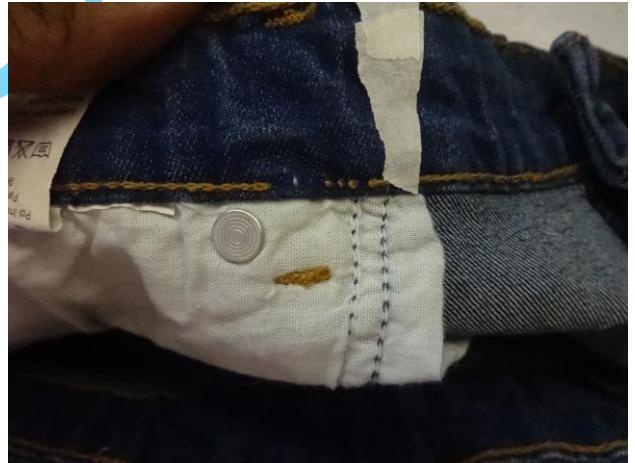
06	Broken stitch	01

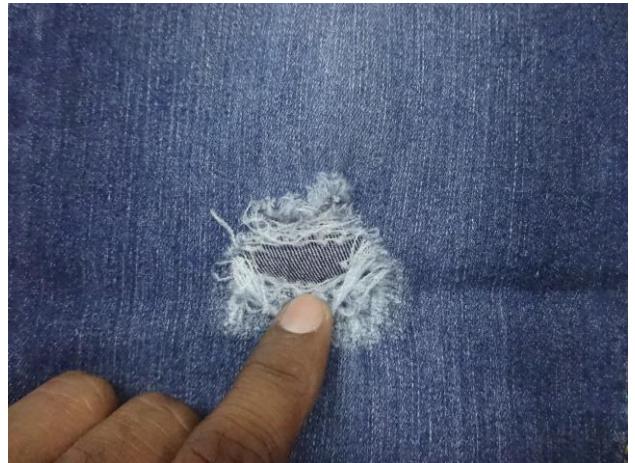
07	Damage grinding	01

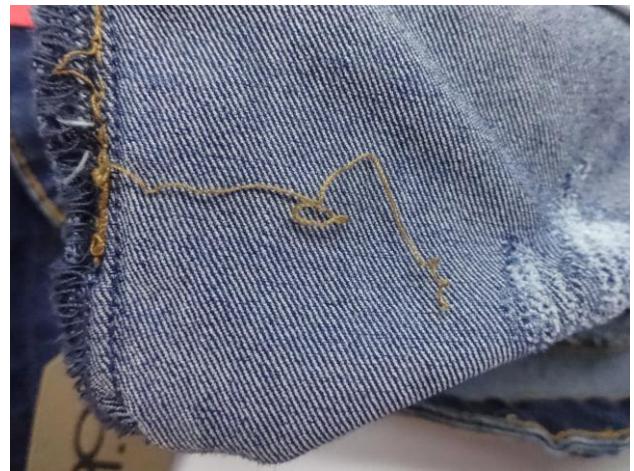
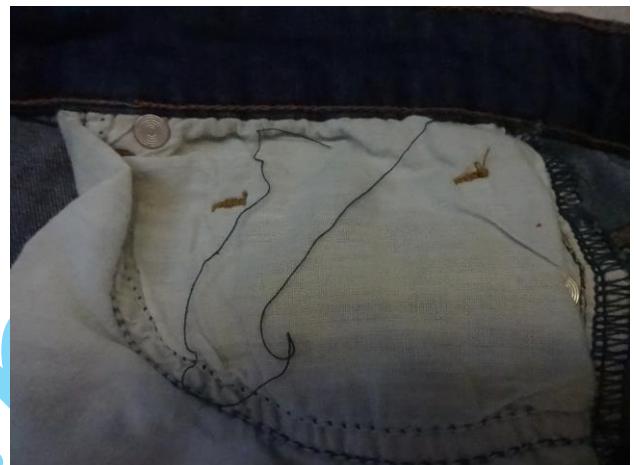
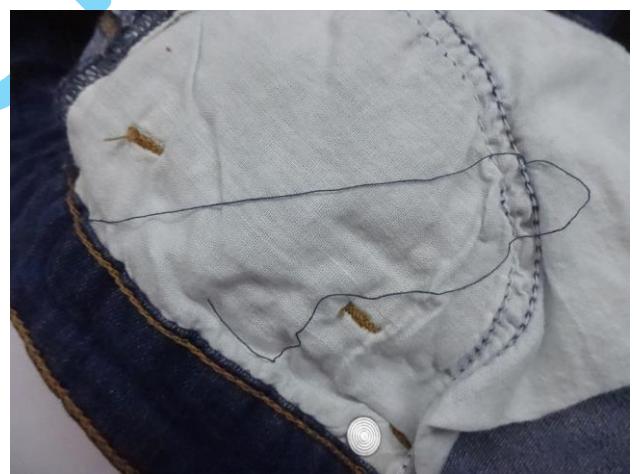
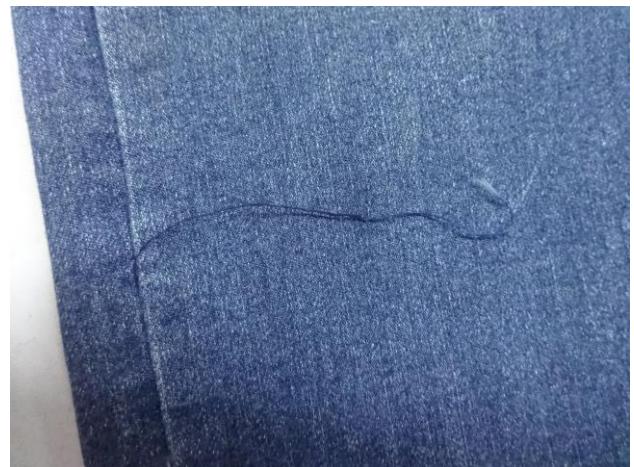
08 Uncut thread

04

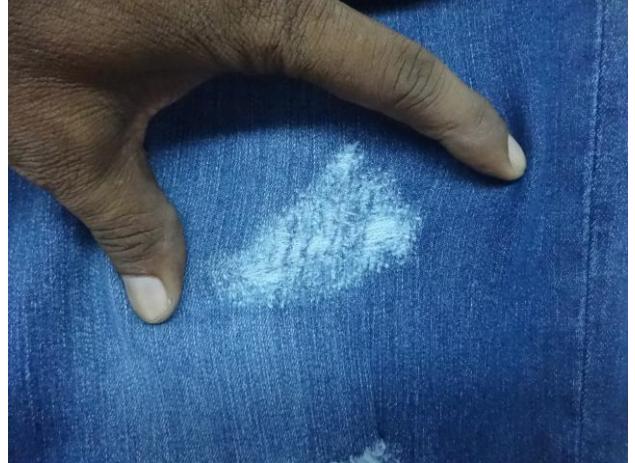
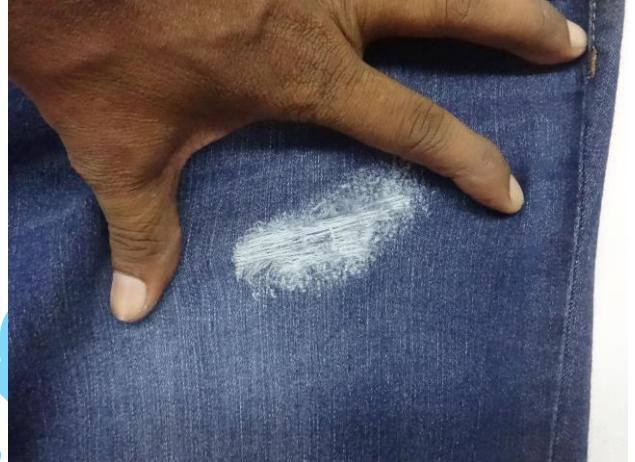
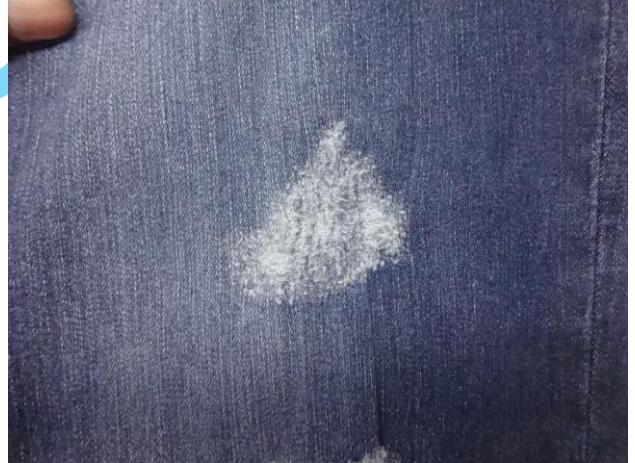
09	Not proper clean grinding			03
