The Division of Occupational Safety and Health has received a complaint (Complaint No. 1166799) alleging the following condition(s) at your workplace at 92111 Pruneridge Ave., Cupertino, which may be a violation of the Safety Orders found in Title 8 of the California Code of Regulations:

1. **The employer (Holder Construction) has not performed clean-up for airborne dust/dirt at the lower basement areas (#1 and #2). The dust is causing congestion for workers in the area. The dust is being tracked in from the outside by workers and industrial trucks. This is on-going for weeks.**
Please refer to Title 8 of CCR Sections 1530.1, 1513, and 1530

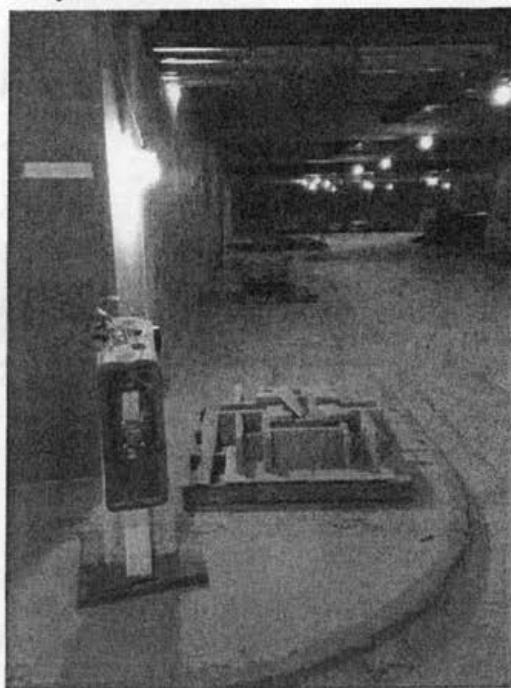
Photo 2: Sample adjacent to E4, B2. Visible suspended dust

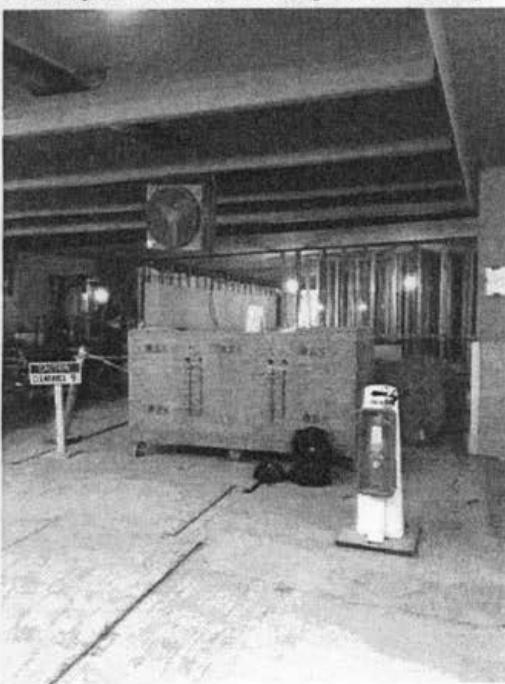
Photo 3: Overhead industrial fan – Non-operation on the day of sampling

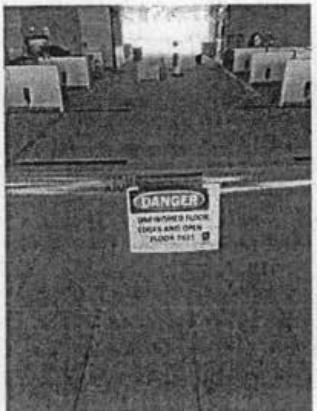
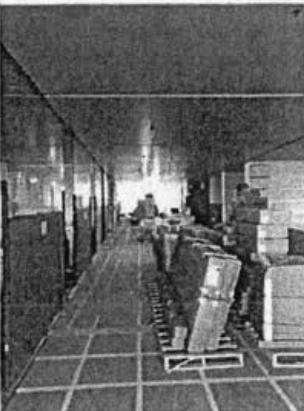
Response: §1632. Floor, Roof, and Wall Openings to Be Guarded- Holder Construction has proactively identified and continues to monitor the ongoing installation and modification of floor tiles referenced in the complaint. The following items are being implemented for specific tasks in regards to floor openings/tiles: Danger Tape and signage is used to restrict the area to Authorized Personnel Only. Employees that are authorized to work in these areas are noting the hazard with the specific task which may include pulling multiple floor tiles at a time to complete the work. (see photos below). Once the task is complete, floor tiles are covered and the restricted area is opened up. In addition, floor openings are inspected daily to ensure they are properly protected and secured. Note that these areas do not affect the primary access/egress routes throughout the site.

Holder Construction is not aware of any roof "openings".

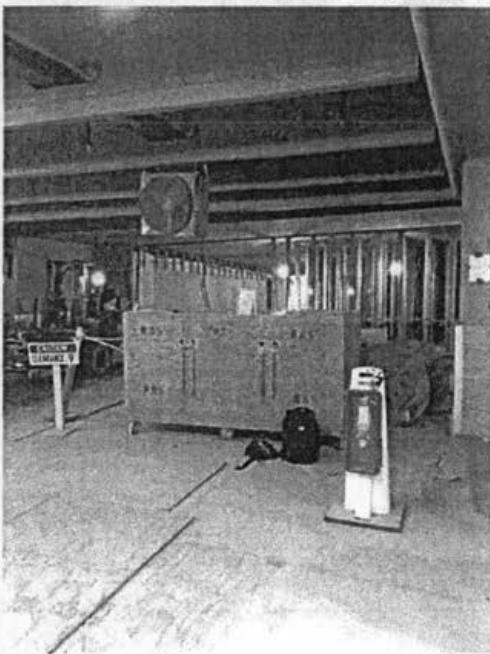
Photo 3: Overhead industrial fan – Non-operation on the day of sampling
