Apple Project

I am responding to your DOSH complaints #1166238-Ltr D and #1166799-Ltr D, alleging the following conditions at a Rudolph and Sletten (R&S) construction project Apple Campus 2 (AC2), located at 10590 N. Tantau Ave., Cupertino.

I am responding to your DOSH complaint #1166238-Ltr D, alleging the following conditions at a Rudolph and Sletten (R&S) construction project Apple Campus 2 (AC2), located at 10590 N. Tantau Ave., Cupertino:

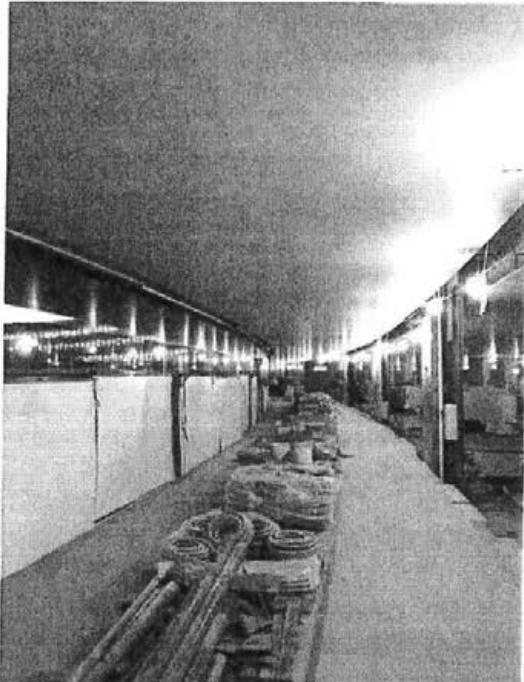
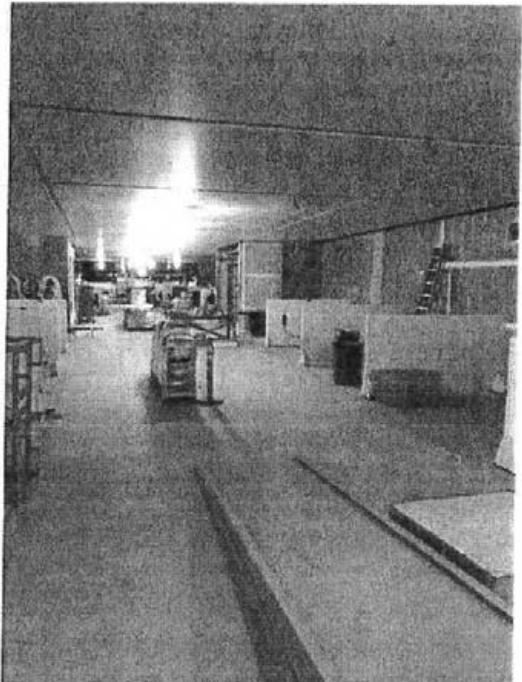
Response: T8CCR §1523 Lighting- The electrical subcontractor is responsible for providing adequate lighting throughout the project site. If such alleged conditions exist, Holder Construction as well as the electrical contractor are tracking these open items and closing them accordingly. Furthermore, the building currently contains over 25 miles of temporary lighting that has been installed, all of which are being maintained by a designated temporary power and lighting crew on a daily basis.

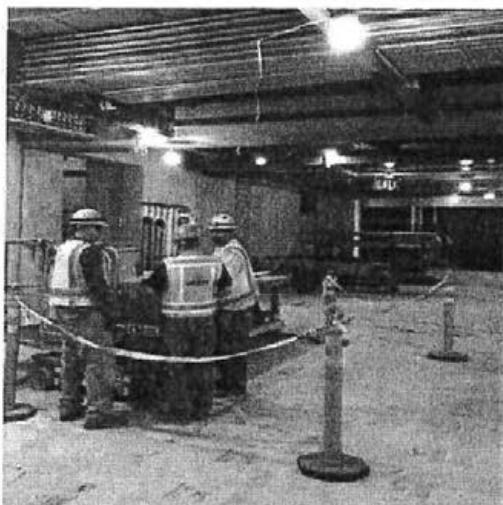
Housekeeping efforts have been continuous and effective. Dedicated walking paths have been established to prevent alleged hazards (see photos below). Clean-up crews conduct clean-up for scrap materials such as pallets, wood, conduit, scrap metals, etc.

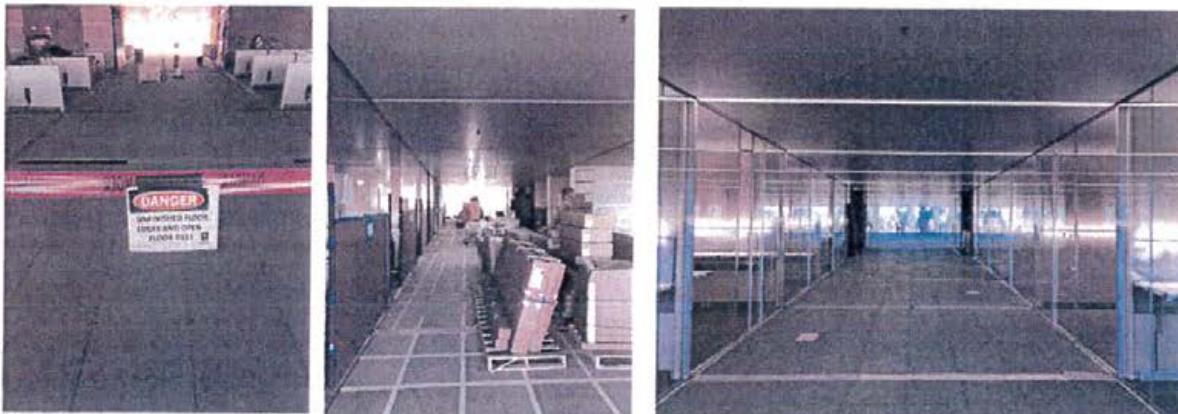
Response: §1632. Floor, Roof, and Wall Openings to Be Guarded- Holder Construction has proactively identified and continues to monitor the ongoing installation and modification of floor tiles referenced in the complaint. The following items are being implemented for specific tasks in regards to floor openings/tiles: Danger Tape and signage is used to restrict the area to Authorized Personnel Only. Employees that are authorized to work in these areas are noting the hazard with the specific task which may include pulling multiple floor tiles at a time to complete the work. (see photos below). Once the task is complete, floor tiles are covered and the restricted area is opened up. In addition, floor openings are inspected daily to ensure they are properly protected and secured. Note that these areas do not affect the primary access/egress routes throughout the site.

Holder Construction is not aware of any roof "openings".

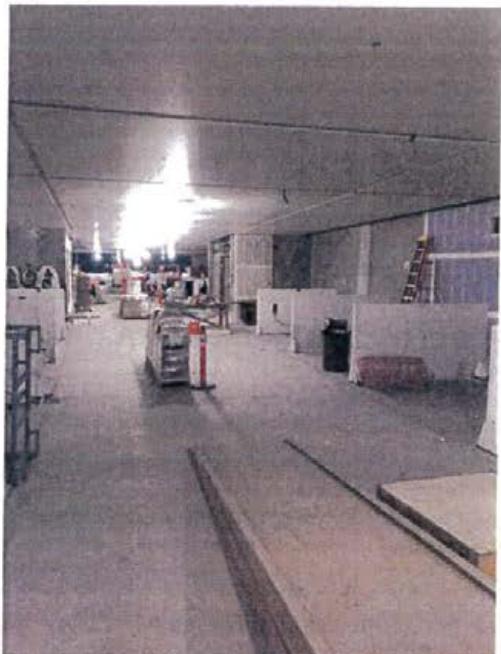
Response: T8CCR §1523 Lighting- The electrical subcontractor is responsible for providing adequate lighting throughout the project site. If such alleged conditions exist, Holder Construction as well as the electrical contractor are tracking these open items and closing them accordingly. Furthermore, the building currently contains over 25 miles of temporary lighting that has been installed, all of which are being maintained by a designated temporary power and lighting crew on a daily basis.

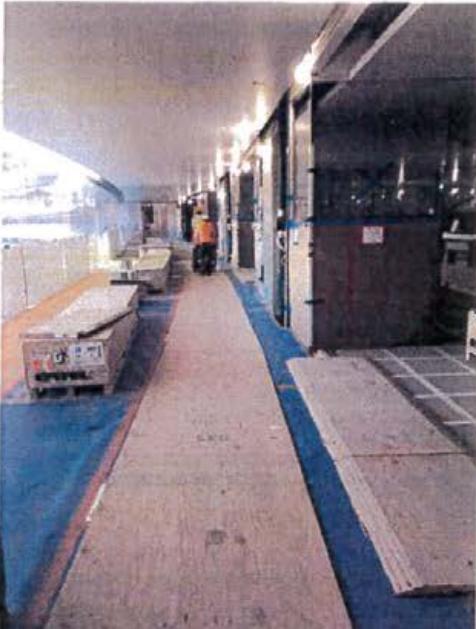
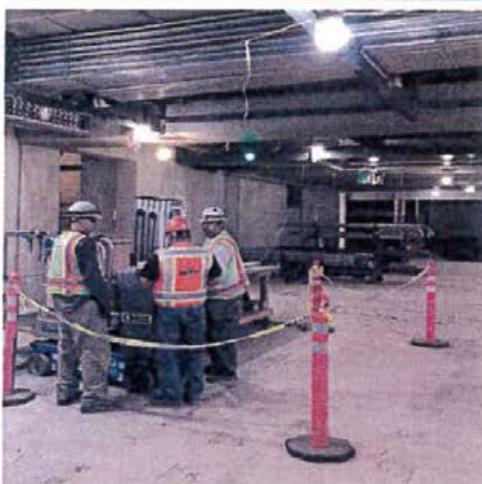
Housekeeping efforts have been continuous and effective. Dedicated walking paths have been established to prevent alleged hazards (see photos below). Clean-up crews conduct clean-up for scrap materials such as pallets, wood, conduit, scrap metals, etc.

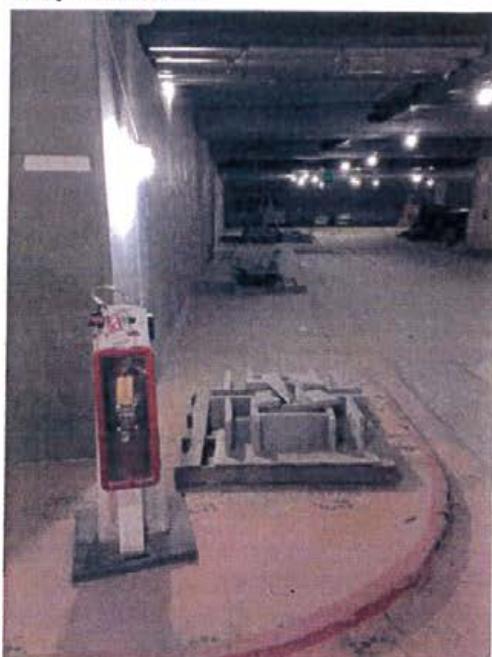
Photo 2: Sample adjacent to E4, B2. Visible suspended dust

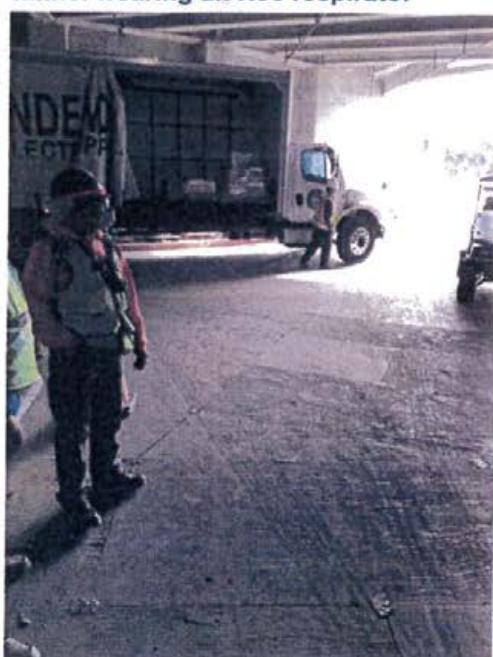
Photo 4: Danilo Acevedo – Flagger in the A1 tunnel wearing an N95 respirator
