# Crashes on the Layfayette Bridge (Hwy 52), 2007-2018

*A comparison of crashes before and after the 2011-2016 Layfayette Bridge project*

John Henderson, jw.hendy@gmail.com

2019 September

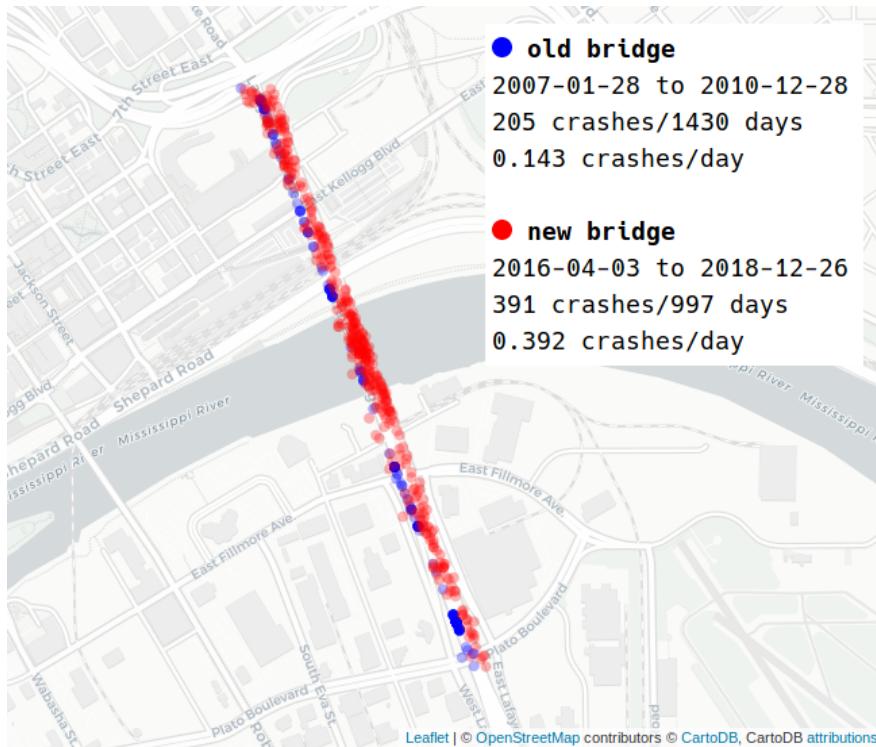
And here all crashes in this data are overplotted on the map:

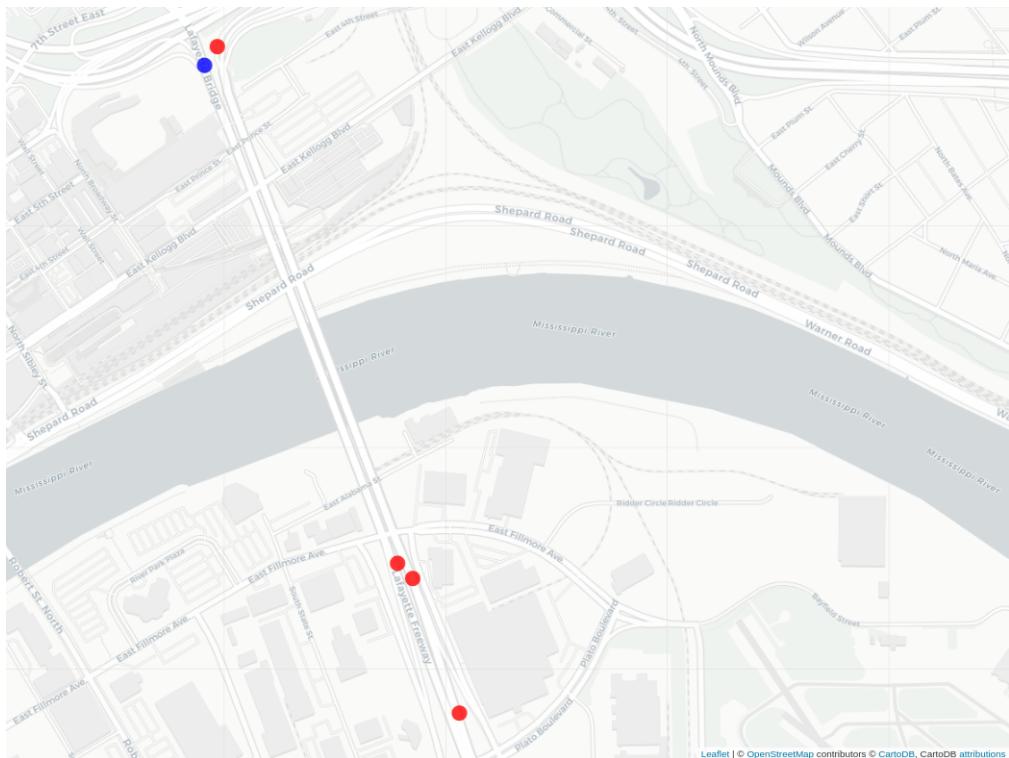
The rates are largely identical, though the increase from 1 to 4 serious injuries during a shorter time span may warrant attention. It is unclear which side of the bridge the crashes are on, but three are near the Plato on ramp to 52N where I believe the most chaotic conditions occur.

I would reiterate my previous requests to make the rules clear and help taxpayers safely endure this stretch of road in the future. In particular, I would strongly consider:

- finding a way to reduce the extreme speed disparities between lanes
- guiding the merging process with signage to reduce: closing gaps to prevent someone from merging, merging immediately following an onramp, drastically reducing speed to merge at the last minute, and passing an individual on the shoulder out of impatience
