Table 2. Analysing Zafer Square in terms of wheelchair users

4.2 Alaaddin Hill

4.3 Hükümet square

4.4 Mevlana square

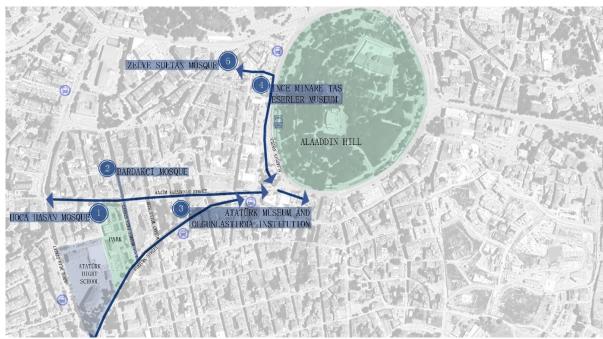
Fig. 10. Current situation analysis of Zafer square (source: author).

Despite heavy pedestrian and vehicle traffic, Zafer Square, one of the busiest areas in Konya, can be easily accessed by public transportation from the farthest points of the city. However, the pavements and walkways, ramps, charging stations, building entrances, pedestrian crossings, public toilets, plants, and signage have been examined under the headings of determining usage problems for wheelchair users (Table 2).

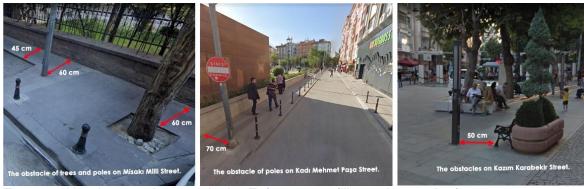
- Unplanned positioning of elements such as trees, benches, transformers, etc. in Zafer Square negatively affects accessibility (according to ADA).

Trees and landscape elements in the Zafer square (illustration: author)
