## MR2 Front Hub Strength

If you are serious about tracking your SW20 MR2, the strength of the front hubs is something you should be at least aware of, if not concerned about. This is one that broke on my car at an *autocross*! What follows is a bit of a deep dive into why they fail, and my solution to the problem.

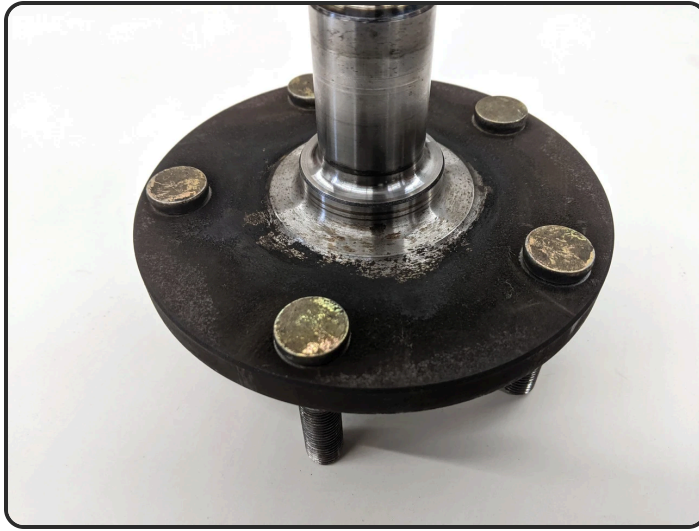
Toyota did improve on the stock hub design in the Rev2 (93+) MR2. They added a slightly thicker section around the spindle, and a slightly larger radius, as shown in the picture below. Interestingly, they did this without changing the part number, so if you buy a new hub from Toyota (if they still have any available) you should get the updated design. This change *helps*, the peak stress for the same loading is reduced from 93ksi to 79ksi. Whether that

enough to prevent breakage depends on the exact material strength (which we don't know), and the use it will see.

From what I have heard from endurance racers, it's not enough.
