Status of MACRO PMT pressure tests at SAB

Logan Lebanowski, Shih-Kai Lin

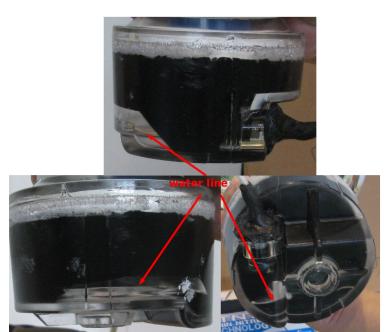
photos: PMT 7934

number	reason
1	Cable dry. No leaks or cracks.
2	1+Some water penetrated the mastic tape seal of the cable
	strain relief plug, but did not penetrate the UW cable plug.
3	Moisture on the SHV end in the sealing tube. Conductivity
	test performed.
4	Acrylic cap contains much water.(see photo)
5	A big crack and a little hole in the PMT. Photocathode was
	gone.(see photo)
