## Status of MACRO PMT pressure tests at SAB

Logan Lebanowski, Shih-Kai Lin

Sep 23, 2010

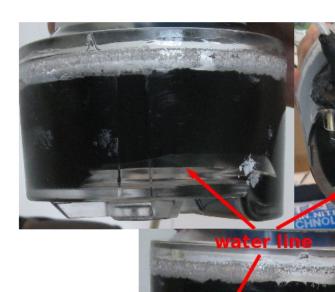
## photos: PMT 7934

number	reason
1	Cable dry. No leaks or cracks.
2	1+Some water penetrated the mastic tape seal of the cable
	strain relief plug, but did not penetrate the UW cable plug.
3	Moisture on the SHV end in the sealing tube. Conductivity
	test performed.
4	Acrylic cap contains much water.(see photo)
5	A big crack and a little hole in the PMT. Photocathode was
	gone.(see photo)
