## ENGINEERING REPORT

ISSUE NO.: **ER-26-0157-01**

| MODEL:<br><b>L1268</b> | TITLE:<br><b>Gap abnormal between Top_Cover and Right_Cover</b> | APPROVED BY:<br> MURAKAMI ATSUSHI |
| PART NO.:<br><b>RC7-0183-000</b> | PURPOSE:<br><b>Record and sharing</b> | CHECKED BY:<br>Le Thi Dung |

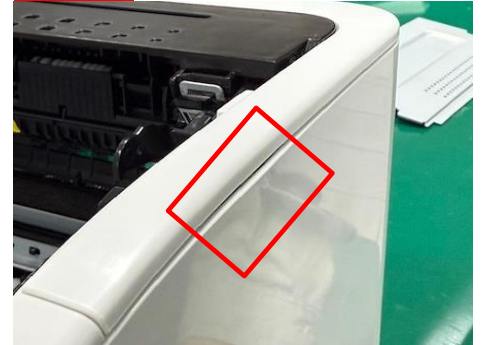
NG

Gap spec: 0~2mm

Actual 2.4 mm

Cause: Interfere with Left cover and Cover\_Gear because Part RC7-0183 have shape not good.

Check 3D VPS newest  
PE1 rework part 87/87 (finished)

Feedback to JP change DWG ( 12-Dec-25)

JP issue ECN **JJR27526**

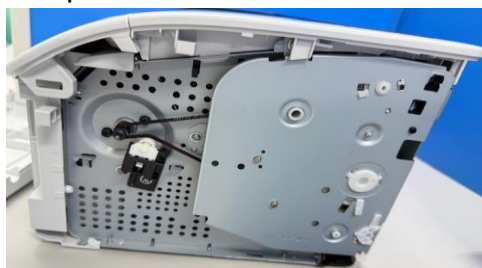
Right side machine : OK - Assembly unit complete

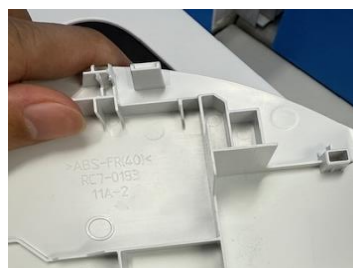
Right Plate: OK - Child part no have abnormal about shape
