# **Understanding and Managing White Spots on Anodized Aluminum**

July 25, 2019

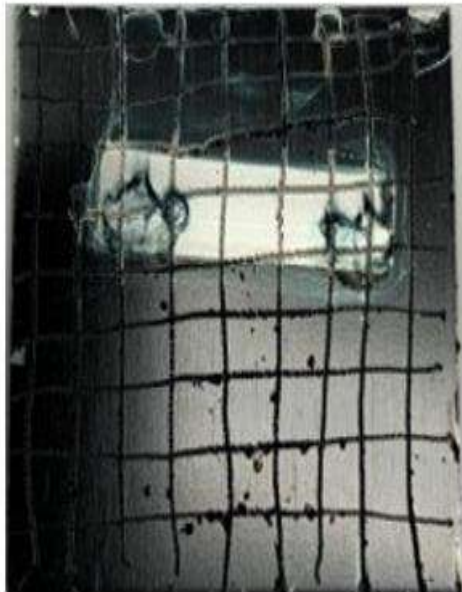
**2000**

**Galvanic Activity**

- Sources of spotting/staining
  - Certain alloy constituents are more susceptible to galvanic activity than others (2000, 7000)
  - Alloys with high levels of Cu, Mg & Zn
  - Rinse water corrosion (Chlorides and pH)
  - Chlorides in Dye tank
- Potential Solutions
  - Understand the alloy type
  - Manage rinsing – Reduce Immersion time, improve water quality
  - Use sacrificial anodes (Magnesium bars)
  - Chloride management – determine source and contain
  - Review tooling (Al vs Ti)

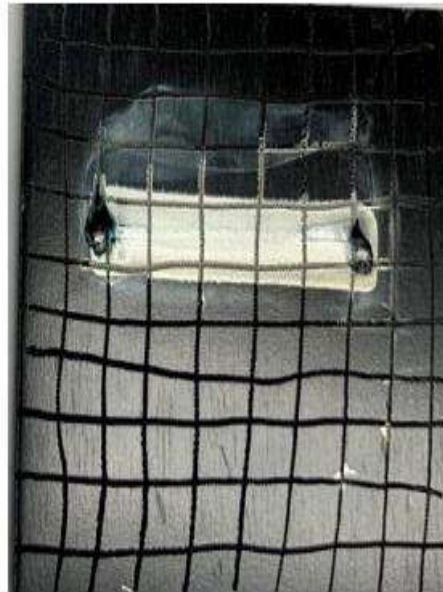
**6000**

**No Galvanic Activity**

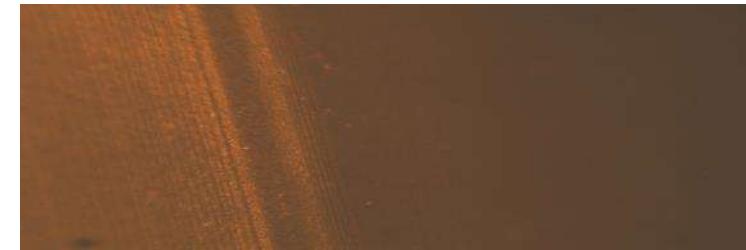
**Moderate Chloride level Al Tooling**

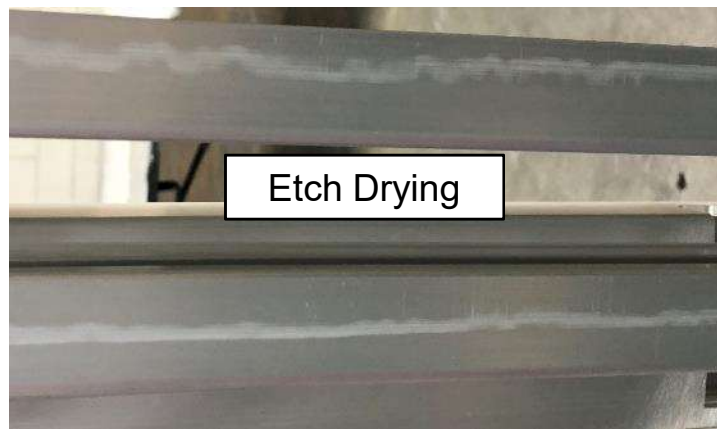
- Sources of spotting/staining
  - When an anodizing load comes out of the tank at the same time as an etch load caustic fumes can deposit on the anodized surface. Particularly if air flows from the etch tank
  - Etch fume staining occurs when etch dries on the part prior to rinsing and usually results in spotting on the top of the load instead of the bottom

- Potential solutions
  - Make sure the etch load and anodize load do not come out simultaneously
  - Reverse airflow to go from anodization tank to caustic tank by using industrial fans
  - Reduce time between etch and rinse or dwell time over etch tank
  - Check etch chemistry

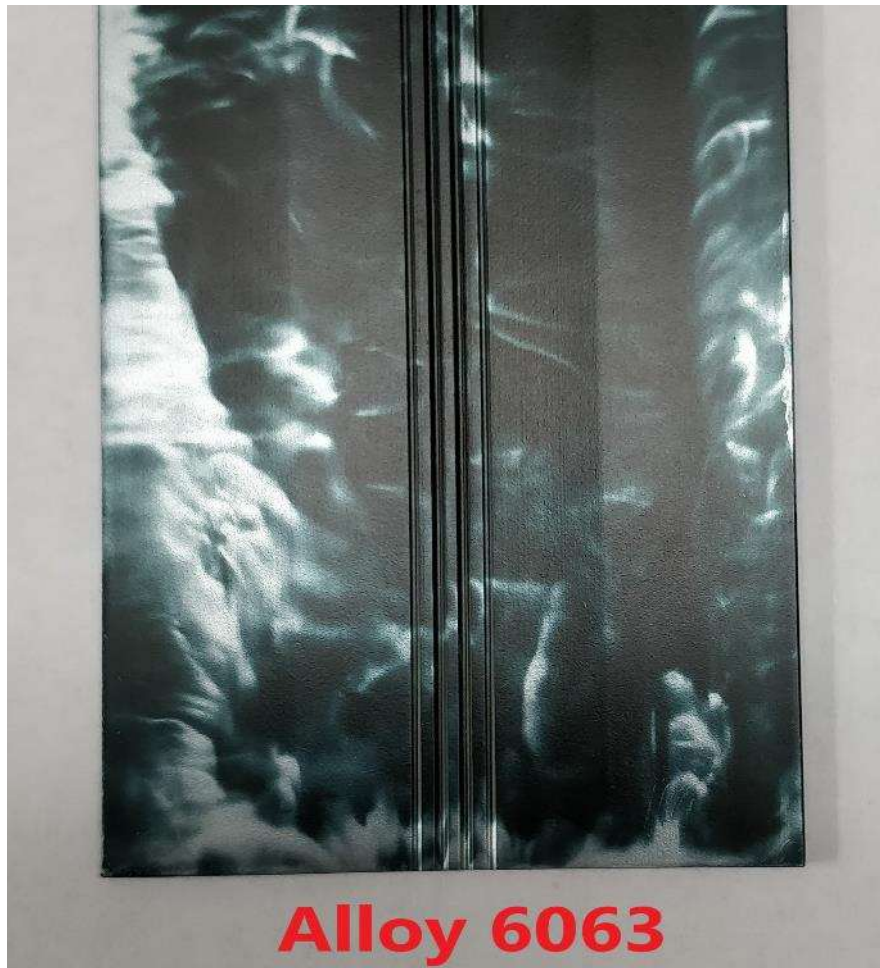
- Sources of spotting/staining
  - Insufficient rinsing after anodizing
  - Poor rinse water quality
  - Certain alloys are more susceptible to poor rinsing
- Potential Solutions
  - Improve rinse process using a spray rinse or higher frequency immersions
  - Use nitric rinse if possible

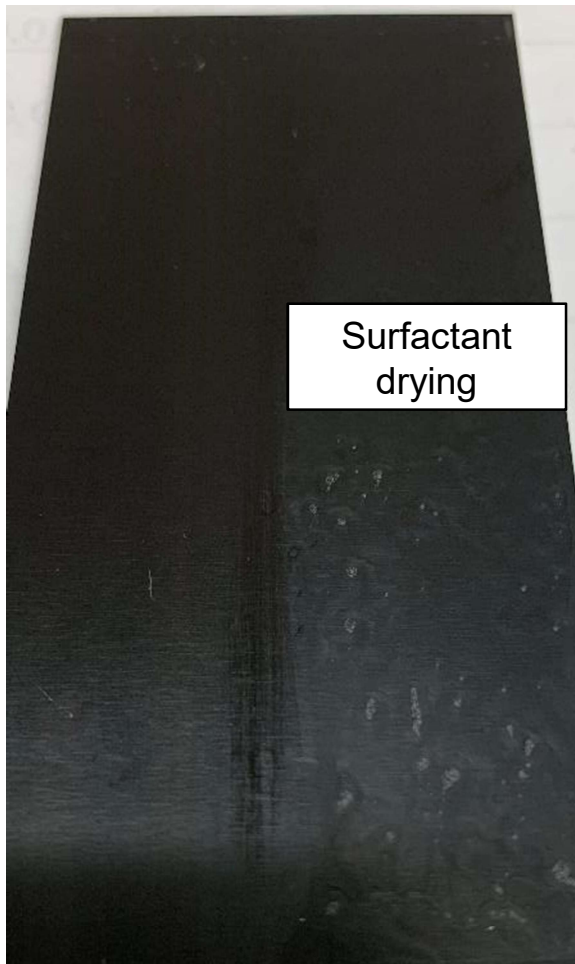
- Sources of spotting/staining
  - Chloride contamination
  - Precipitated Salts
  - Surfactant drying
  - Algae residue
- Potential solutions
  - Check water quality
  - Review temperature of seal chemistry
  - Check pH of seal

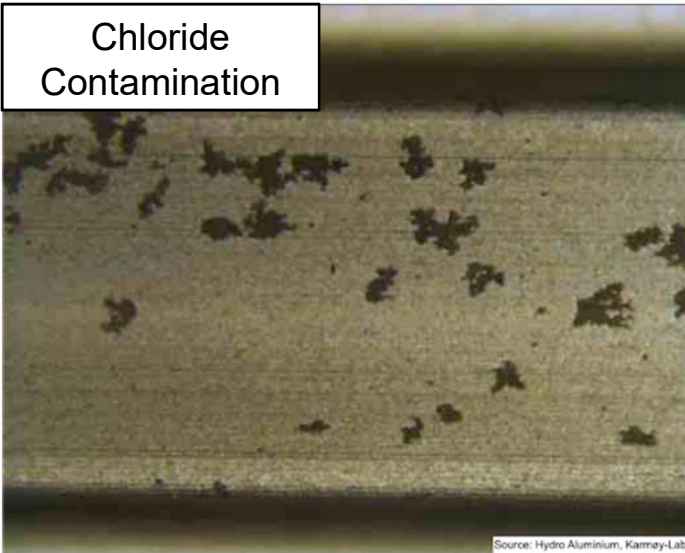
Chloride  
Contamination

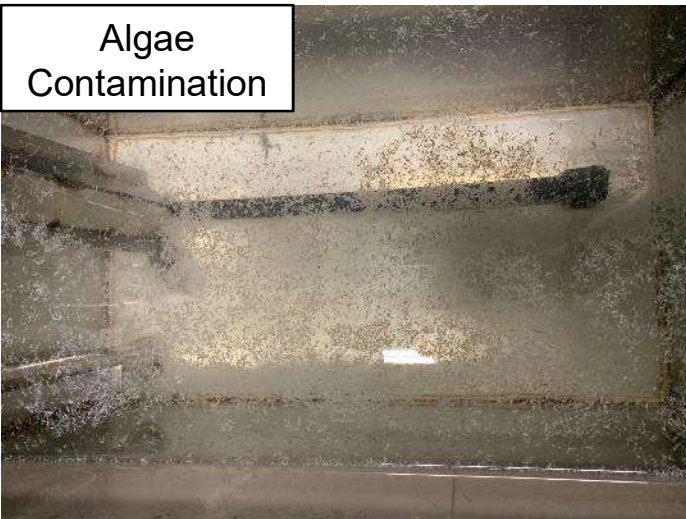
Algae  
Contamination

- Water contaminants can include the following:
  - Chlorides
  - Algae
- Chloride levels can vary significantly depending on the source of water therefore using DI water for all tanks after the pre treatment will significantly reduce the likelihood of chlorides
- Additionally chemistry should be checked for chlorides therefore contact your vendor to understand what chlorides if any could be in the following products:
  - Anodizing Additives
  - Post Anodize Rinse Additives
  - Dyes
  - Seals
- Algae is typically linked to dyes because many dyes are consumed by algae. Therefore dye tanks should be regularly dosed with algaecides particularly in summer months
- Furthermore when storing dyes for extended periods of time be sure to follow supplier guidelines on storage. In many cases liquid dyes are more susceptible to algae contamination.

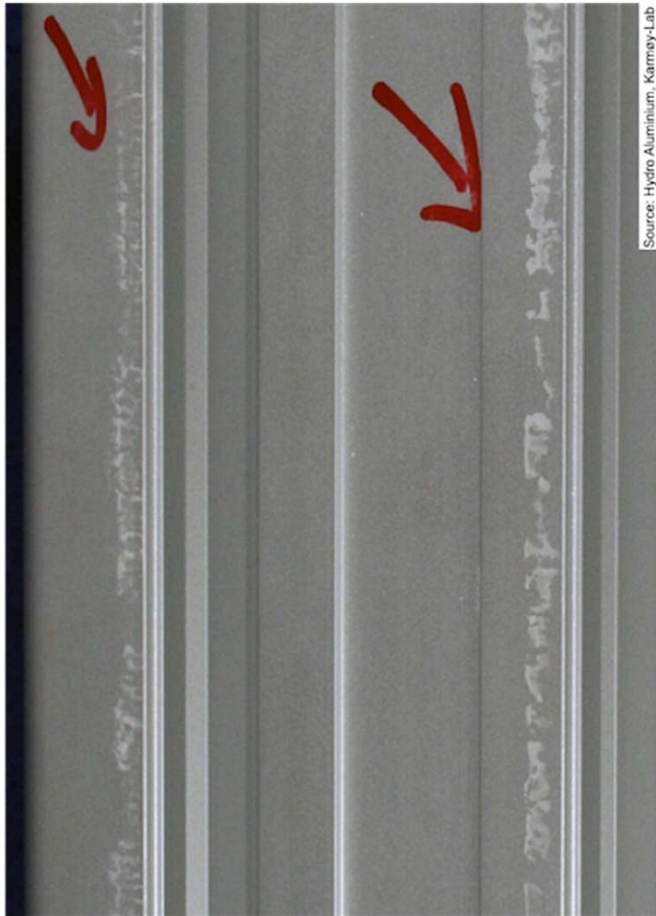
- Caustic fume staining occurs when parts are removed from the etch tank and are exposed to etch fumes for extended periods or when the etch dries on the part without immediate rinsing.
- There are several factors that can contribute to caustic fume staining/drying
  - Crane lift time
  - Ventilation/air flow around etch tank
  - Timing between etch and first rinse
  - Etch Chemistry

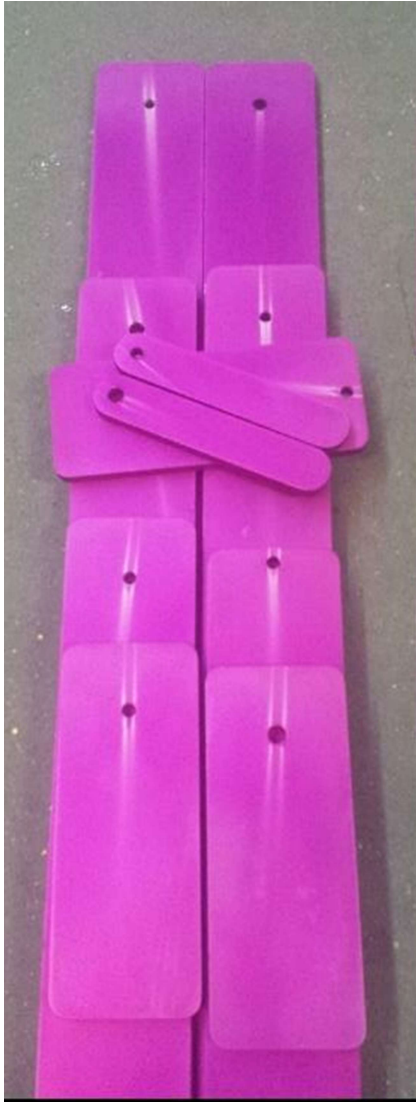
- Bleed out occurs when hot etch solutions cause threaded holes to expand and trap caustic which carries over to till the next hot process tank which is the dye tank
- When the etch “bleeds out” it creates white stains that do not take color
- There are several factors that can contribute to bleed out
  - Part orientation
  - Rinse cycle and frequency
  - Rinse aid chemistry

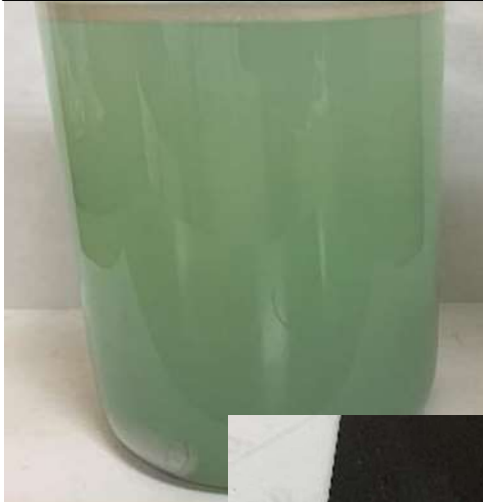
Nickel Hydroxide  
Precipitate

- Precipitates and other solids residue on a part are most often seen during the final stages of the anodizing process such as dyeing or sealing
- There are several factors that can cause precipitates or other residue:
  - Nickel Hydroxide precipitate from seal
  - Surfactant drying from seal
  - Algae residue from dye or rinse tanks prior to seal
- Nickel Hydroxide formation this can be linked to a high pH (>6.0). When this happens the nickel hydroxide precipitate forms and cannot go back into solution
