# Image-Only ADR Similarity Screen — Mixed 2017 Challenger, Charger and Chrysler 300 Catalog Drawings

2026-07-31

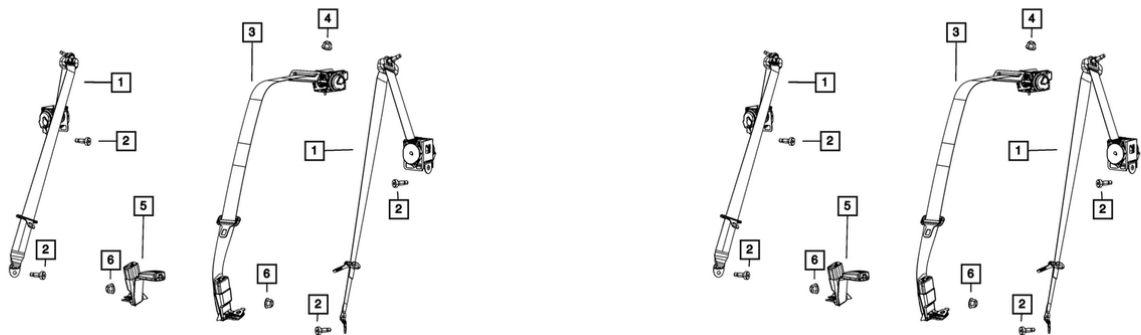
# seat-belts

**Visual grade:** HIGHLY SIMILAR (Very high confidence)

**Visible commonalities:** The best pair is visually indistinguishable after pixel normalization; webbing paths, retractors, buckles and callout placement coincide.

**Visible differences/limits:** Image identity does not prove fitted identity, webbing specification, pretensioner behaviour or anchorage strength.

seat-belts: Challenger vs Charger  
visual grade=HIGHLY SIMILAR automated pixelscore=1.0

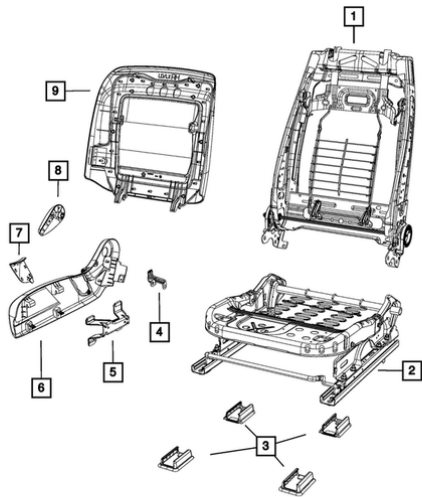
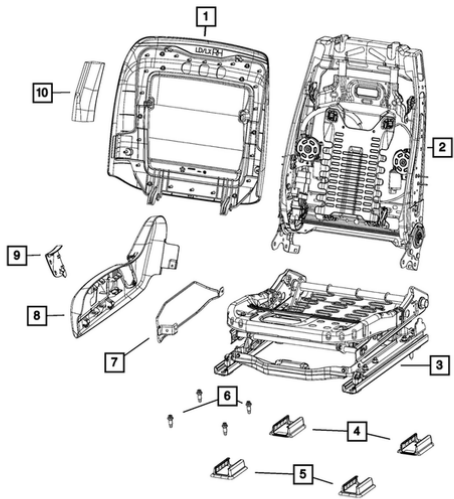
# front-seat-adjusters

**Visual grade:** SIMILAR WITH VISIBLE DIFFERENCES (High confidence)

**Visible commonalities:** Both drawings show matching seat-back frame, cushion/track frame, side shield and floor-foot arrangement.

**Visible differences/limits:** Spring field, side hardware and small attachment layout differ.

front-seat-adjusters Chrysler 300 vsCharger  
visual grade=SIMILAR WITH VISIBLE DIFFERENCES; automated pixel score=0.758966

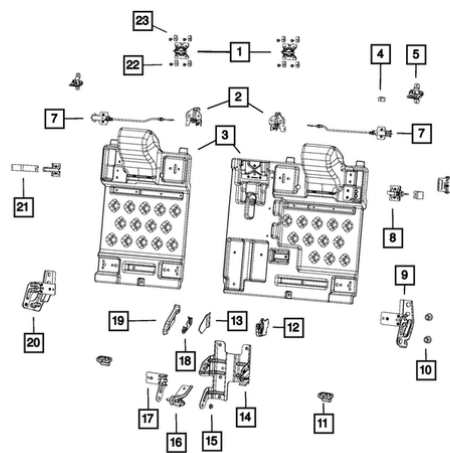
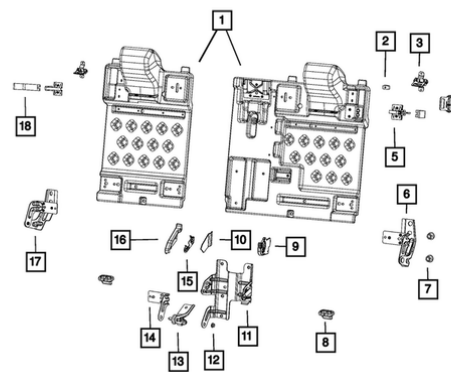
# rear-seat-adjusters

**Visual grade:** HIGHLY SIMILAR (High confidence)

**Visible commonalities:** Twin seat-back frames, perforated panels, central latch/bracket cluster and peripheral hardware have closely corresponding geometry.

**Visible differences/limits:** Callout numbering and several small peripheral pieces differ.

rear-seat-adjusters: Chrysler 300 vs Charger  
visual grade=HIGHLY SIMILAR; automated pixel score=0.664822

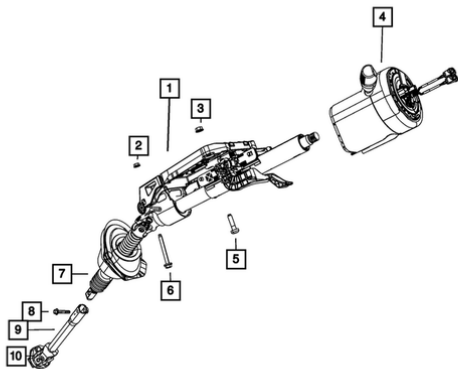
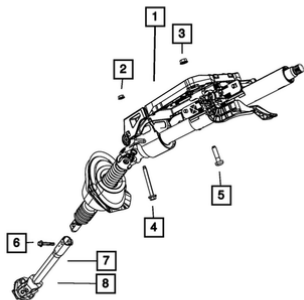
# steering-column

**Visual grade:** HIGHLY SIMILAR (High confidence)

**Visible commonalities:** Angled column shaft, upper housing, mounting bracket, coupling and fastener locations closely correspond.

**Visible differences/limits:** One drawing includes an additional large shroud/module and callout layout differs.

steering-column: Chrysler 300 vs Charger  
visual grade=HIGHLY SIMILAR, automated pixel score=0.58138

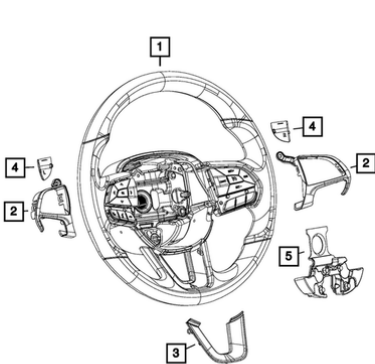
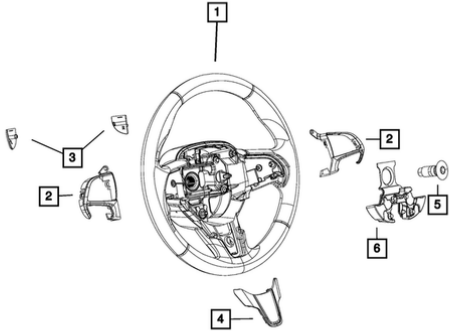
# steering-wheel

**Visual grade:** SIMILAR WITH VISIBLE DIFFERENCES (High confidence)

**Visible commonalities:** Both show a round three-spoke wheel, central airbag/hub interface, side switch/trim modules and lower spoke trim.

**Visible differences/limits:** Spoke trim, hub detail and peripheral module shapes differ.

steering-wheel: Challenger vs Chrysler 300  
visual grade=SIMILAR WITH VISIBLE DIFFERENCES automated pixel score=0.641131

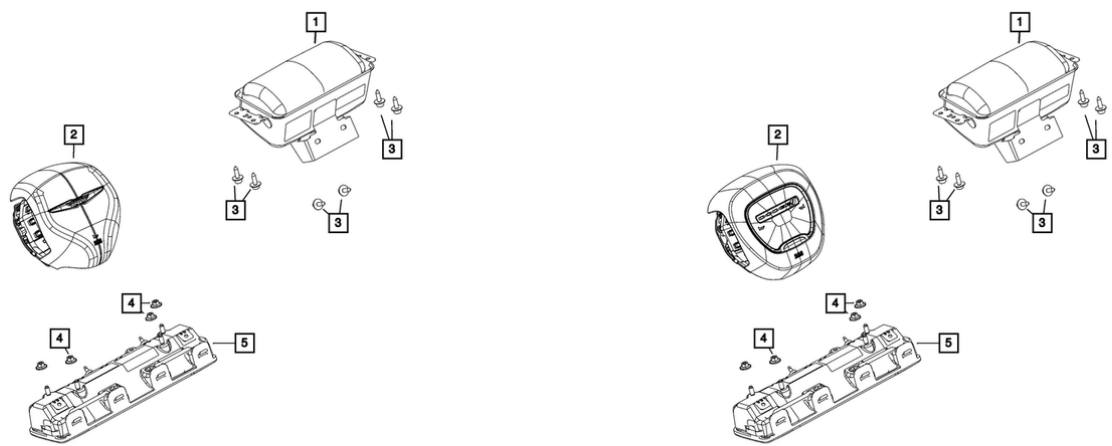
# air-bags

**Visual grade:** HIGHLY SIMILAR (High confidence)

**Visible commonalities:** Passenger-airbag module, steering-wheel airbag family and lower bolster occupy the same three-part exploded layout.

**Visible differences/limits:** Steering-wheel hub/spoke detail differs; the drawing does not show calibration, sensors or deployment behaviour.

air-bags: Chrysler 300 vs Charger  
visual grade=HIGHLY SIMILAR automated pixel score=0.853304

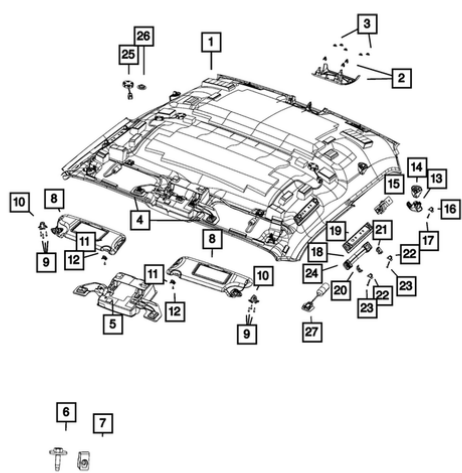
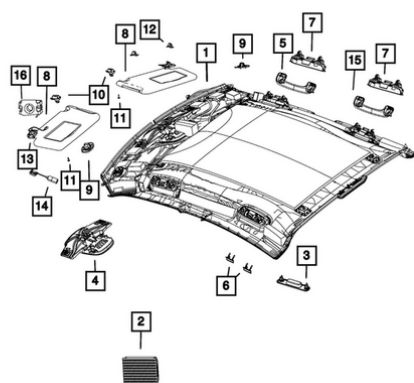
# headliners-visors

**Visual grade:** SIMILAR WITH VISIBLE DIFFERENCES (Medium confidence)

**Visible commonalities:** Both show a large roof-liner panel with front visor/console attachment groups and perimeter fasteners.

**Visible differences/limits:** Roof openings, panel contour and quantity/location of smaller attachments differ; visor geometry is small in the source view.

headliners-visors: Challenger vs.Charger  
visual grade=SIMILAR WITH VISIBLE DIFFERENCES, automated pixel score=0.568377

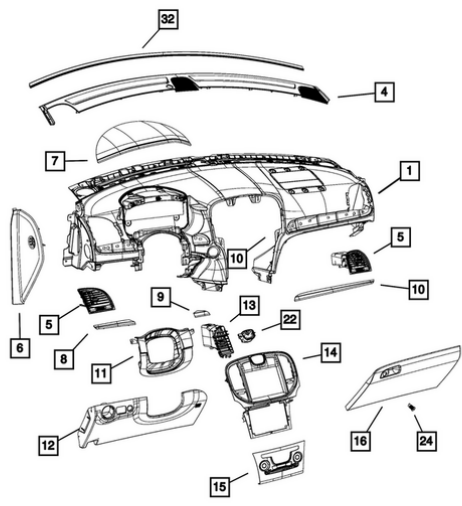
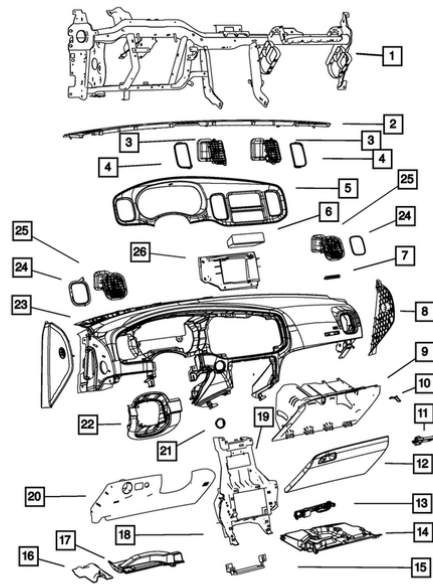
# instrument-panel

**Visual grade:** SIMILAR WITH VISIBLE DIFFERENCES (Medium confidence)

**Visible commonalities:** Both show a full-width dashboard shell with instrument binnacle, centre stack, vent groups, glove-box region and lower trim.

**Visible differences/limits:** Main shell contour, centre-stack shape, component count and callout arrangement visibly differ.

instrument-panel: Chrysler 300 vs Charger  
visual grade=SIMILAR WITH VISIBLE DIFFERENCES, automated pixel score=0.554849

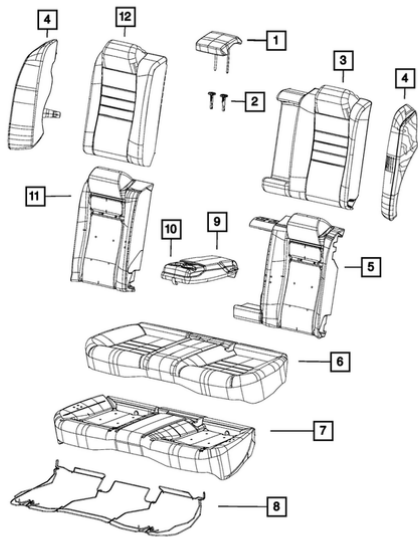
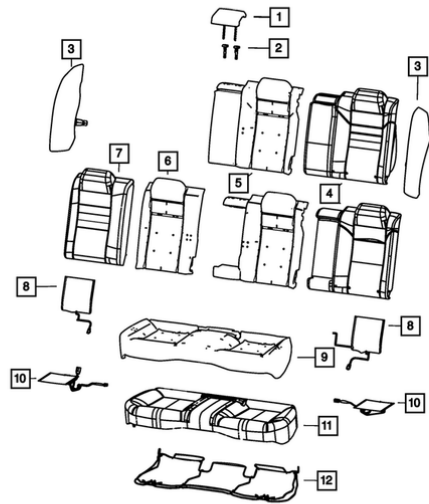
# rear-seats-second-row

**Visual grade:** SIMILAR WITH VISIBLE DIFFERENCES (Medium confidence)

**Visible commonalities:** Both show split rear seat-backs, head restraints, side bolsters, cushions and lower trim in a comparable exploded arrangement.

**Visible differences/limits:** Backrest split/configuration, cushion segmentation and accessory layout differ; child anchors are not visibly isolated.

rear-seats-second-row: Chrysler 300 vs Charger  
visual grade=SIMILAR WITH VISIBLE DIFFERENCES; automated pixelscore=0.627052
