# **Micrometeoroid and Orbital Debris (MMOD) Risk Overview**

**Eric Christiansen  
NASA Johnson Space Center  
July 2014**

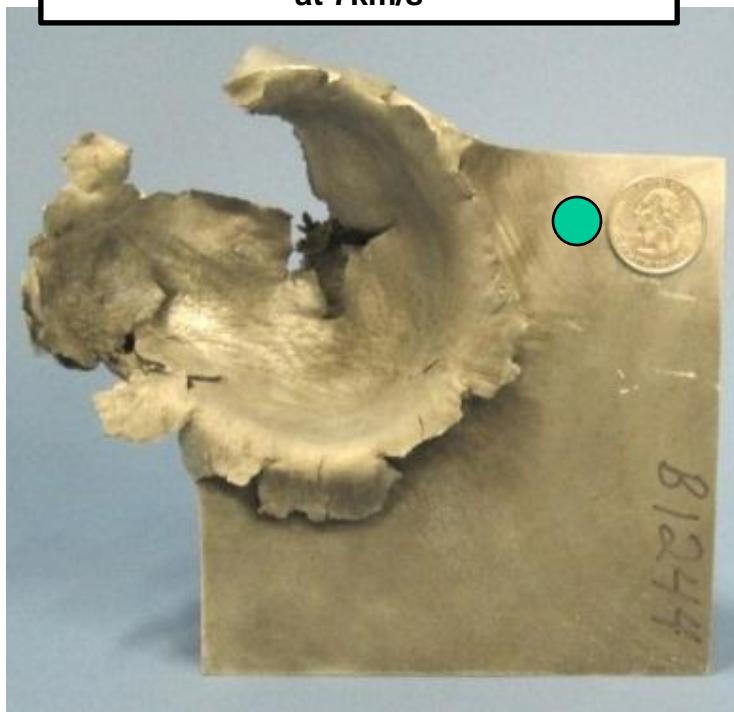
- Even small MMOD impacts can cause a lot of damage
  - Hypervelocity MMOD impacts represent a substantial threat to spacecraft
  - Rule of thumb: at 7km/s, aluminum sphere can penetrate completely through an aluminum plate 4x the sphere's diameter

Damage from a 1.3cm diameter sphere at 7km/s

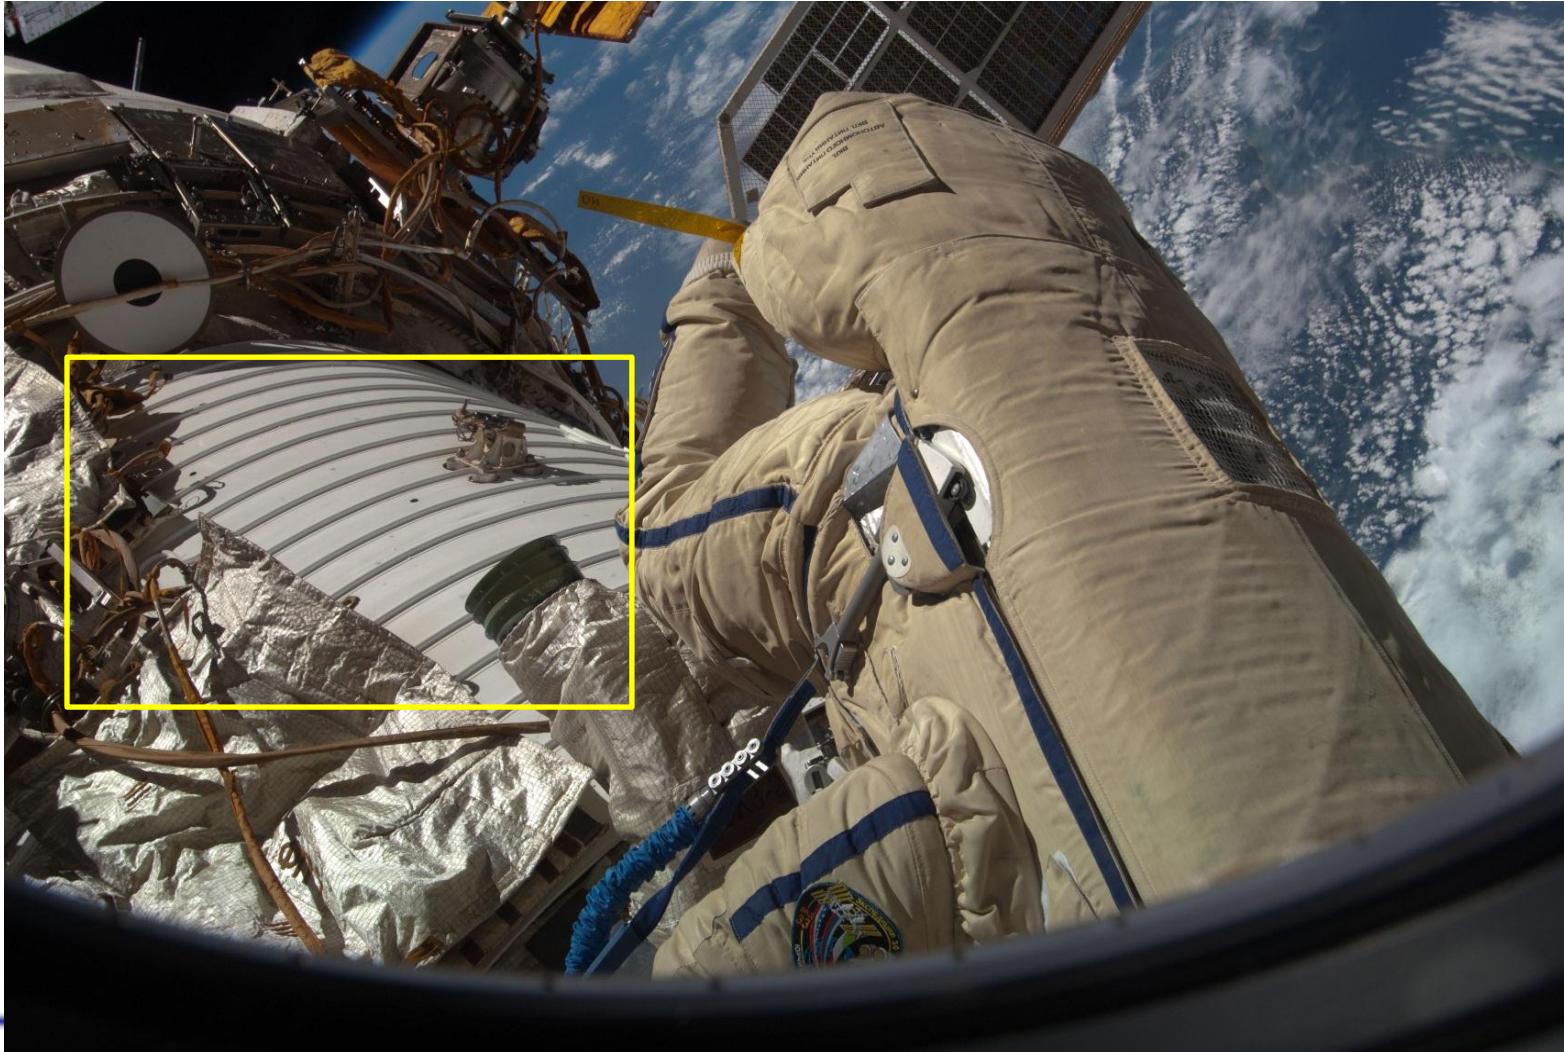
- MMOD impact damages observed to ISS radiator panels during Russian EVA (June 2013)

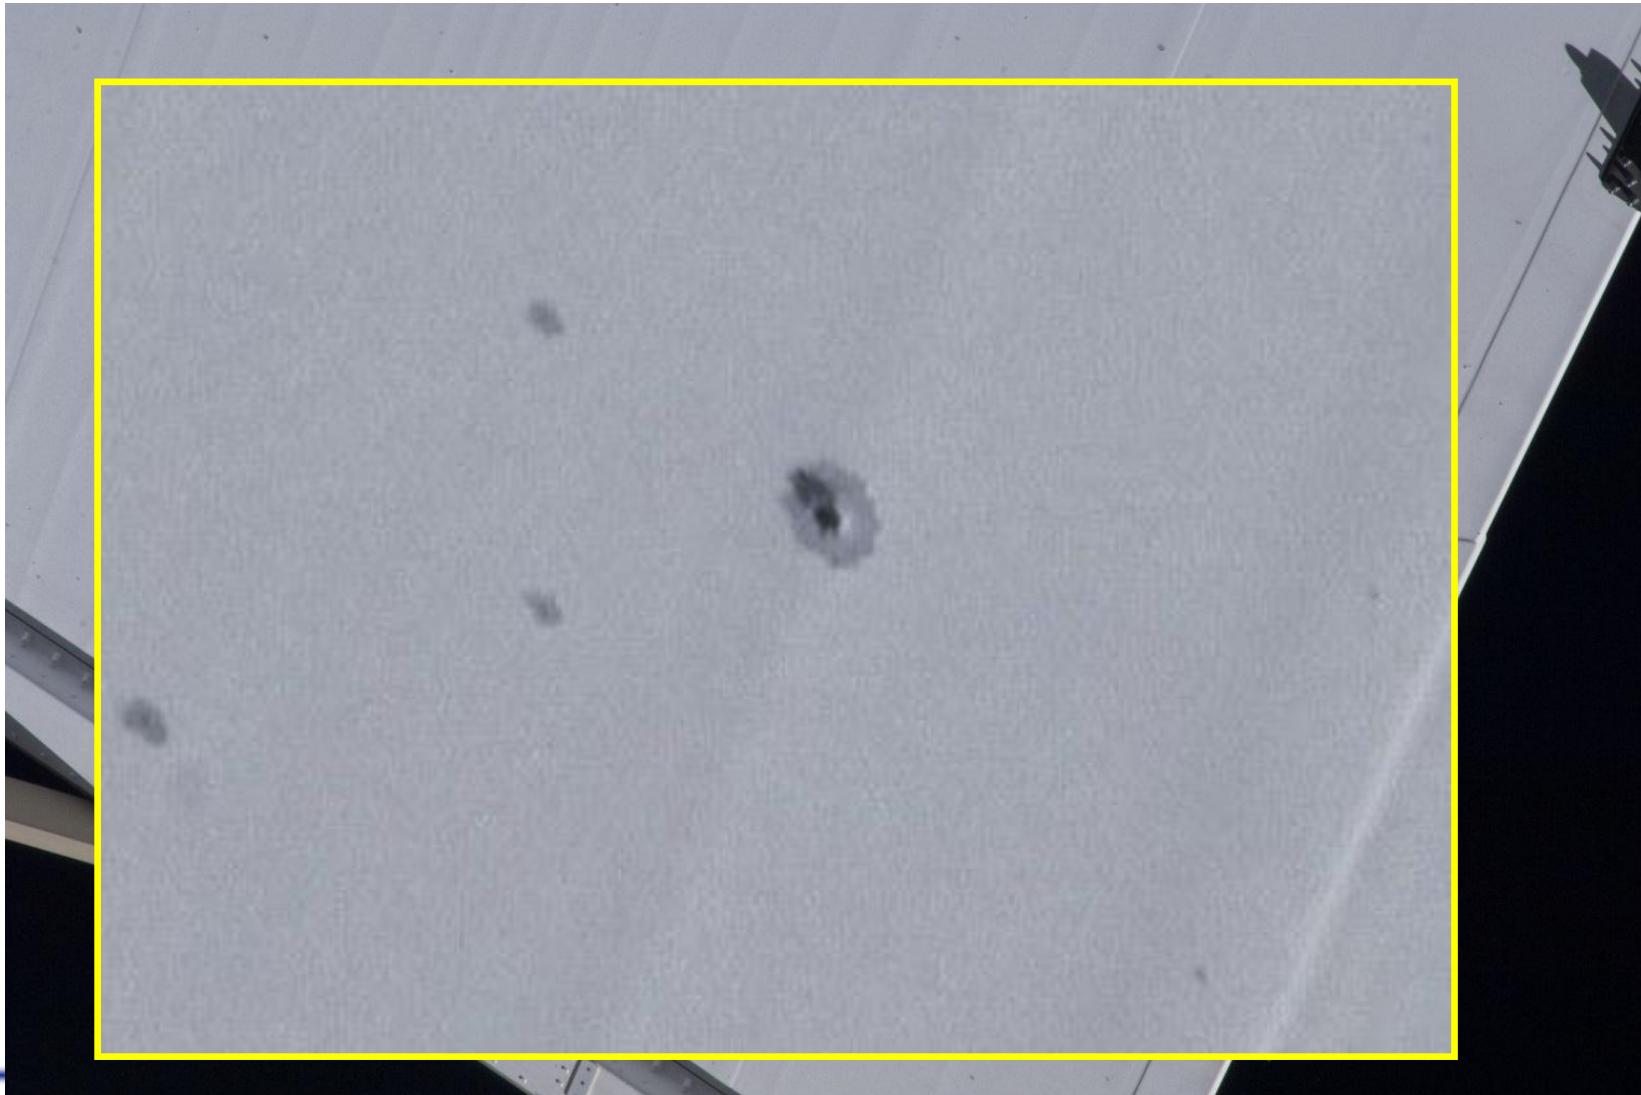
- MMOD impact damages observed to ISS radiator panels (Aug. 2013)

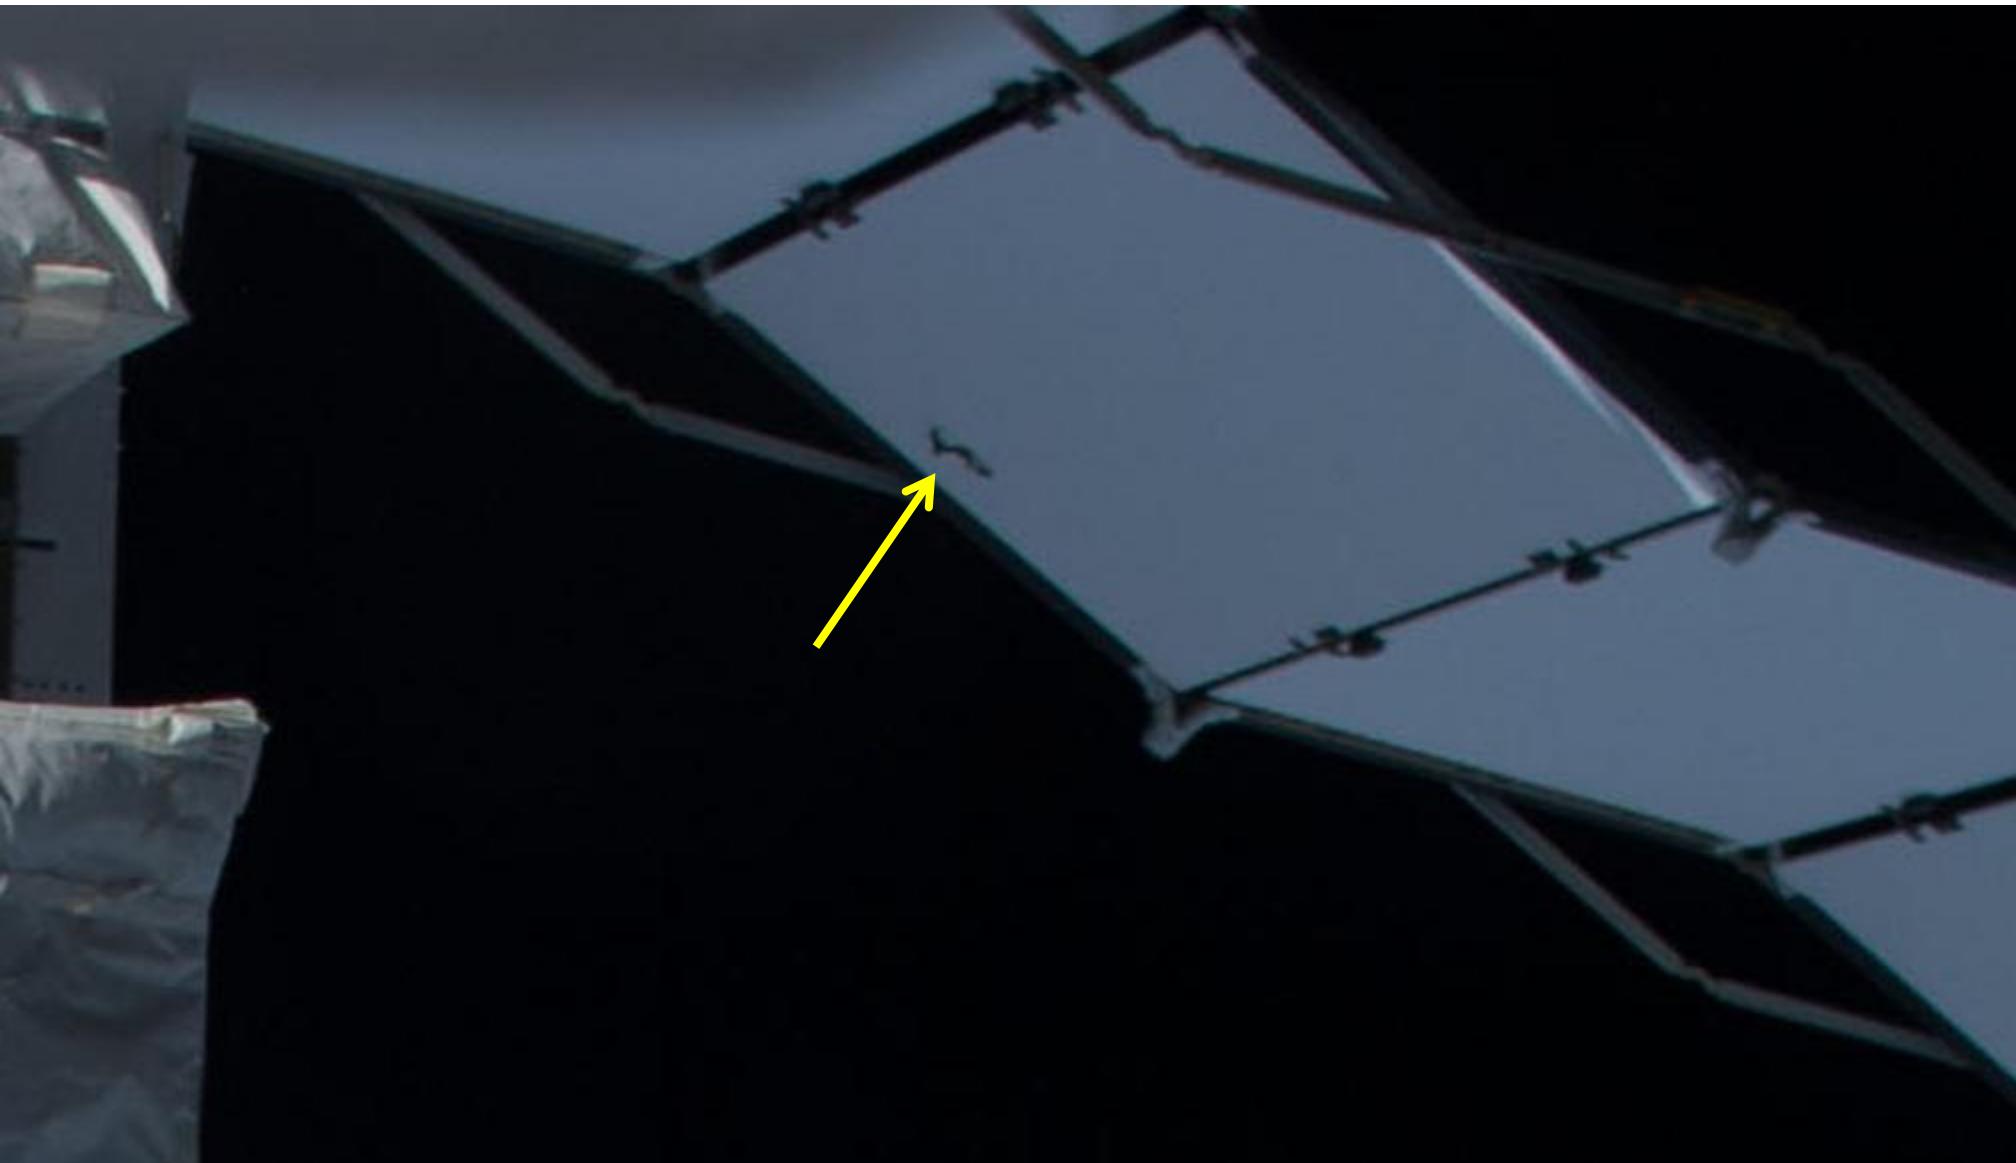
## P4 photovoltaic radiator

- Initial indication found on 6/30/2014

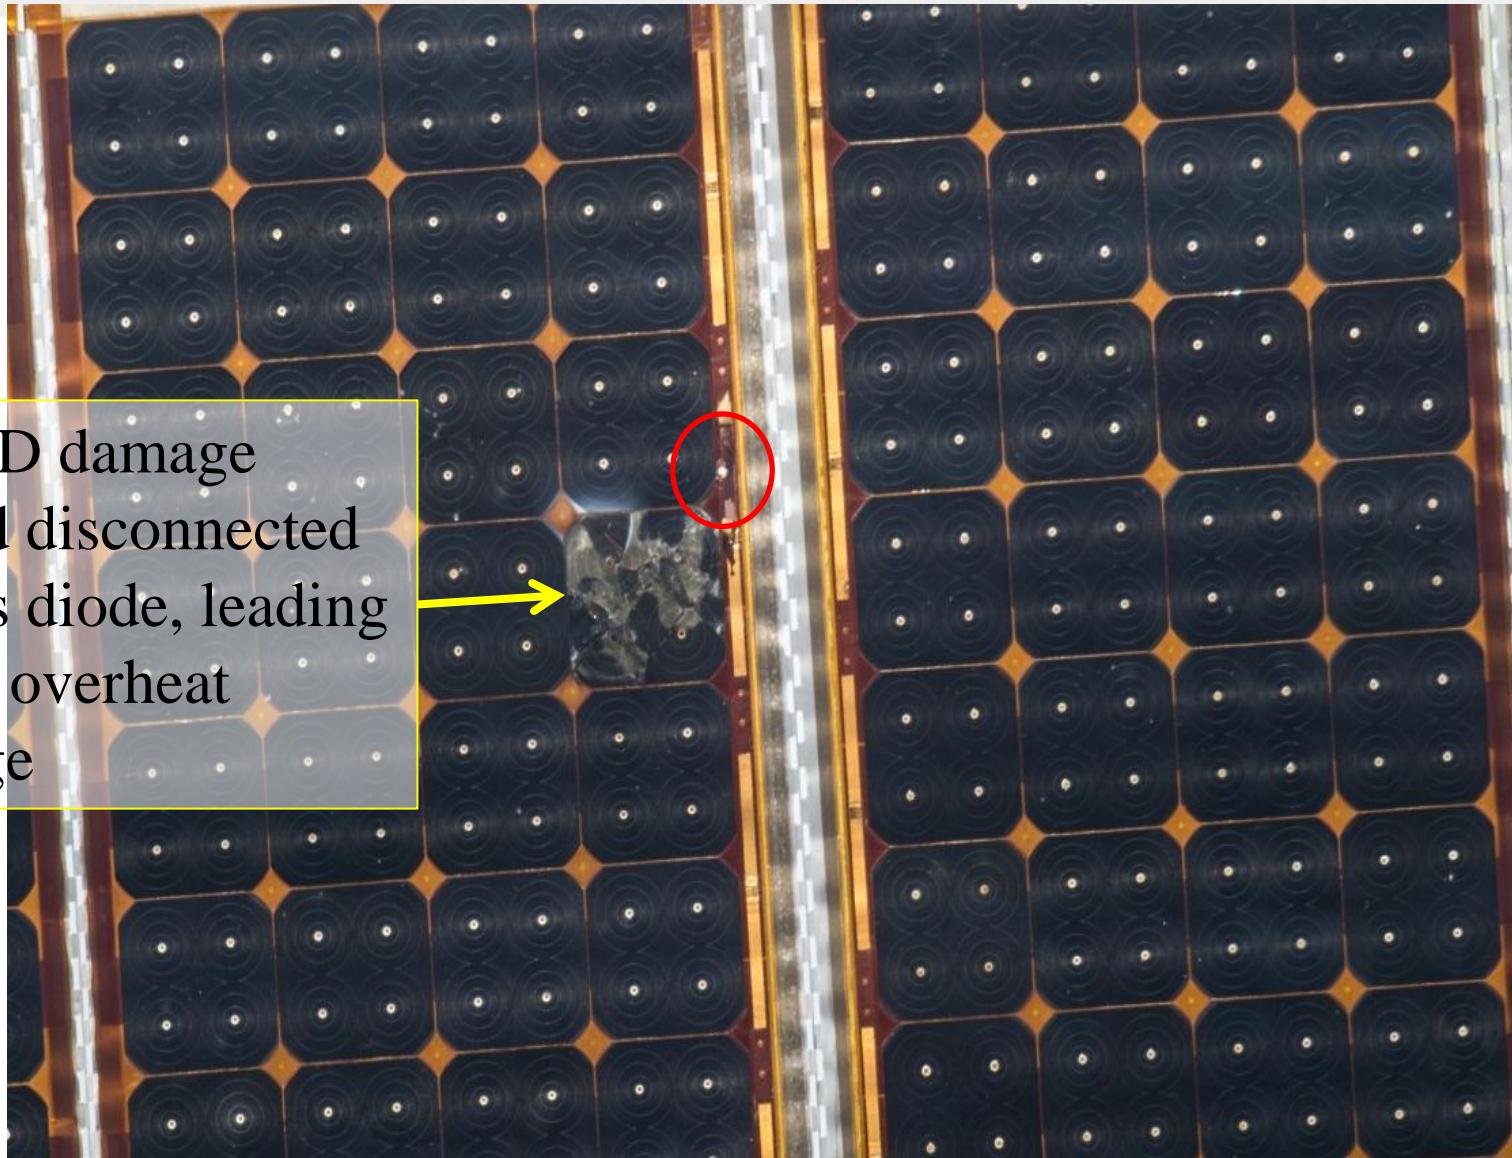
## ISS Solar Array Damage

MMOD damage  
caused disconnected  
bypass diode, leading  
to cell overheating  
damage

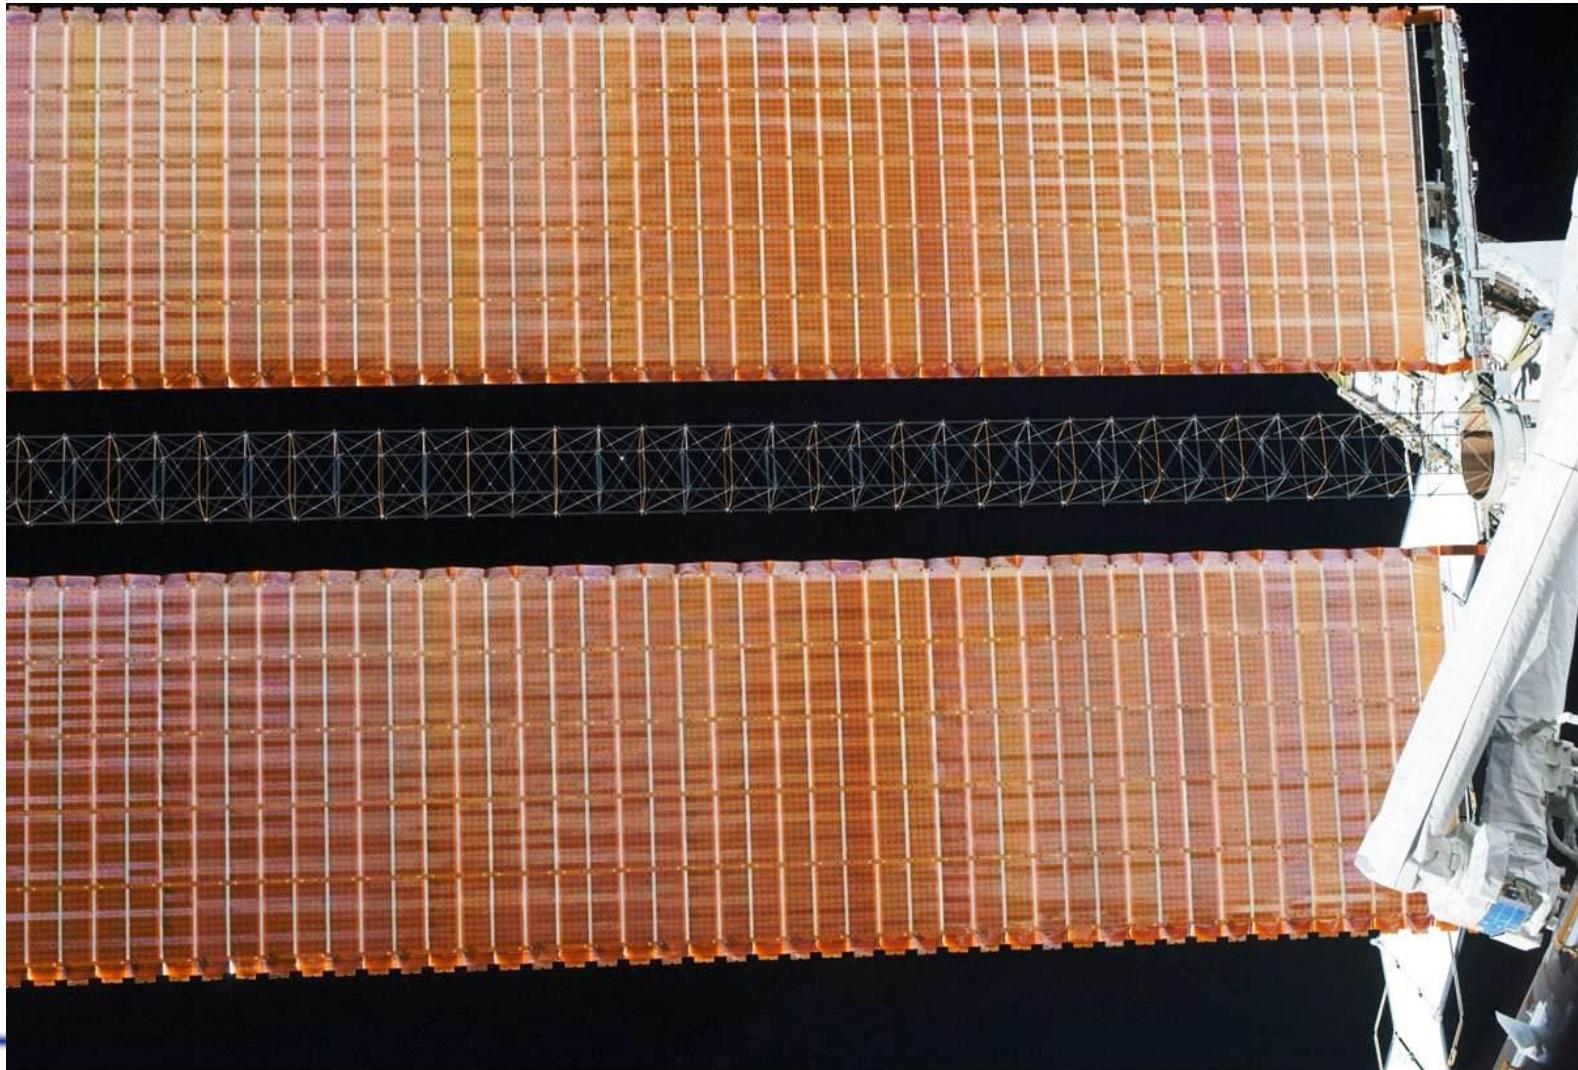
ISS022E067792

- Deployable structural booms or masts used to support ISS solar arrays

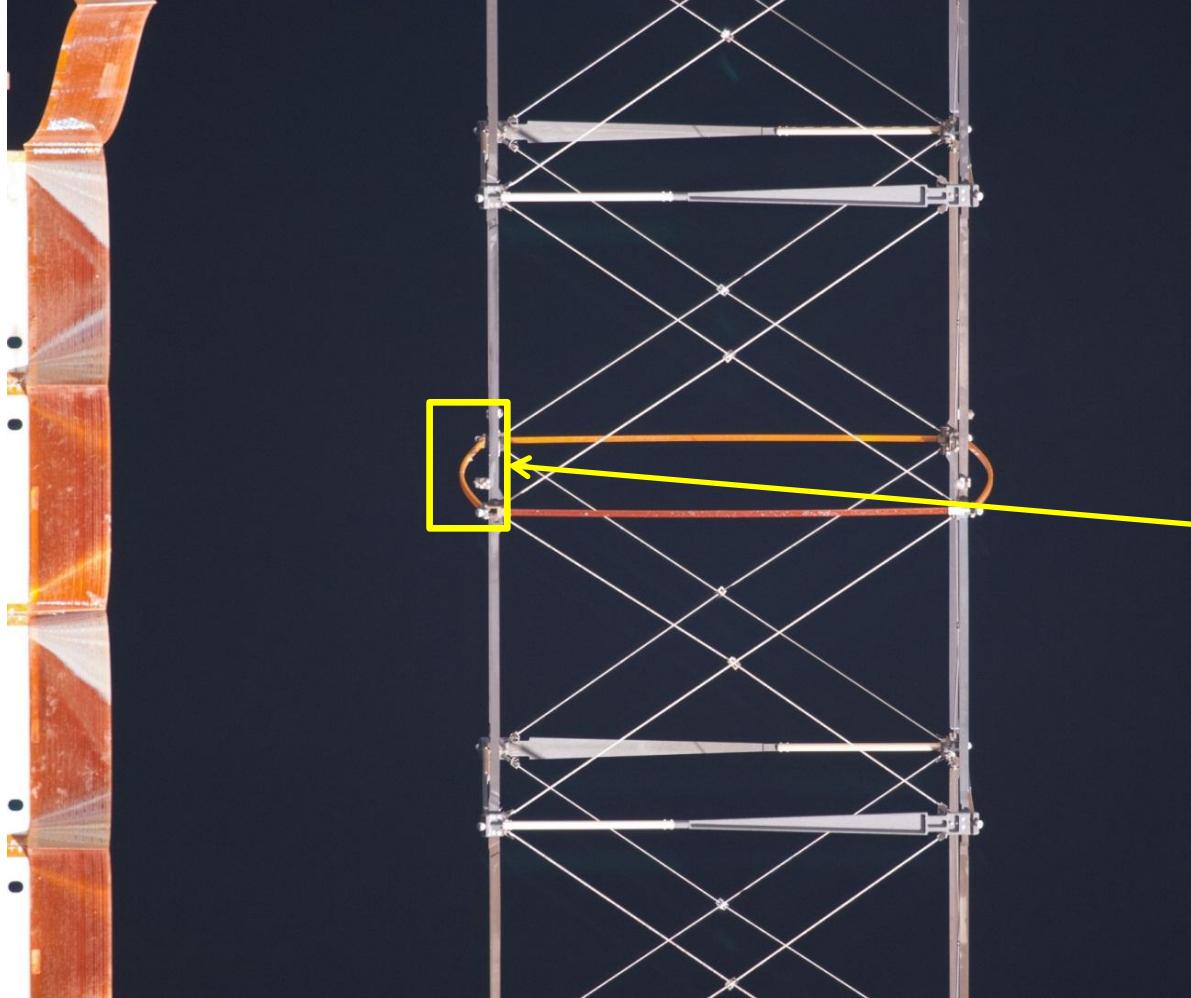
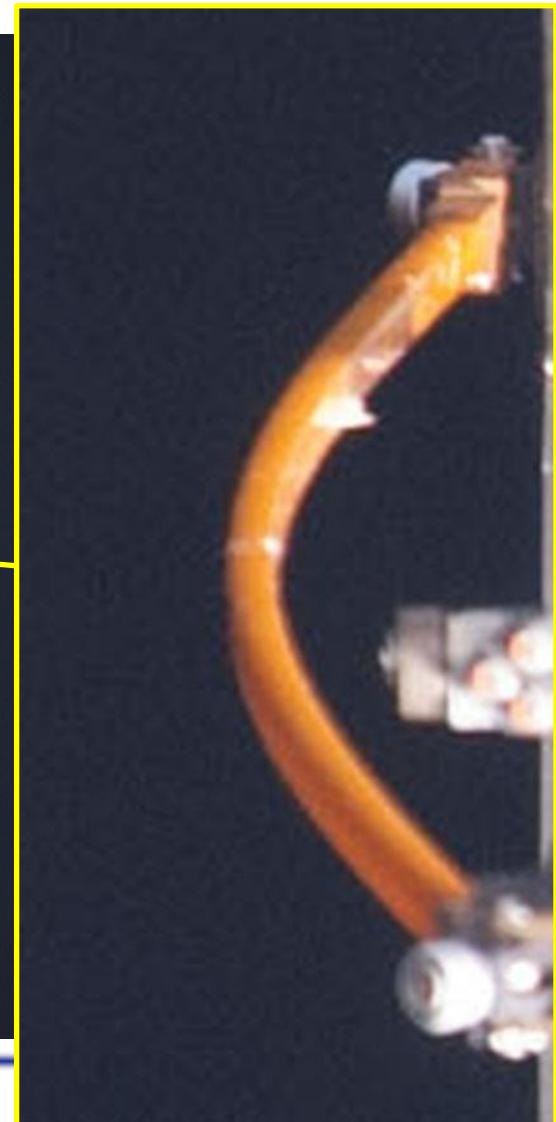
- Elements of the solar array masts have been damaged from MMOD impacts

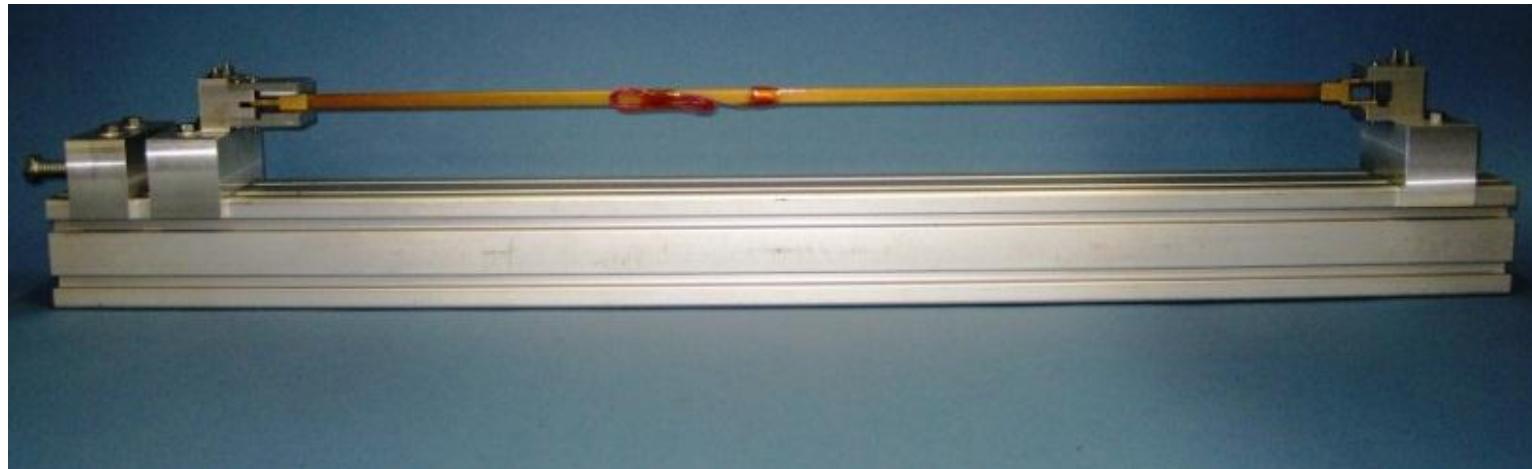
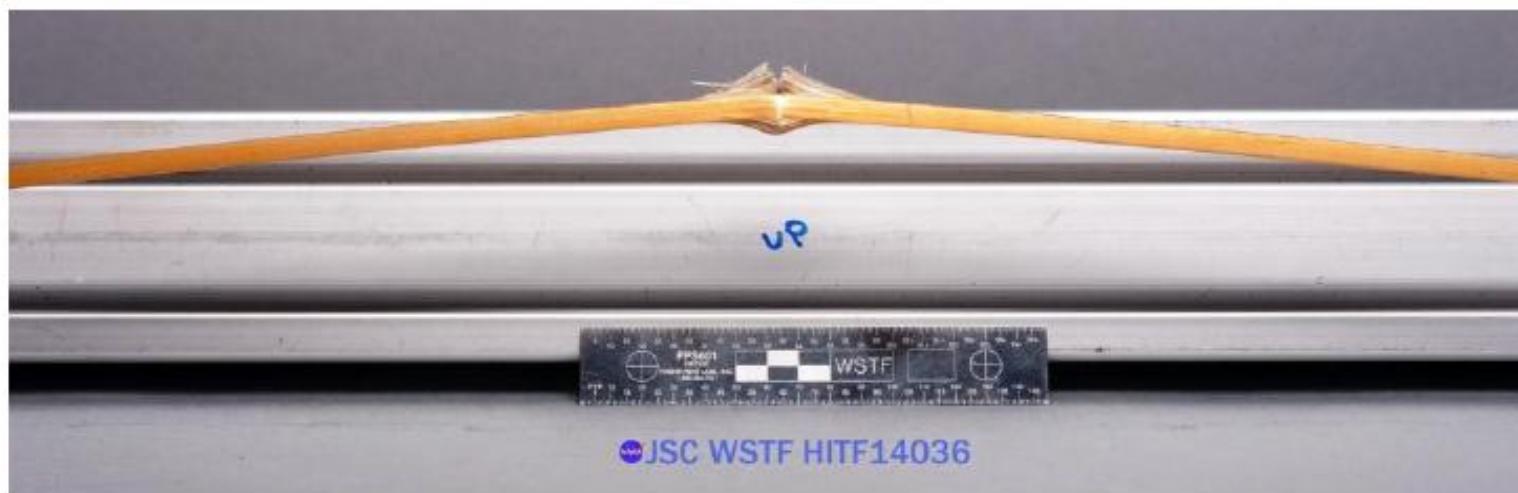
## Hypervelocity impact tests

- Mast elements have been hypervelocity impact tested and structurally tested to assess residual strength for ISS life extension

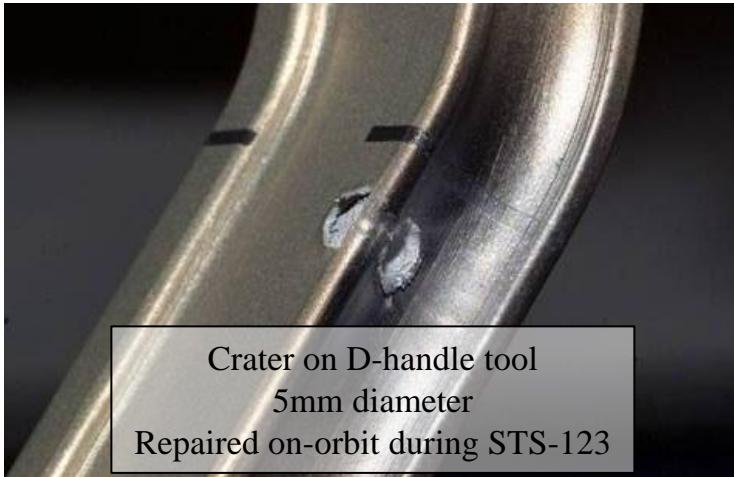
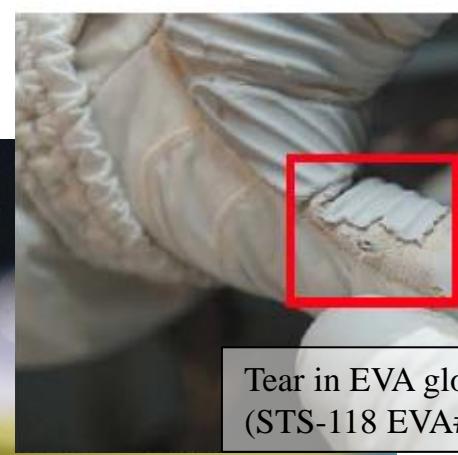
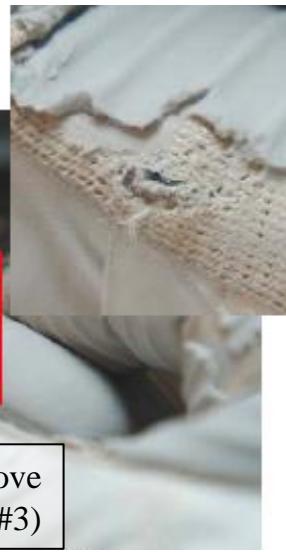
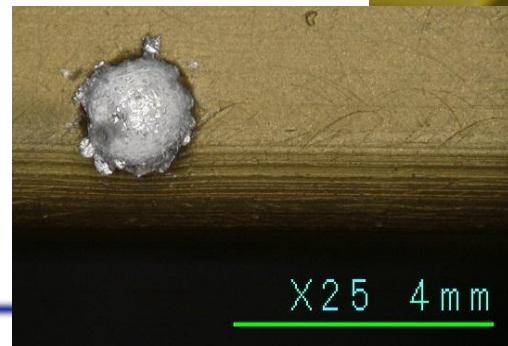
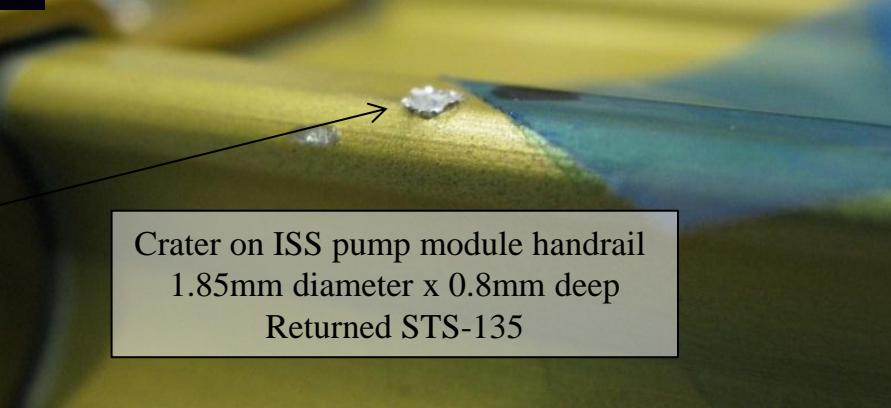
- Many craters noted to ISS handrails and EVA tools
- Sharp crater lips have lead to cuts on EVA gloves
- EVA terminated early on STS-118 due to glove cuts
- Modifications to EVA suit and ISS EVA procedures necessary to reduce cut glove risk from MMOD damage

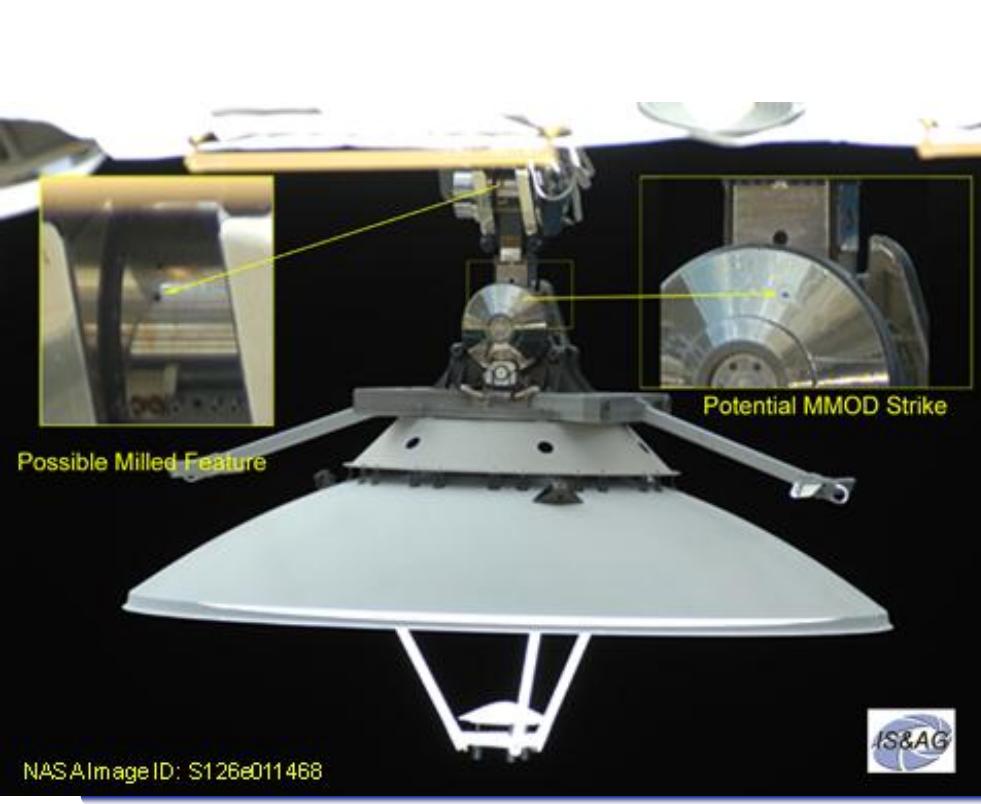
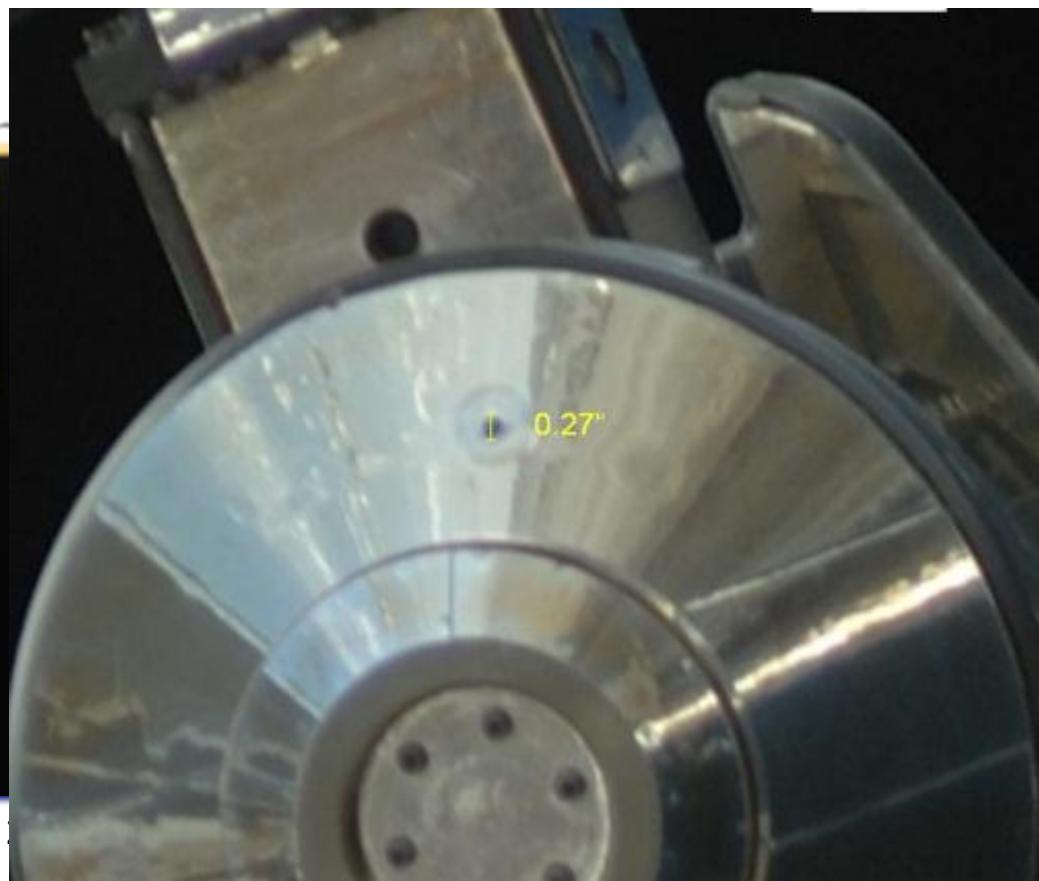
## Ku-band antenna

- An MMOD Strike was seen on the ISS Ku Antenna Gimbal Gear Cover. The image was captured during Mission ULF2 / STS-126.
- Interior damage?

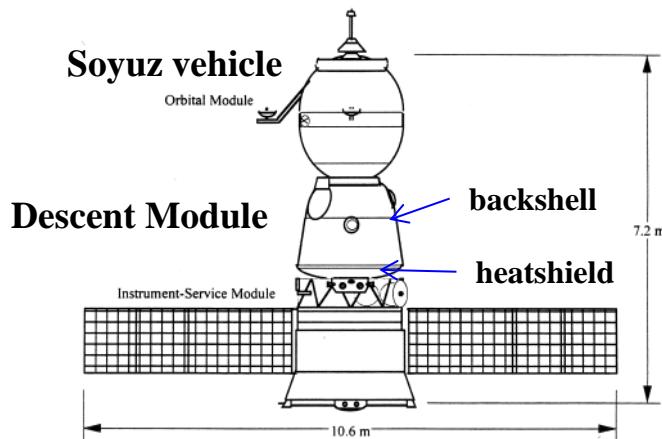
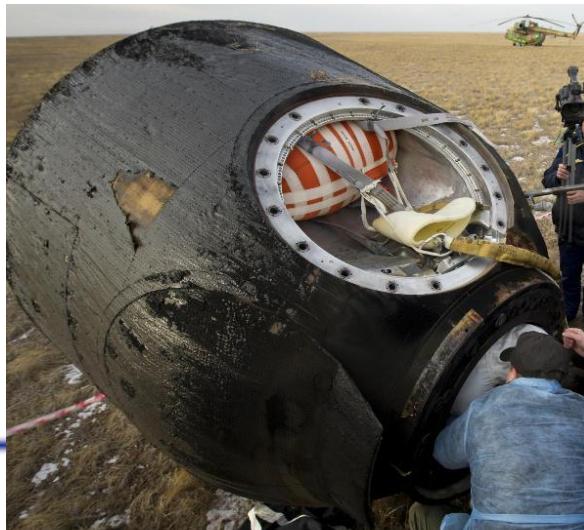
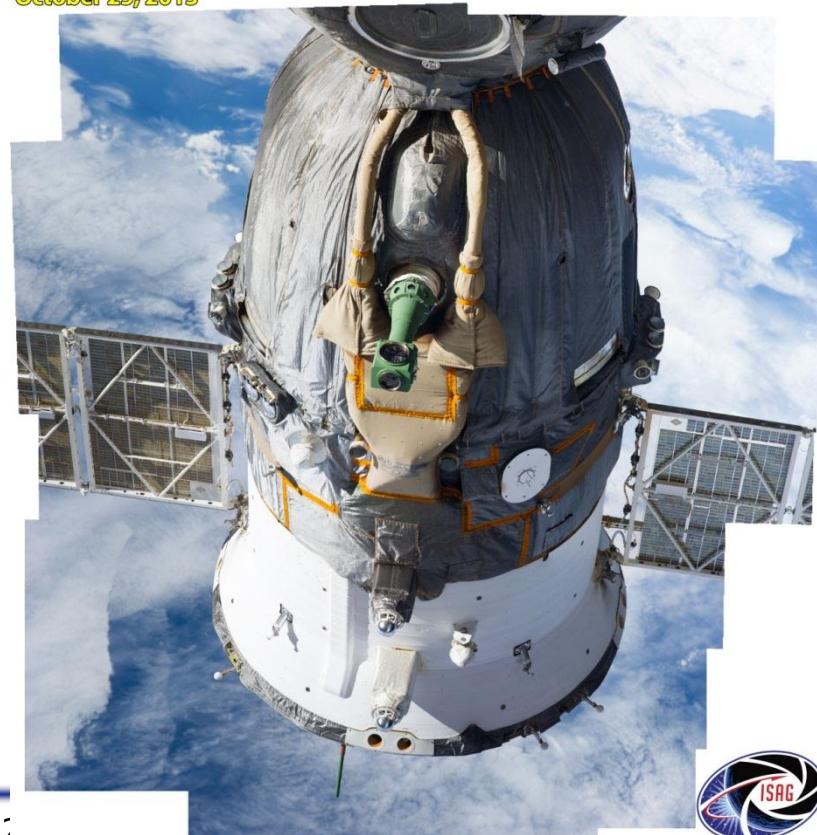
INC 37 Soyuz 35S  
Cupola W5  
D3s w/180mm lens  
October 25, 2013

- **MMOD risk to thermal protection system (TPS) of ISS crew return vehicles (Soyuz, Commercial vehicles) is high**
  - Concern is TPS damage that can lead to loss-of-vehicle during reentry
  - Issue can be mitigated by inspection and repair or safe-haven (not Program baseline)

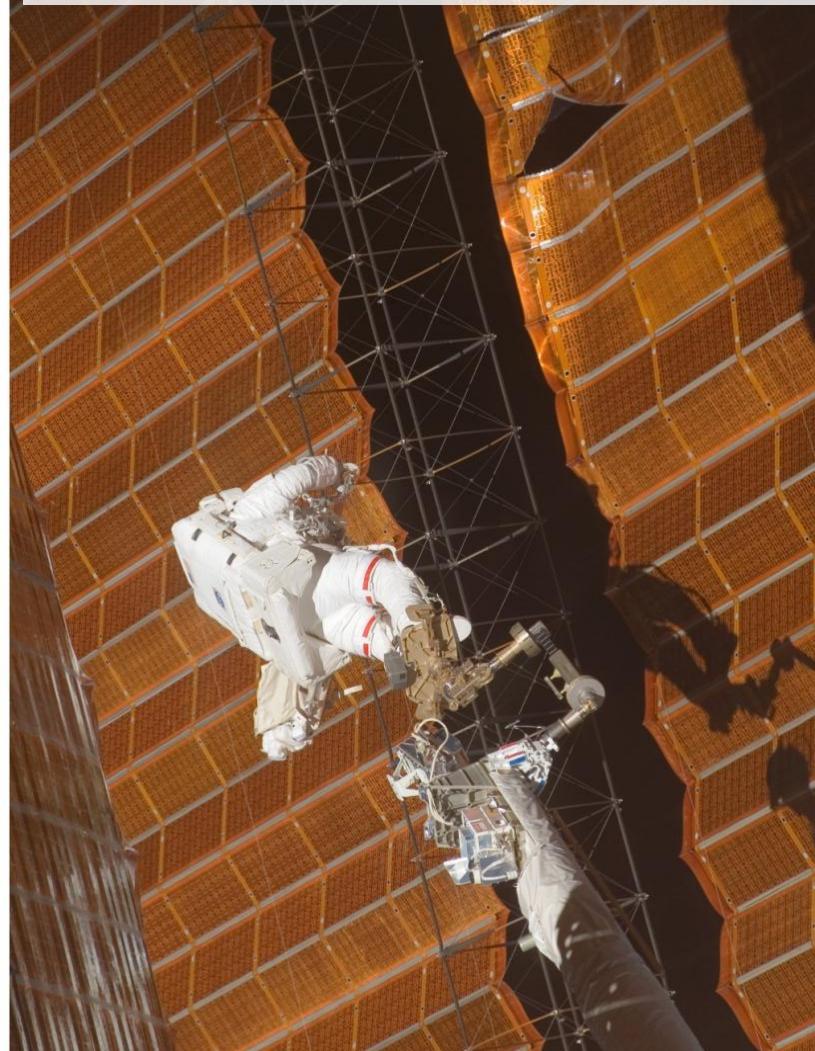
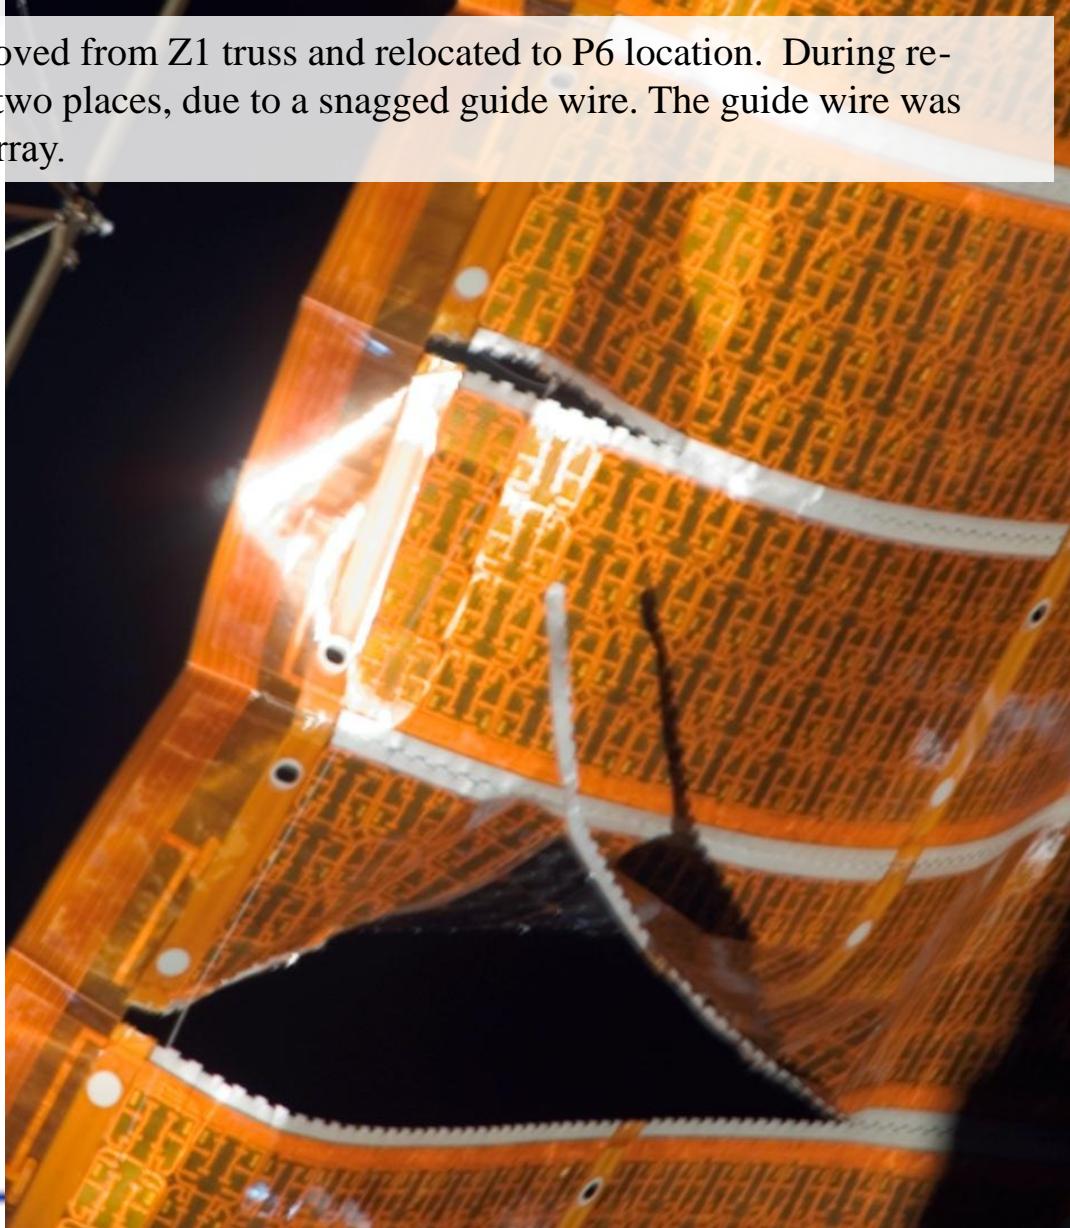
ISS016E009184

## STS-120 Solar Array Wing (SAW) EVA repair was caused by MMOD impact damage

During STS-120 two solar array wings were removed from Z1 truss and relocated to P6 location. During re-deployment, the 4B solar array wing was torn in two places, due to a snagged guide wire. The guide wire was removed and “cuff-links” added to stabilize the array.

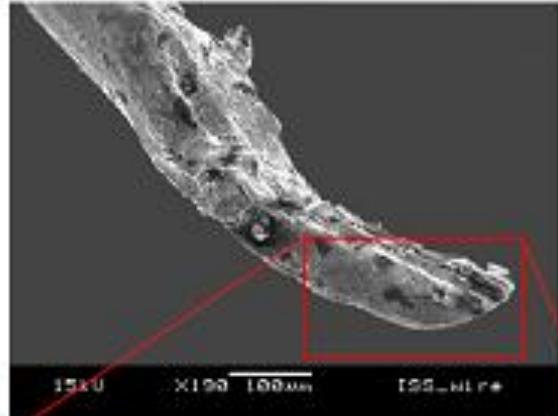
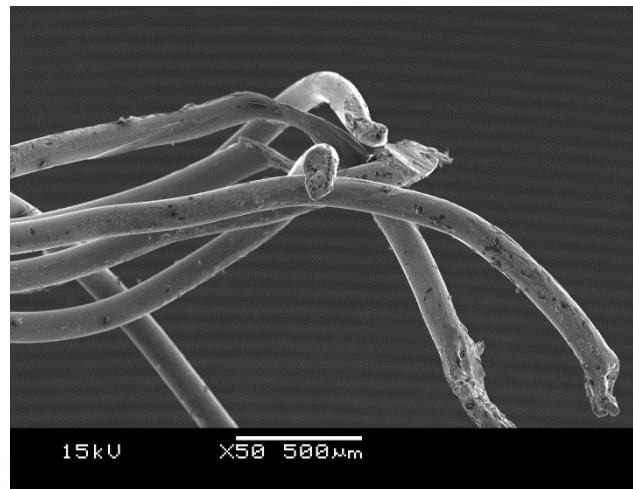
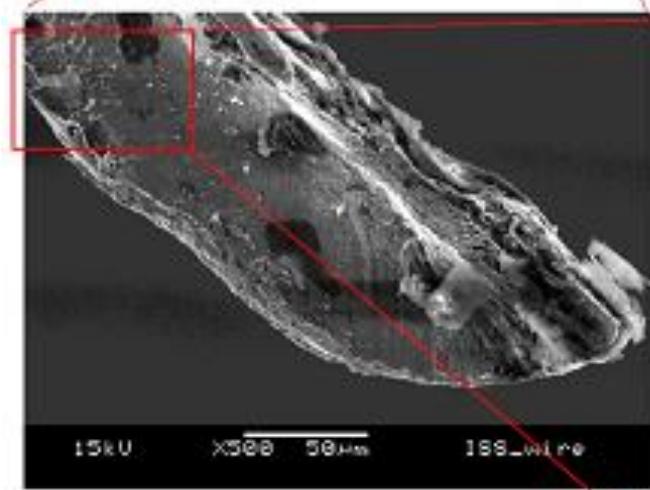
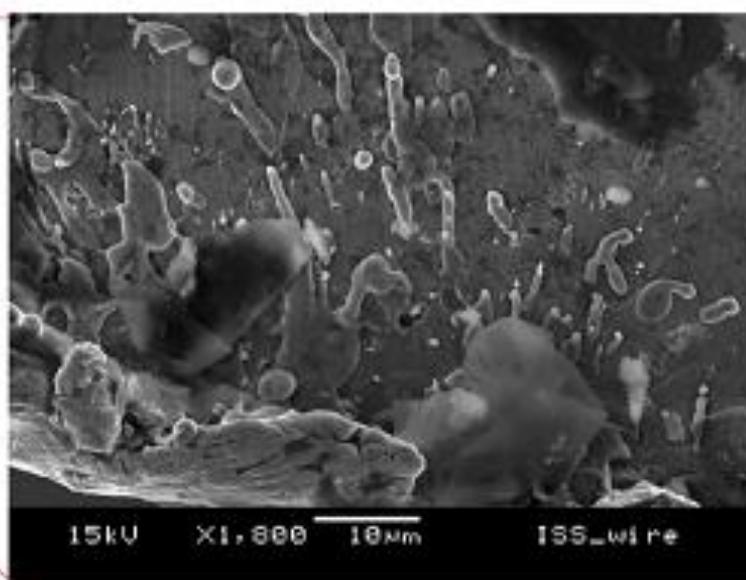
7 of 21 wires in the guide wire cable were broken, causing the guide wire to hang-up in a solar array grommet.  
3 of the 7 cut wires exhibited evidence of extensive melt at broken ends, indicative of MMOD impact.
