# **Micrometeoroid and Orbital Debris (MMOD) Risk Overview**

**Eric Christiansen  
NASA Johnson Space Center  
July 2014**

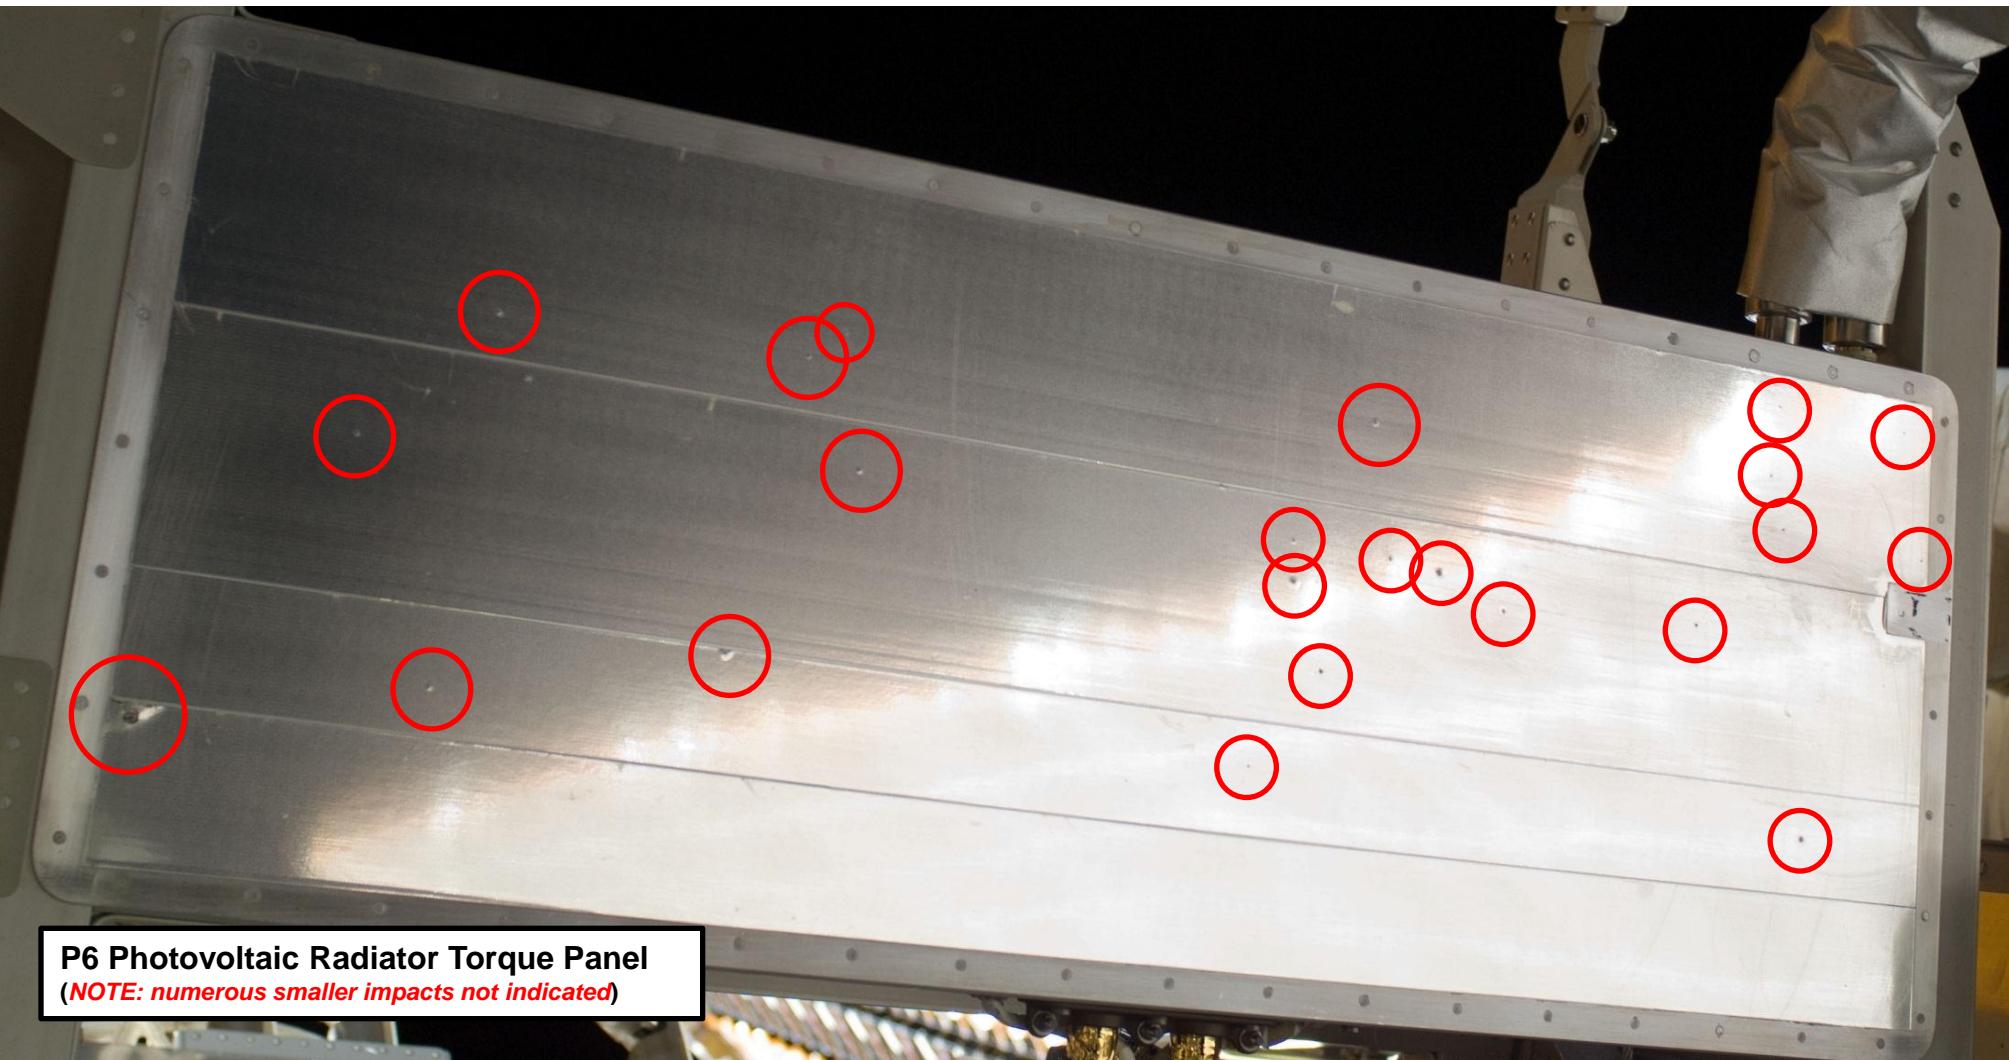
- MMOD impact damages observed to radiator panel during EVA-20 (Nov. 2012)

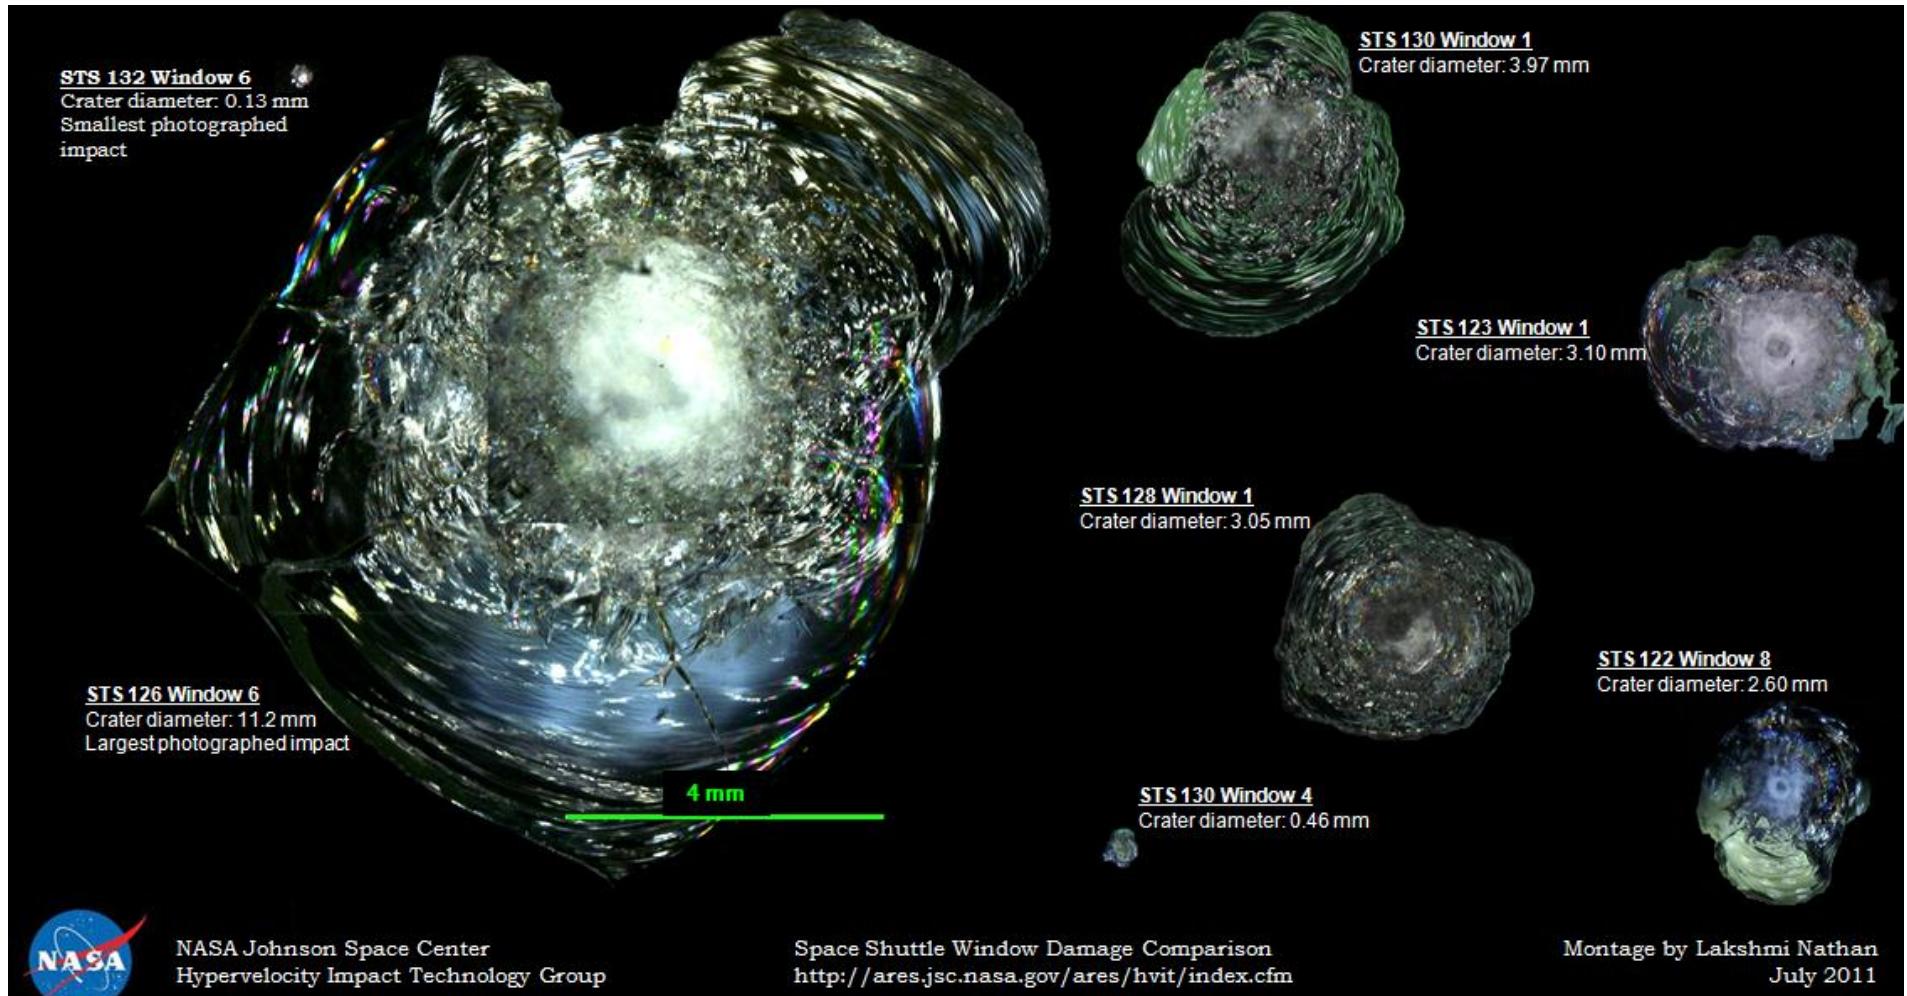
**Sampling of Shuttle Window MMOD Impact Craters**  
(all displayed on same dimensional scale)
