**The ICEE Conference 2025**

# **Transformer Protection – Incidents and Lesson Learnt**

**Name: Karl M.H. LAI**

**Company/University: CLP Power Hong Kong / HKU**

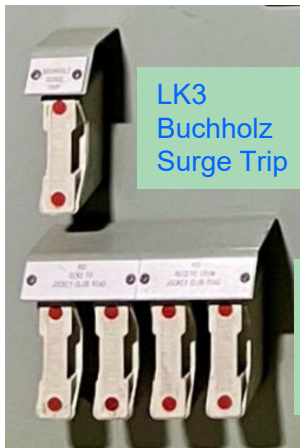
1. Tap Changer (TC) Buchholz Surge Trip Activated at Plant side

LK3  
Buchholz  
Surge Trip

LK4 –  
Intertrip Send to JCR  
LK5 –  
Intertrip Receive to JCR
