Report Details

| Report ID | FR-2026-001 |
| Machine | CBM-003 Siemens EQ.9 Plus Connect |

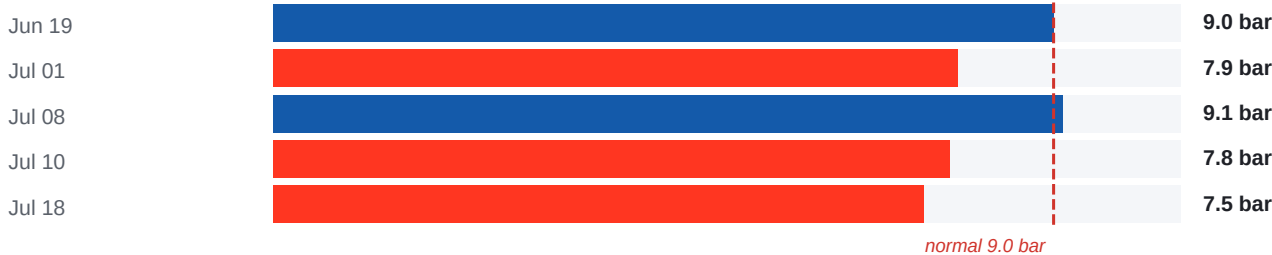
Brew Pressure - Last 5 Readings

Fault code E-07 (Pressure Sensor Fault) has triggered three times in 18 days. Events on 2026-07-01, 2026-07-10, and 2026-07-18. The first two were resolved by TECH-01 but the fault recurred each time. The machine is still operational but pulling shots at 7.5-8.2 bar versus the normal 9.0 bar. Roughly 20% of espresso shots were rejected during fault windows. Customer complaints were logged on 12 Jul and 17 Jul.

- Urgent inspection required - fault is escalating, not stabilising.
- Likely root cause: worn pump assembly or cracked pressure line.
- Parts anticipated: pump assembly (SIE-EQ9-PUMP-003), pressure line kit (SIE-EQ9-PL-KIT).
- Previous pressure transducer replacements (2 Jul, 11 Jul) did NOT resolve the fault.
- Contact: sara.m@sunnybayroastery.com | +1-415-555-0103
