### Report Details

| Report ID | FR-2026-002 |
| Machine | CBM-009 Siemens EQ.9 Plus Connect |

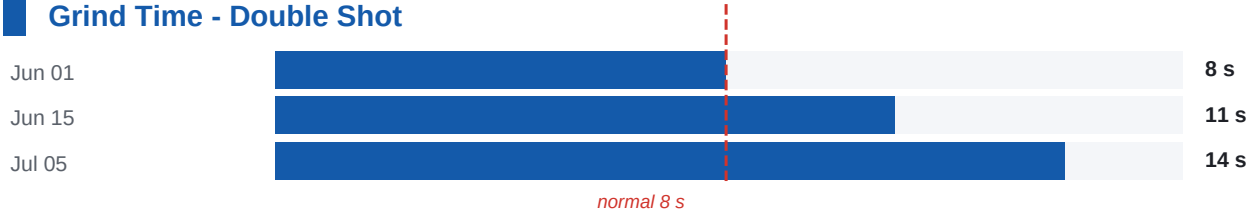
### Grind Time - Double Shot

Fault code W-12 (Grinder Motor Degradation). Grind time for a double shot has increased from a normal 8 seconds to 14 seconds. First occurrence 15 Jun 2026, partially resolved, then returned 5 Jul 2026. The machine is 7 years old with no major overhaul on record. Grinder burrs are likely worn beyond the service threshold.

- Schedule grinder burr replacement and a full motor inspection.
- No urgent production impact yet, but further degradation is expected within 2-3 weeks.
- Part: grinder burr set (SIE-EQ9-BURR-STD).
