Report Details

| Report ID | FR-2026-005 (Supplement to FR-2026-001) |
| Machine | CBM-003 Siemens EQ.9 Plus Connect |

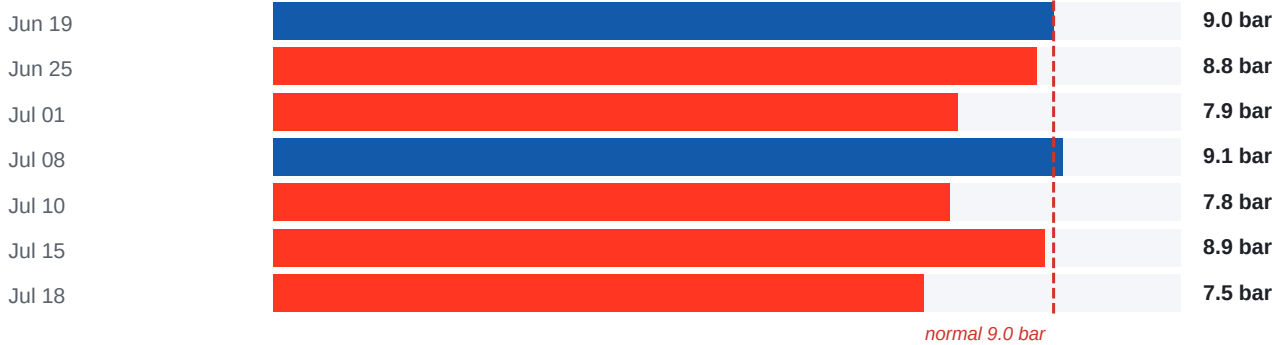
Pressure Readings - 30 Day Log

The pressure transducer was replaced twice (2 Jul, 11 Jul) and the fault persists. The pattern indicates a worn pump or a cracked pressure line upstream of the transducer, not the sensor itself.

- Pump assembly: SIE-EQ9-PUMP-003
- Pressure line kit: SIE-EQ9-PL-KIT
- Estimated repair time: 2 hours on-site.
- Escalate to senior technician - this is now the top-priority machine in the fleet.
