Report Details

| Report ID | FR-2026-005 (Supplement to FR-2026-001) |
| Location | Mission - 2847 Mission St |
| Machine | CBM-003 Siemens EQ.9 Plus Connect |

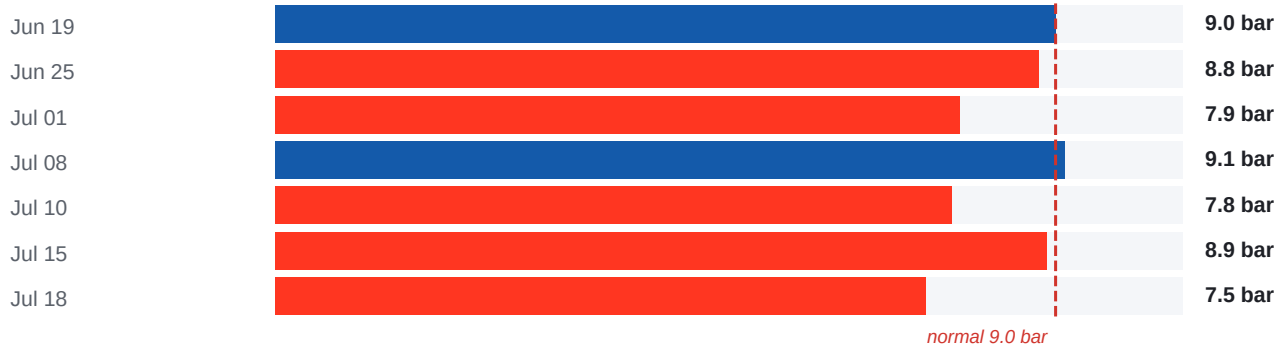
Pressure Readings - 30 Day Log

Fault code E-07 (Pressure Sensor Fault) remains unresolved. The pressure transducer was replaced twice (2 Jul, 11 Jul) and the fault persists. The pattern indicates a worn pump or a cracked pressure line upstream of the transducer, not the sensor itself.

- Pump assembly: SIE-EQ9-PUMP-003
- Pressure line kit: SIE-EQ9-PL-KIT
- Estimated repair time: 2 hours on-site.
- Escalate to senior technician - this is now the top-priority machine in the fleet.
