BLACK ROCK WEEKLY REPORT

Weekly PSD Report  
EPIROC SA

## Weekly Service Report – Black Rock Mine Operations

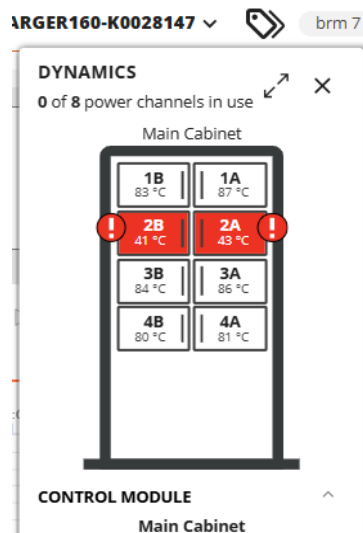
Figure 2: Chargers 1, 8 and 7 have faulty fans that need to be replaced
