# Weekly Site Report

BLACK ROCK WEEKLY REPORT

Weekly PSD Report  
EPIROC SA

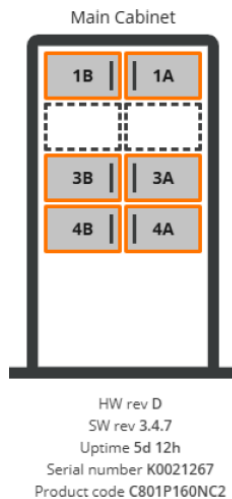
## Charger (BRM 1)

- Charger status has not changed since the last report in December 2025
- Charger still missing 2X power modules
- Charging power still reduced
- Modules still need to be replaced
- Charger currently running with no faults
- When Charger modules are highlighted orange, Means charger is currently charging
- Charger currently on new SW V3.4.7

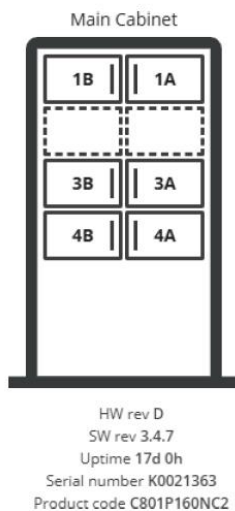
## Charger (BRM 2)

- Charger status has not changed since the last report in December 2025
- Charger still missing 2X power modules
- Charging power still reduced
- Modules still need to be replaced
- Charger currently running with no faults
- Charger currently on new SW V3.4.7

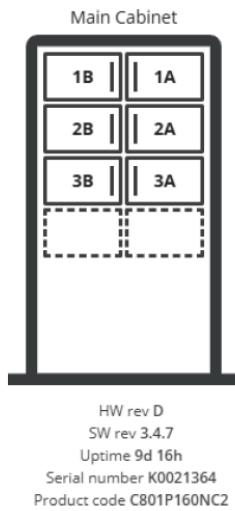
## Charger (BRM 3)

- Charger status has not changed since the last report in December 2025
- Charger still missing 2X power modules
- Charging power still reduced
- Modules still need to be replaced
- Charger currently running with no faults
- Charger currently on new SW V3.4.7

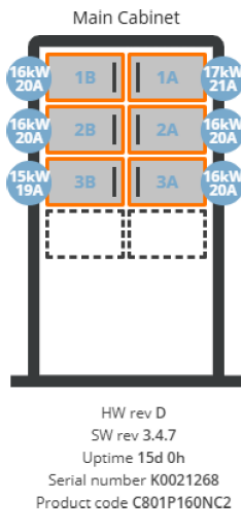
## Charger (BRM 4)

- Charger status has not changed since the last report in December 2025
- Charger still missing 2X power modules
- Charging power still reduced
- Modules still need to be replaced
- Charger currently running with no faults
- When Charger modules are highlighted orange, Means charger is currently charging
- Charger currently on new SW V3.4.7

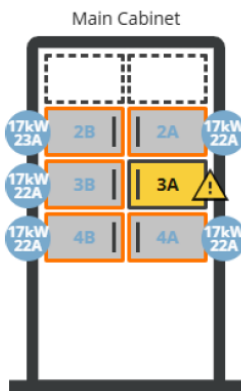
## Charger (BRM 5)

**POWER MODULE FAULT**  
MC 3A

PMC 3A on Main cabinet: SSC\_PMC\_FAN\_CURRENT

- Charger status has not changed since the last report in December 2025
- Charger still missing 2X power modules
- Charging power still reduced
- Charger still currently running with a defective fan on the power module highlighted yellow, Charger fan needs to be replaced.
- Charger on new SW V3.4.7

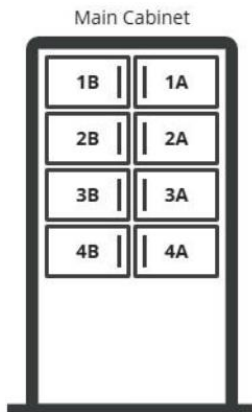
## Charger (BRM 6)

- Charger currently offline, online Audit not possible for now.
- Charger currently on new SW V3.4.7

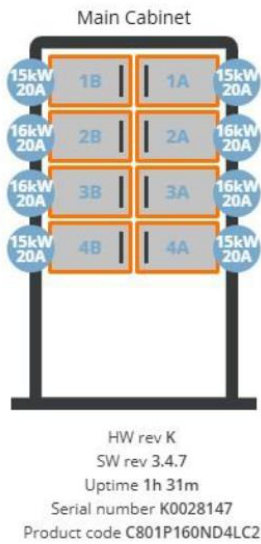
## Charger (BRM 7)

- Charger currently running with no faults
- Charger currently on new SW V3.4.7

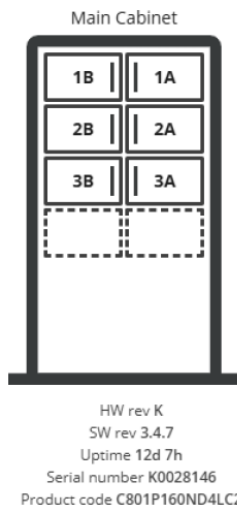
## Charger (BRM 8)

- Charger status has not changed since the last report in December 2025
- Charger still missing 2X power modules
- Charging power still reduced
- Modules still need to be replaced
- Charger currently running with no faults
- Charger currently on new SW V3.4.7
