# SiteCheck AI — Inspection Report

Session: 3a05d096591f

Ruleset: IS456 | Units: metric

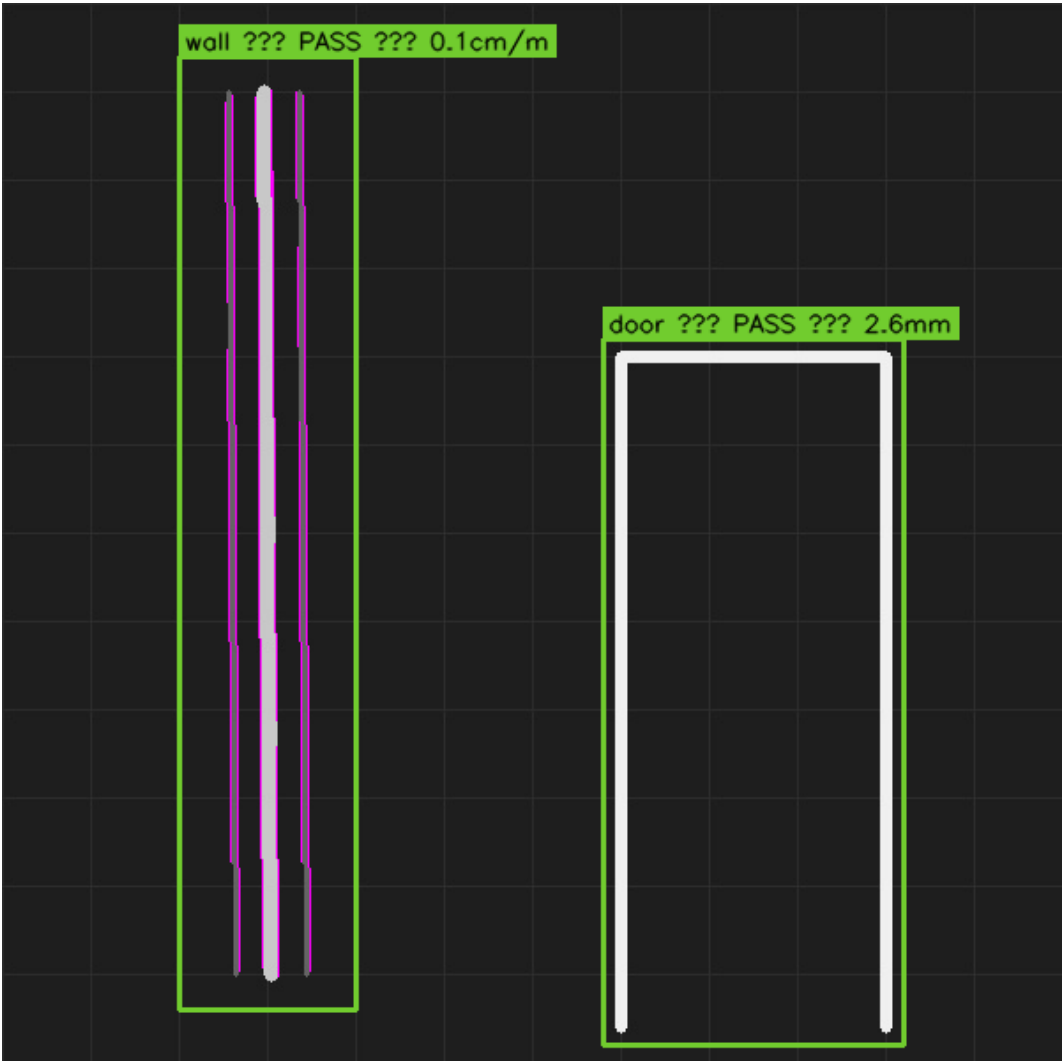
| Element | Measurement | Expected | Deviation | Status |
|---|---|---|---|---|
| wall | plumb_angle_deg: 0.04 deg,... | — | 0.07 cm/m | PASS |

- case1\_wall\_plumb\_pass.jpg — 2 elements
- Photo may be too dark — consider re-uploading with better lighting.
- Photo appears blurry — measurements may be unreliable.

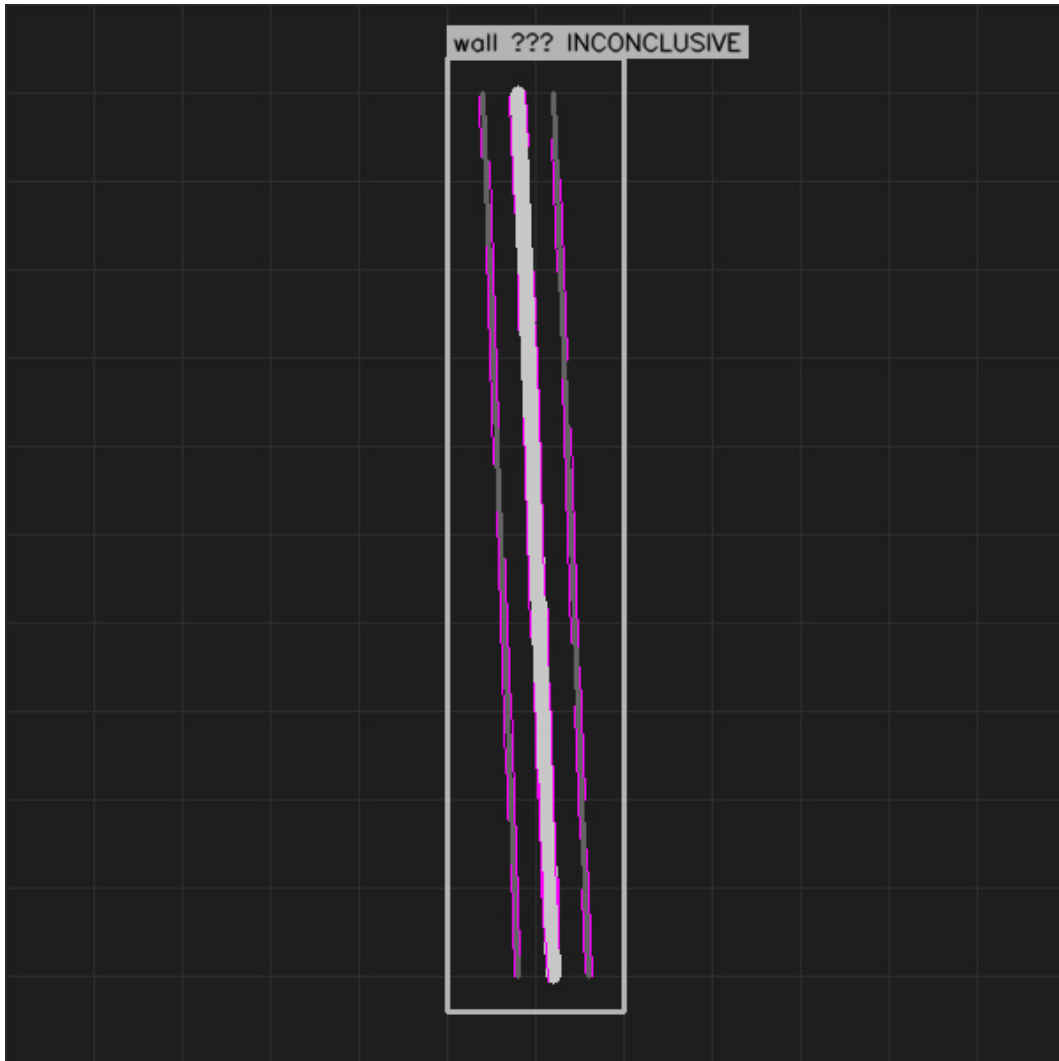
| Element | Measurement | Expected | Deviation | Status |
|---|---|---|---|---|
| wall | plumb_angle_deg: 1.71 deg,... | — | — | INCONCLUSIVE |

- case2\_wall\_plumb\_uncalibrated.jpg — 1 elements
- Photo may be too dark — consider re-uploading with better lighting.

- Photo appears blurry — measurements may be unreliable.

- Re-capture photo for wall — measurement inconclusive.
- Rectify wall deviation before proceeding.
- Review door: Door frame gap asymmetry  $\approx 29.8$  mm.

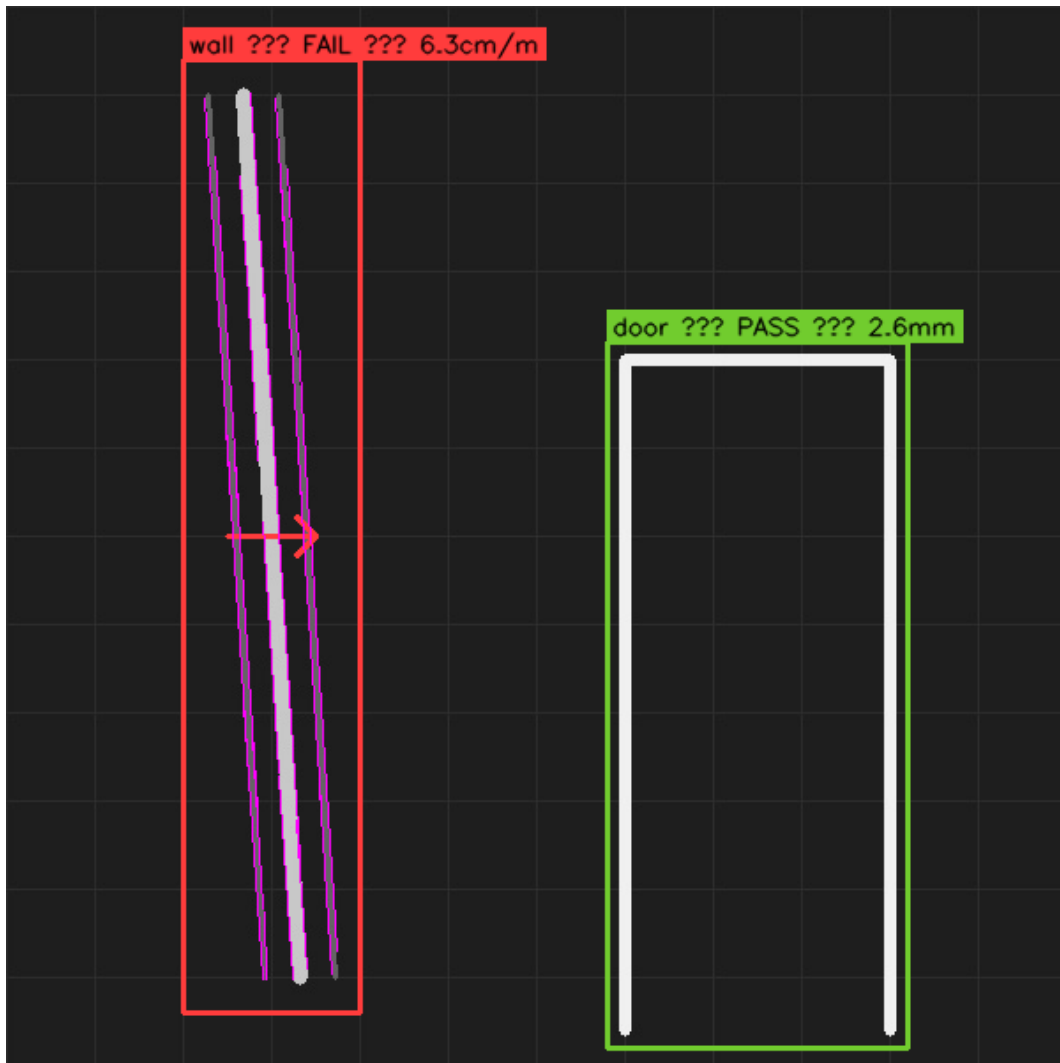
- wall failed check: wall: vertical deviation 6.26 cm/m (3.6° from plumb).

| Element | Measurement | Expected | Deviation | Status |
|---|---|---|---|---|
| wall | plumb_angle_deg: 3.58 deg,... | — | 6.26 cm/m | FAIL |

- case3\_wall\_plumb\_fail.jpg — 2 elements
- Photo may be too dark — consider re-uploading with better lighting.
- Photo appears blurry — measurements may be unreliable.

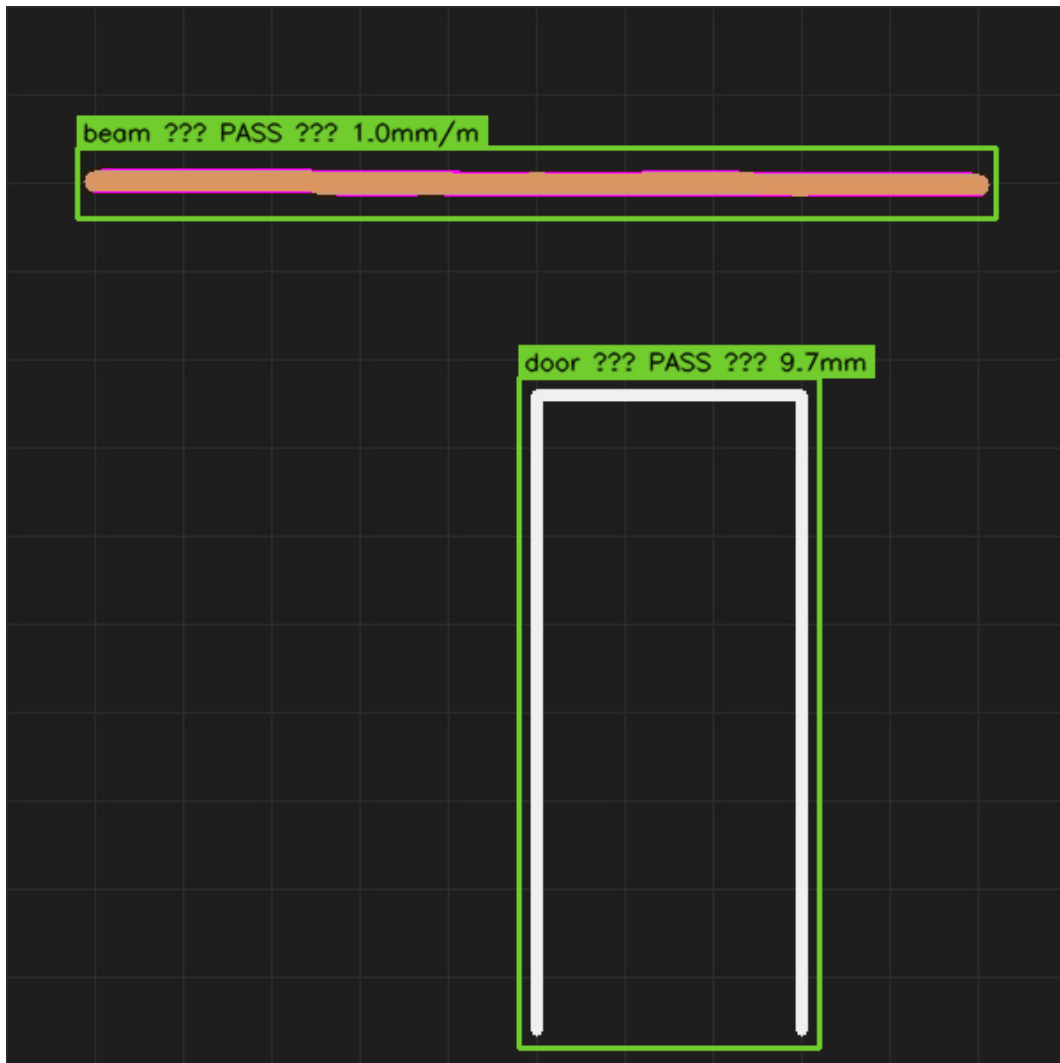
| Element | Measurement | Expected | Deviation | Status |
|---|---|---|---|---|
| beam | level_angle_deg: 0.06 deg,... | — | 1.02 mm/m | PASS |

- case4\_beam\_level\_warning.jpg — 2 elements
- Photo may be too dark — consider re-uploading with better lighting.
- Photo appears blurry — measurements may be unreliable.
