CATASTROPHES CAUSED BY CORROSION

Zoran C. Petrović

ARTICLE TYPE: Review Paper

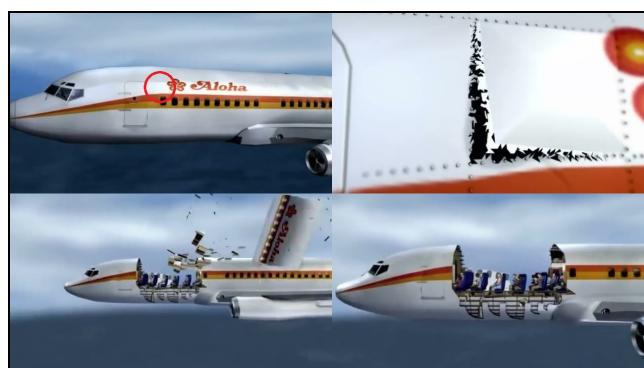
Structural damage to the plating on the Boeing 737 aircraft, operated by the US airline Aloha Airlines, which took place on 28 April 1988, undoubtedly contributed to the creation of awareness of aircraft aging. This aircraft suffered very serious damage caused by explosive decompression during flight. At 8,000 m above the ground, a large segment of the upper fuselage was literally torn off and it made a big hole in the passenger cabin (Miller, 1990).

Figure 1 – Simulation of the flight of an airplane Boeing 737 Aloha Airlines, Flight 243

The crew landed the plane safely on the island of Maui in Hawaii. One flight attendant got killed, while 65 out of 94 survivors were injured. In the remaining structure of the aircraft, in several lap joints of the fuselage skin, in the holes of the upper row of fasteners, subsequent investigations discovered more cracks caused by fatigue (Wildey, 1990).

In the skin of the Aloha Boeing 737 aircraft, multiple damage was found in the form of cracks caused by fatigue which had led to the final structural damage. The report of the National Committee for Traffic Safety, made after the completion of the investigation in 1989, attributed the responsibility for the incident to the program of maintenance and detection of damage from corrosion. Earlier, in 1981, a similar plane suffered an in-flight break-up with more than one hundred fatalities. Investigations have indicated the existence of damage mechanisms to the fuselage skin panels caused by fatigue assisted by corrosion (<http://www.corrosion-doctors.org/Aircraft/Aloha.htm>).

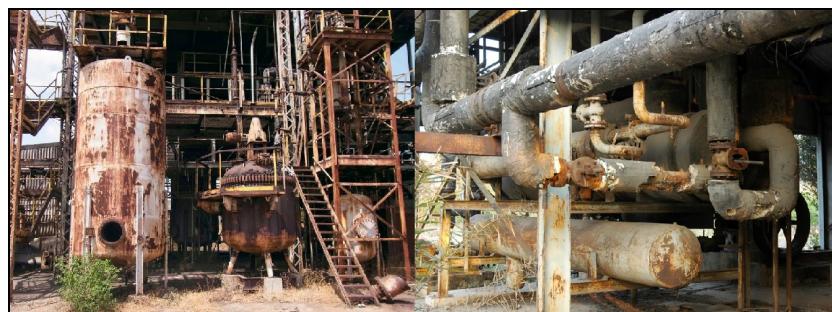
Figure 7 – Elements of the UCIL pesticide plant in Bhopal
Рис. 7 – Завод по производству пестицидов UCIL в Бхопале
Slika 7 – Elementi postrojenja za proizvodnju pesticida UCIL u Bopalu

As already mentioned, the immediate cause of the chemical reaction was the rush of 500 liters of water into the MIC storage tank. Many researchers and scientists have agreed that the corrosion of the pipelines and other safety equipment are the main culprit for this disaster. The following facts support this statement (Nitin, nd):

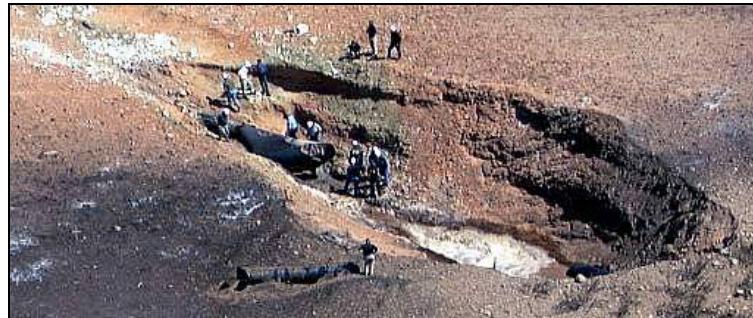
The force of the rupture and the violent ignition of the escaping gas created a crater 16 meters wide and blew out three large pieces of the pipeline. All three ejected pieces showed evidence of internal corrosion damage, but one of the pieces showed significantly more corrosion damage than the other two. Corrosion pits were visible on the inside surface of this piece, and the pipeline wall was significantly thinned at several locations. A perforation of the wall was visible at one location. No significant corrosion damage was visible on the outside surfaces of the three pieces or on the two ends of the pipeline remaining in the crater (National Transportation Safety Board, 2003).

Figure 8 – The crater that was created in the explosion

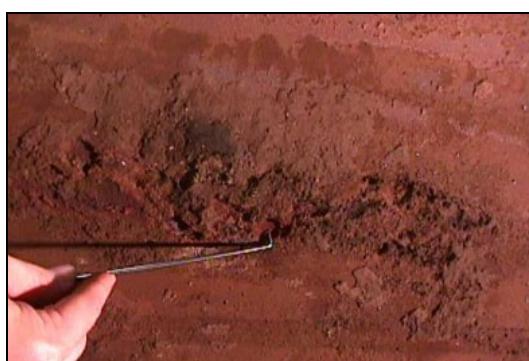
Interconnecting pits were observed on the inside of the pipe in the ruptured area (Figures 9 and 10). Striations characteristic for microbiological corrosion were observed in these pits. A pit profile showed that chloride concentration in the pits increased steadily from the top to the bottom. Increased concentrations of chloride can be caused by some kind of microbial activity. All four types of microbes (sulfate reducing microbes that produce acid, aerobic and anaerobic) which may affect the corrosion process, were found in the samples collected from the pits in one piece from line 1103 with internal corrosion, discovered after the incident 630 m away from the place of explosion. Although the individual contribution of various microbes in the corrosion process could not be estimated, the damage morphology and the corrosion product analyses data suggest that microbiological activity contributed to the corrosion process (Nitin, nd).

Figure 9 – Corrosion pitting on the inside of the pipe near the rupture site

The El Paso Natural Gas Company (EPNG) committed itself to spend \$ 86 million on the replacement of 10,000 miles of the gas pipelines destroyed in the incident. Also, after this accident, the EPNG company developed a program to train staff on internal corrosion and implemented a program for integrity management which applies to 46,000 miles of the gas pipelines of the company. The EPNG identified 60 segments of the pipelines with the estimated risk of internal corrosion. These segments were inspected by non-destructive methods and internal corrosion was discovered on 8 pipelines. In the metallurgical laboratory of the company, on one of these lines, the experts found general internal corrosion which had reduced the thickness of the pipe wall for about 42% (<https://abduh137.wordpress.com/2008/04/28/the-50-major-engineering-failures-1977-2007-part-3/>).

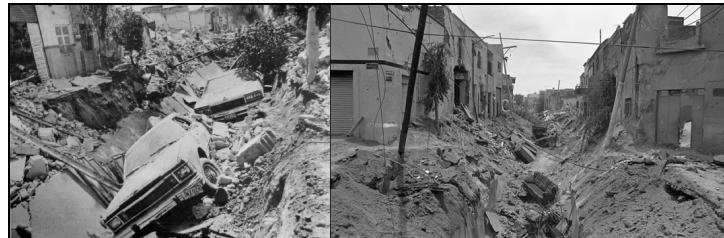
The sewer explosion was traced to the installation of the water pipe which had been placed above the gas installations several years before the explosion. The corrosion of the water pipes caused water leaks out of them, which subsequently caused the corrosion of the gas pipes and gas leaks in the sewers (Nitin, nd).

Figure 11 – Aftermath of the Guadalajara sewer explosions
Рис. 11 – Последствия взрыва канализации в Гвадалахаре
Slika 11 – Posledice eksplozije kanalizacije u Gvadalahari

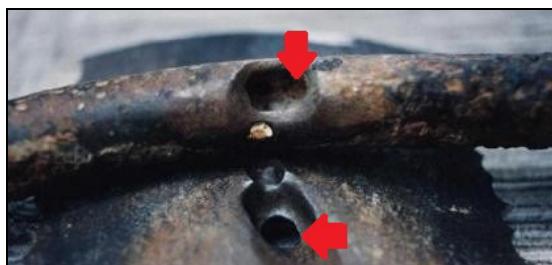
Figure 12 – Corrosion pits in the water pipelines
Рис. 12 – Коррозийные пittingы на трубе водопровода
Slika 12 – Korozivni pitovi u vodovodnim cevima
