Emma Smith
Roger Chen
Leo Carney
Katie Hahm

Bridge Final Report

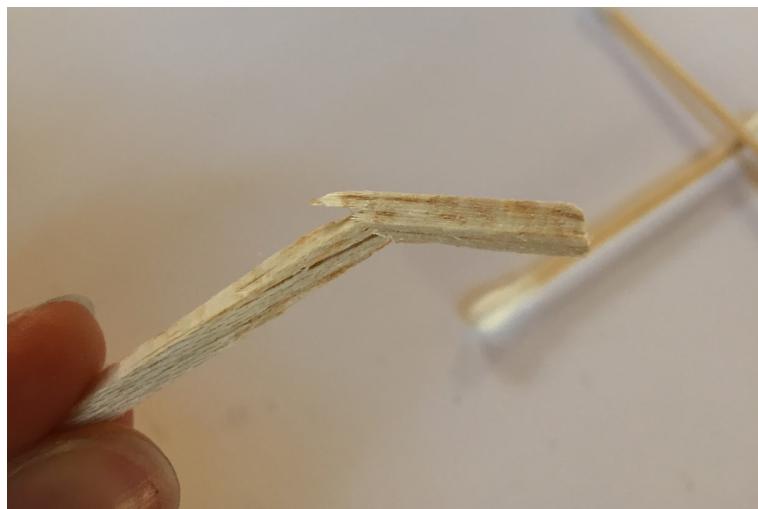
Figure 7. A cracked piece of balsa wood that didn't make it into our final truss

One problem we ran into with sanding the balsa wood members down to length was splintering and cracking, as shown in Figure 7. If the constructor pressed down too hard while sanding the member, it would crack in the center. If the constructor sanded against the grain of the balsa wood, it would splinter from the rough edges. We think our rough x-acto knife cutting work probably contributed to this problem, since it was difficult to cleanly and completely cut through the wood.
