## Repair or replace faulted component

GEAR BEARING FRONT TEMP.

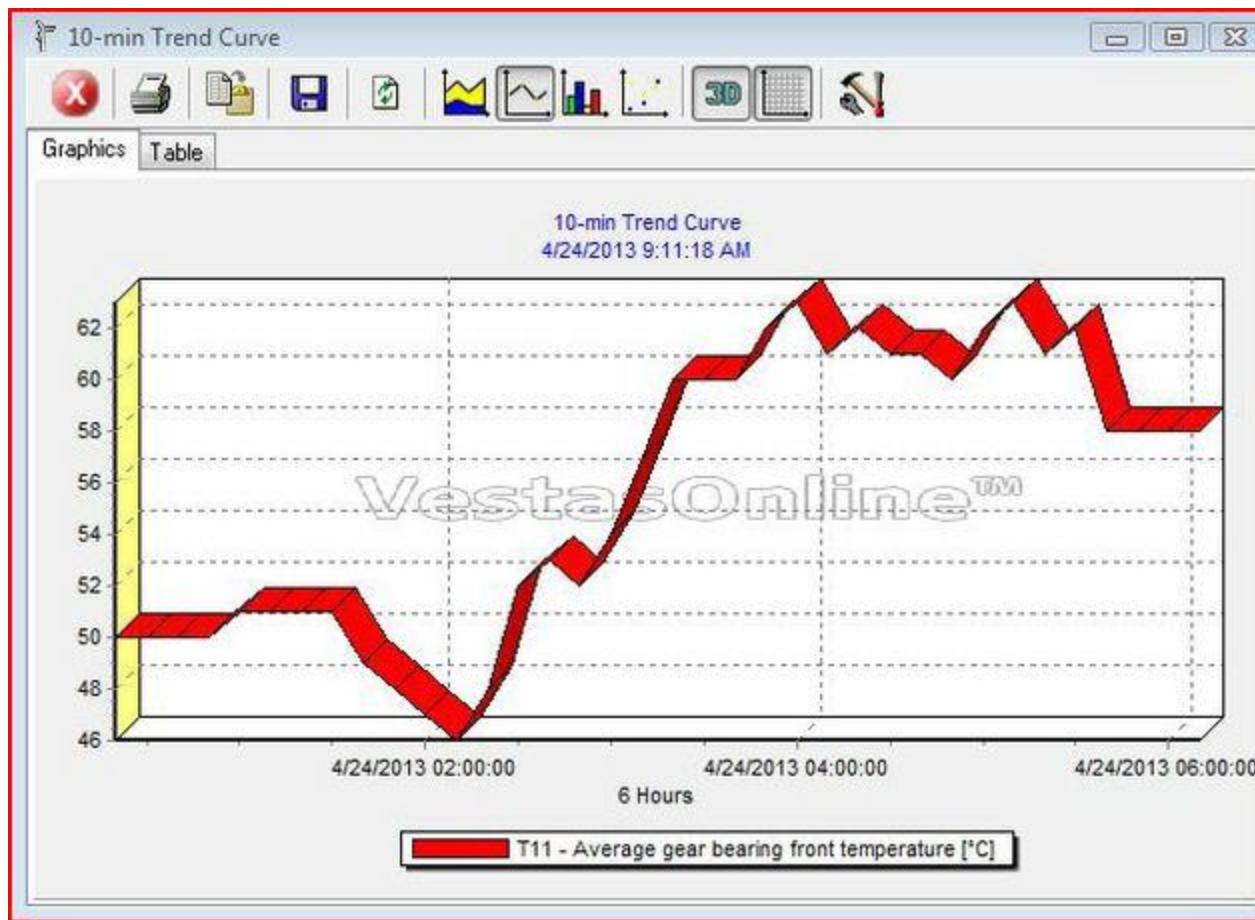
Also look at the average temperature values for the front gear bearing. A smooth change in temperature means that the PT100 is likely operating correctly while sudden spikes in temperature mean a defective PT100 or wiring issue
