Reset breaker

The main circuit breaker can trip in many ways, mostly its related to grid errors, but sometimes it's also related to different turbine problems.

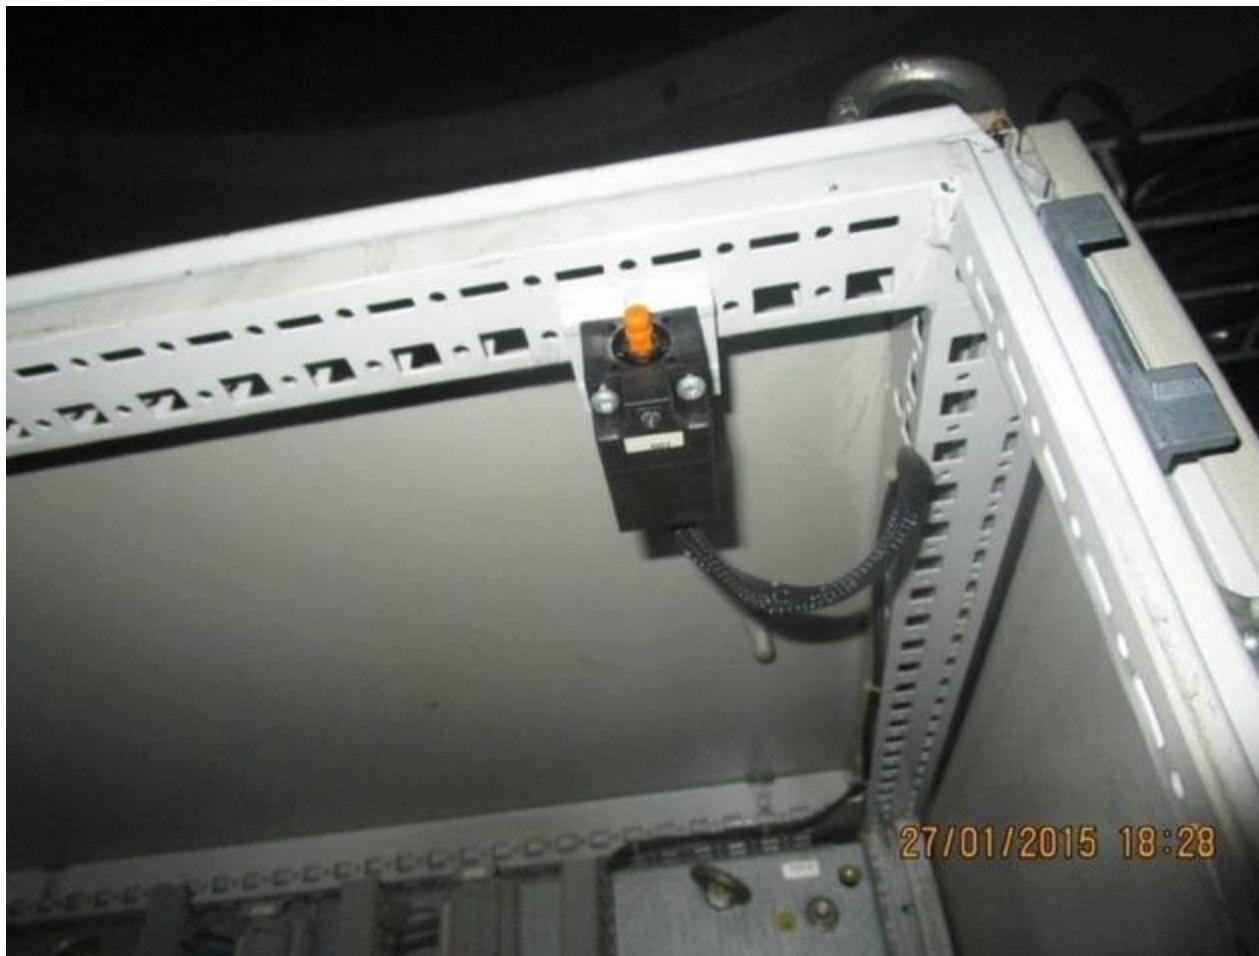
Door limit switch view:

Incorrect alignment of door limit switches on +AT1 & +AT3

Check and align the door limit switches. Improper alignment of these switches will cause nuisance trippings of MCCB while turbine running.

If Switch NO/NC contact problem, replace the switch.

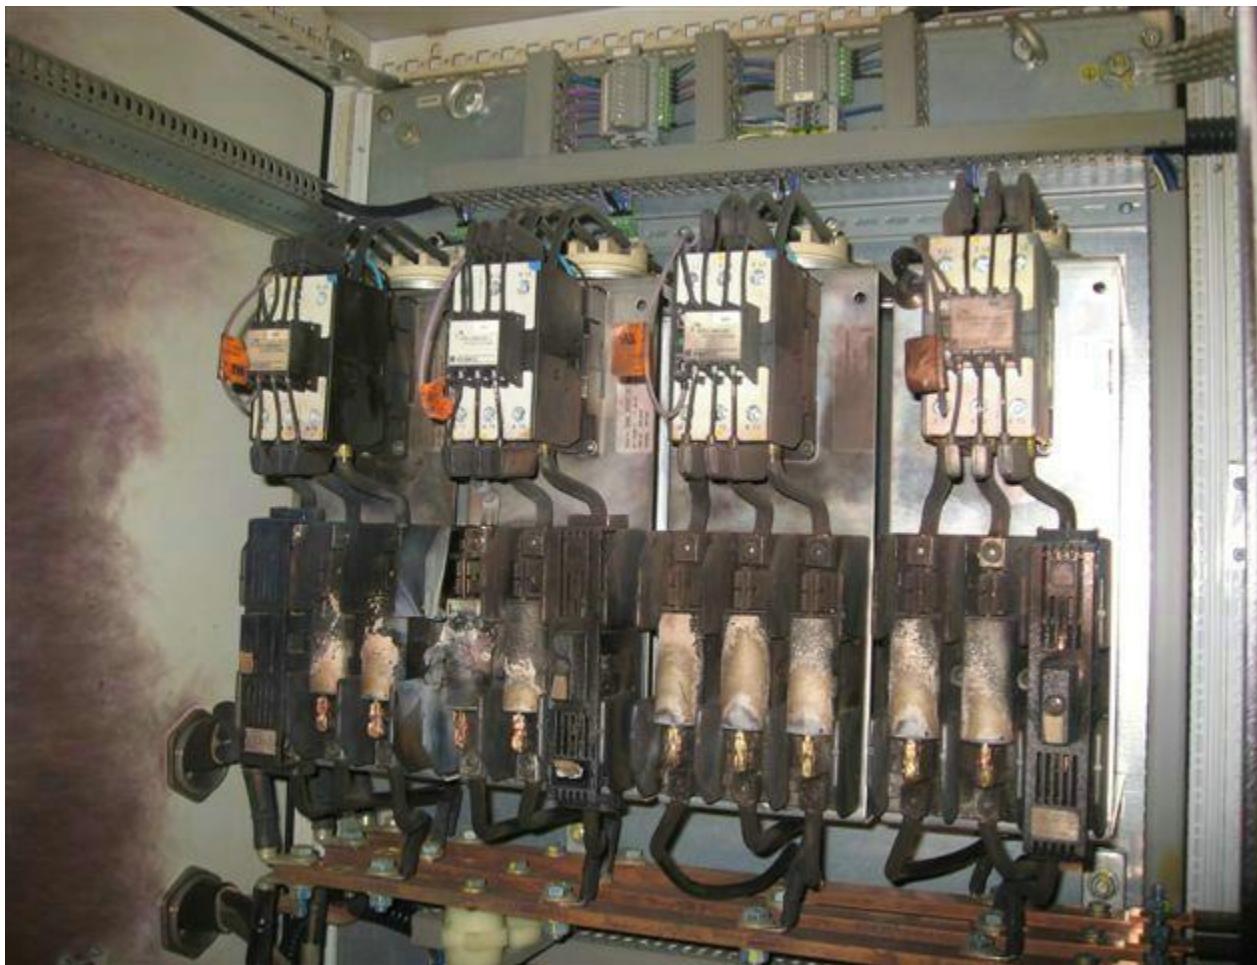
Check Phase Compensation cabinet (AT3), damage could be addressed by [CIM1993](#) and [CIM1994](#). Check the CIM cases for the latest information regarding inspection, reporting and replacement of components.

Check the continuity of contactors individual phases and ensure no internal welding/ short circuit in the contact sets. Due to contact stuck, the fuse and MCB can trip.

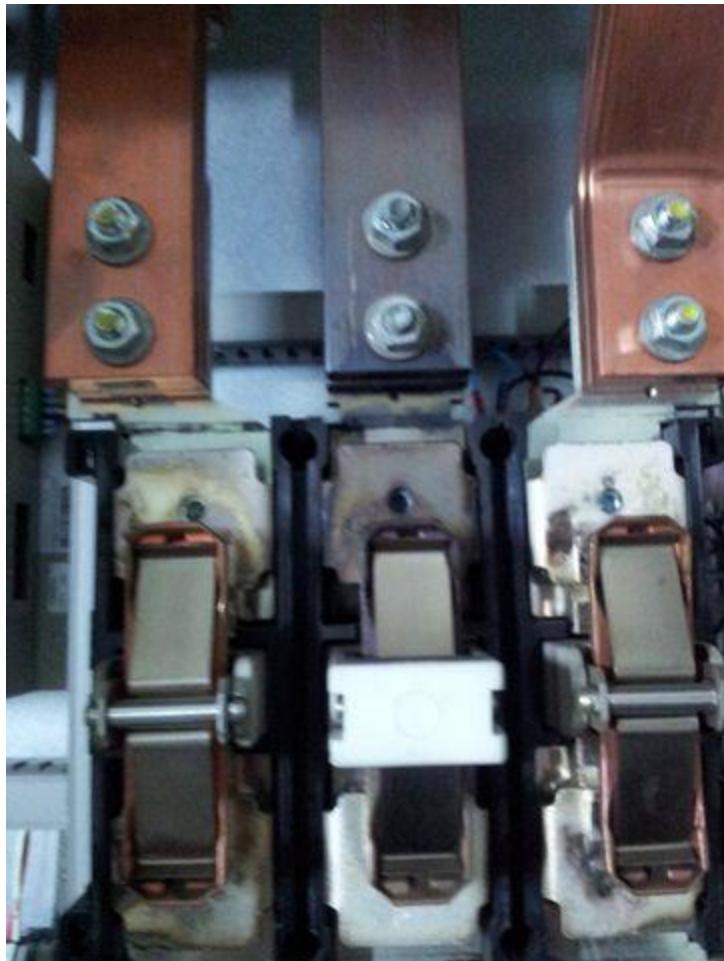
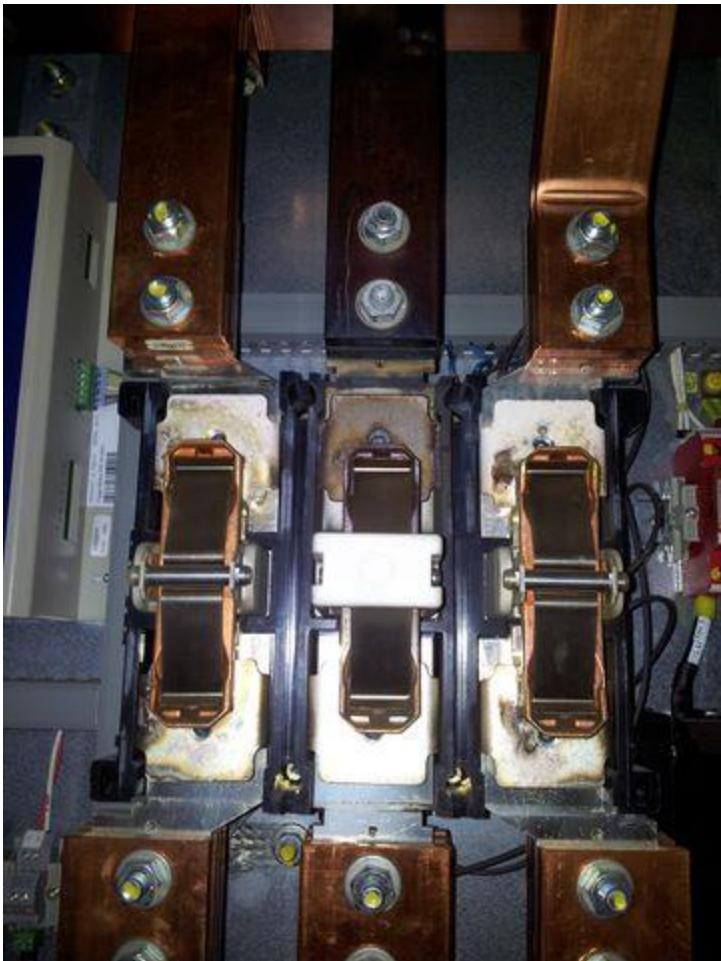
In the AT1 Main Panel, inspect the main contactors K02, K01, K03. Open the contactor front covers and check for any visible signs of damage and/or burn marks.

Also check the copper bus bars for any damage, signs of burns, overheating or arcing.

Sites have experienced contactor damage and heat transfer to bus bars as a result which have also been damaged. Replace any defective contactors and damaged bus bars as required.
