### Replace the yaw box

#### IN THE NACELLE:

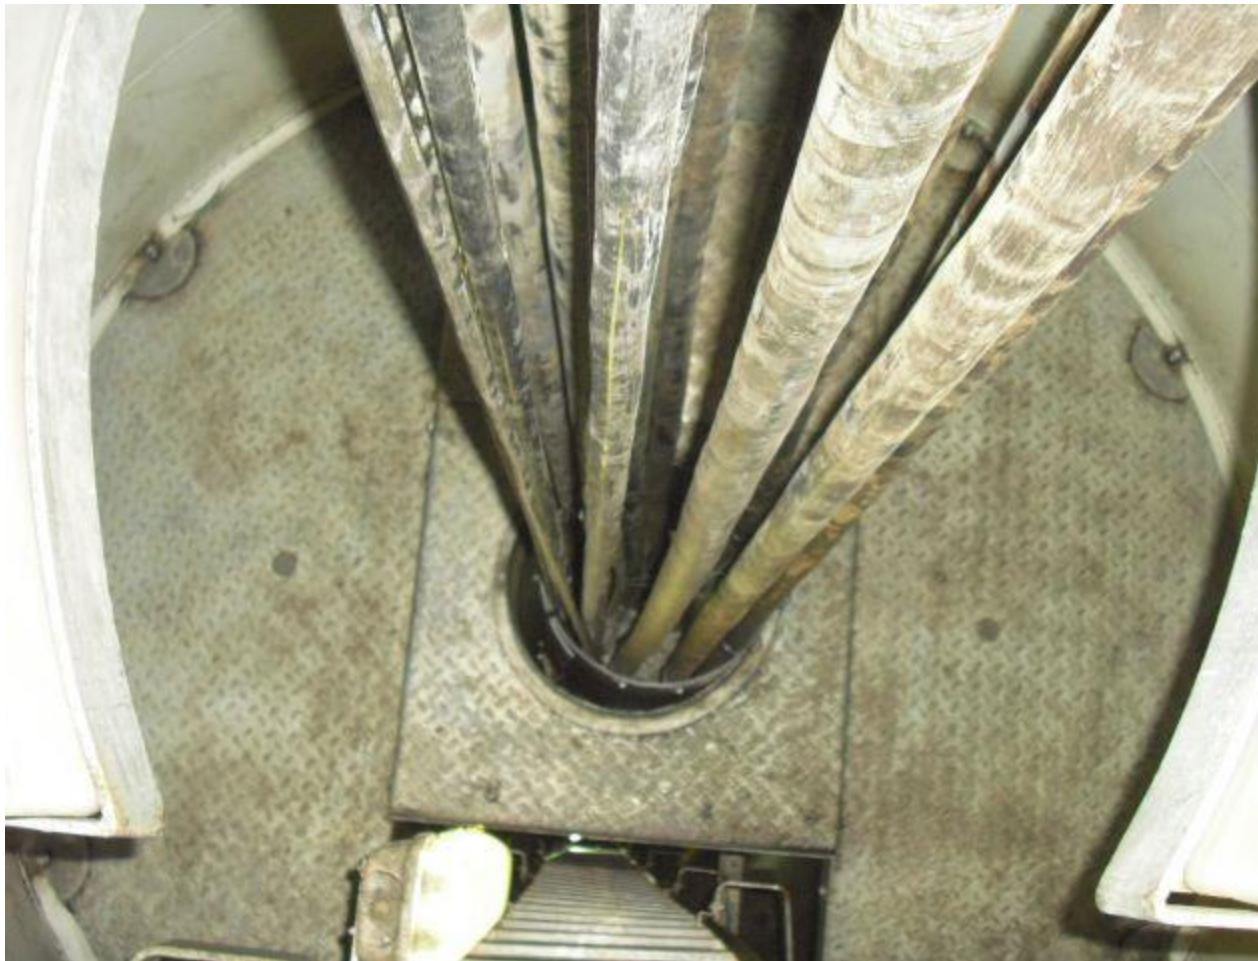
Check the power cable when the nacelle has rotated to the maximum cable twist. If required, manually operate the yaw system and return the nacelle to zero manually.
