Replace the defective converter

993 - TOI number 2 comm. Fault - V82

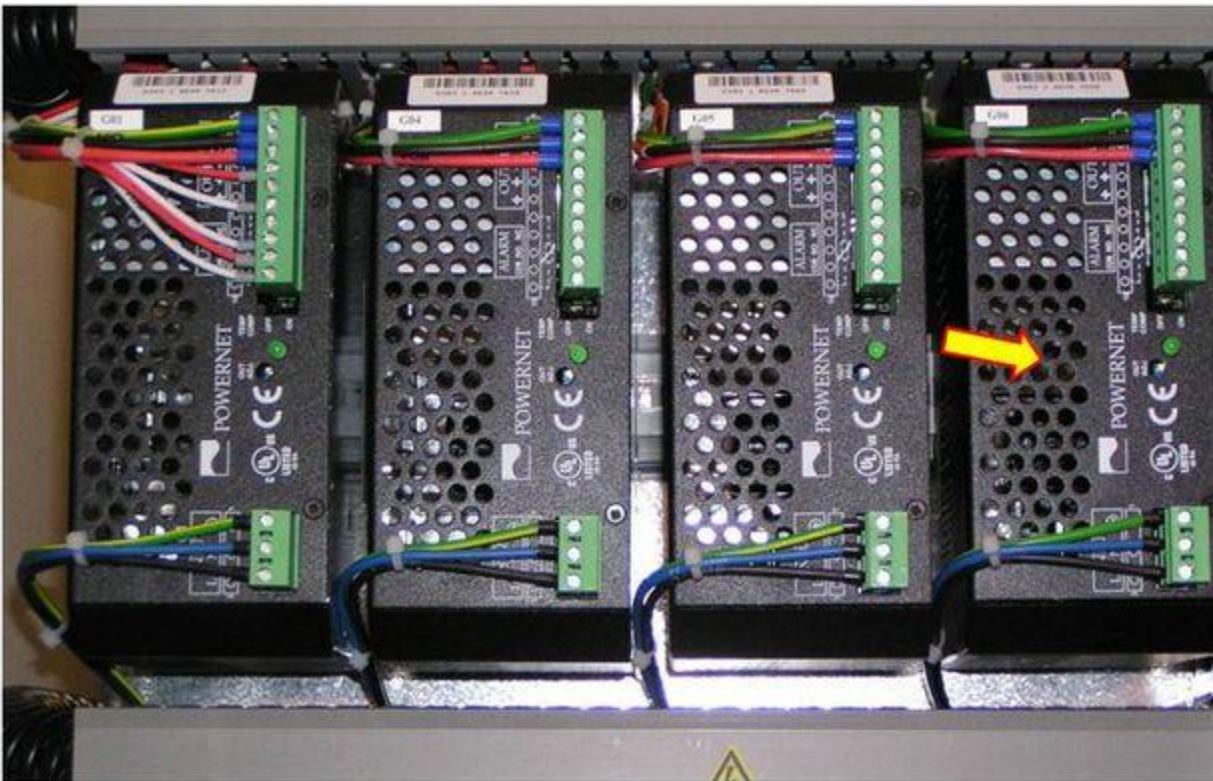
Check the power net (G06) for any loose connections.

Check the input and output voltage 230/115VAC => 24VDC.

Replace the power net if it is defective.

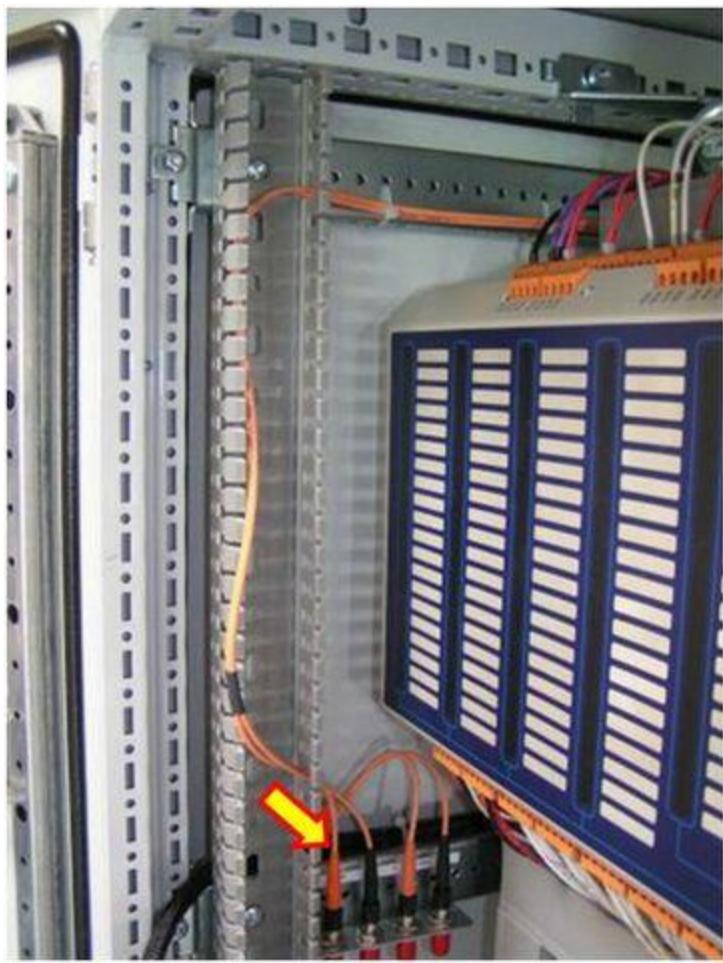
Ensure that the fiber optical (W700) cable is properly connected.

Check the fiber opptic cable for damage.

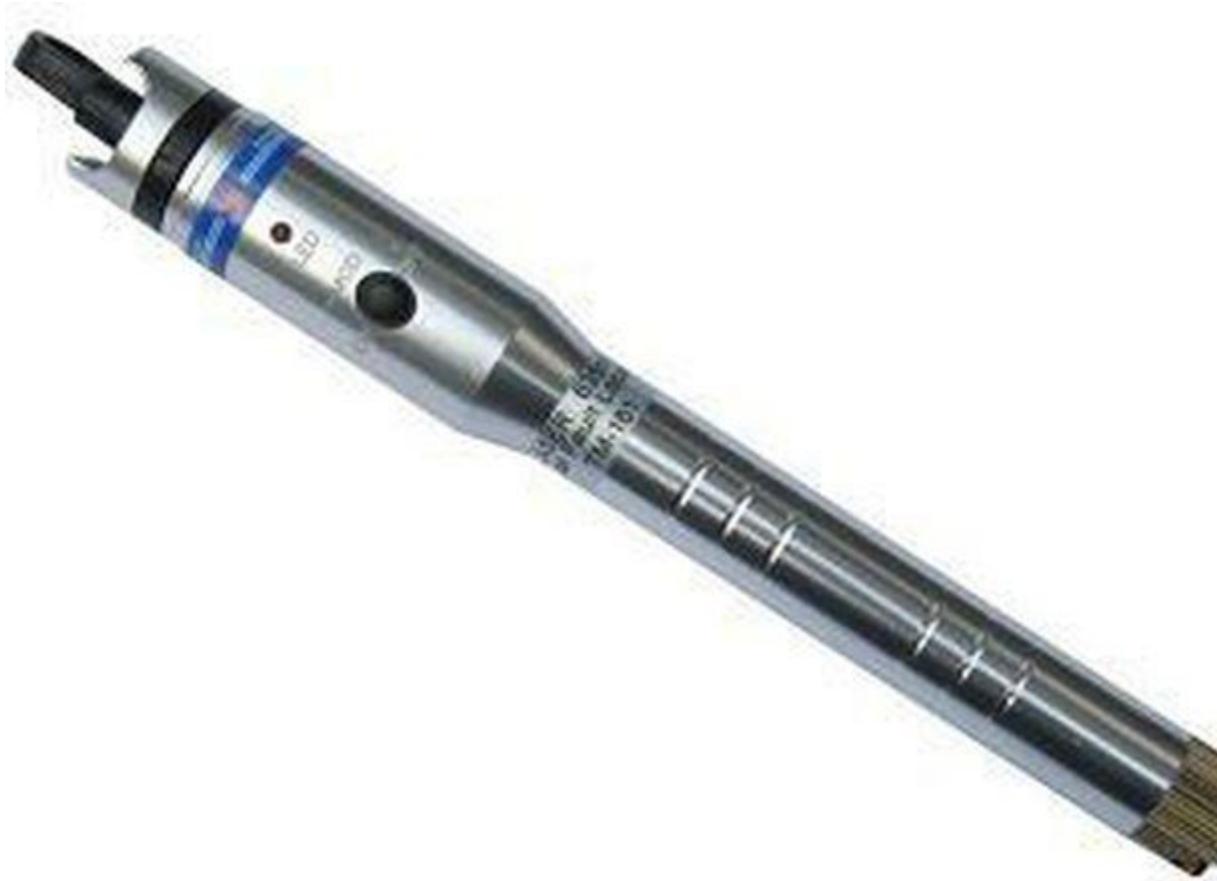
Check the fiber optic cable (W700) through VT715619- OFC Visual Fault locator instrument.

Replace the cable if it is found to be defective.

CABLE W700 FIB optic L=65m	60020886
CABLE W700 FIB optic L=70m	60020887
CABLE W700 FIB optic L=84m	60020888
Cable W700 fibre optic L=96m	60022225
CABLE W700 8 CONDUCTER 110m	60021517

**NOTE: W700 cable length will vary depends on tower/HH.**

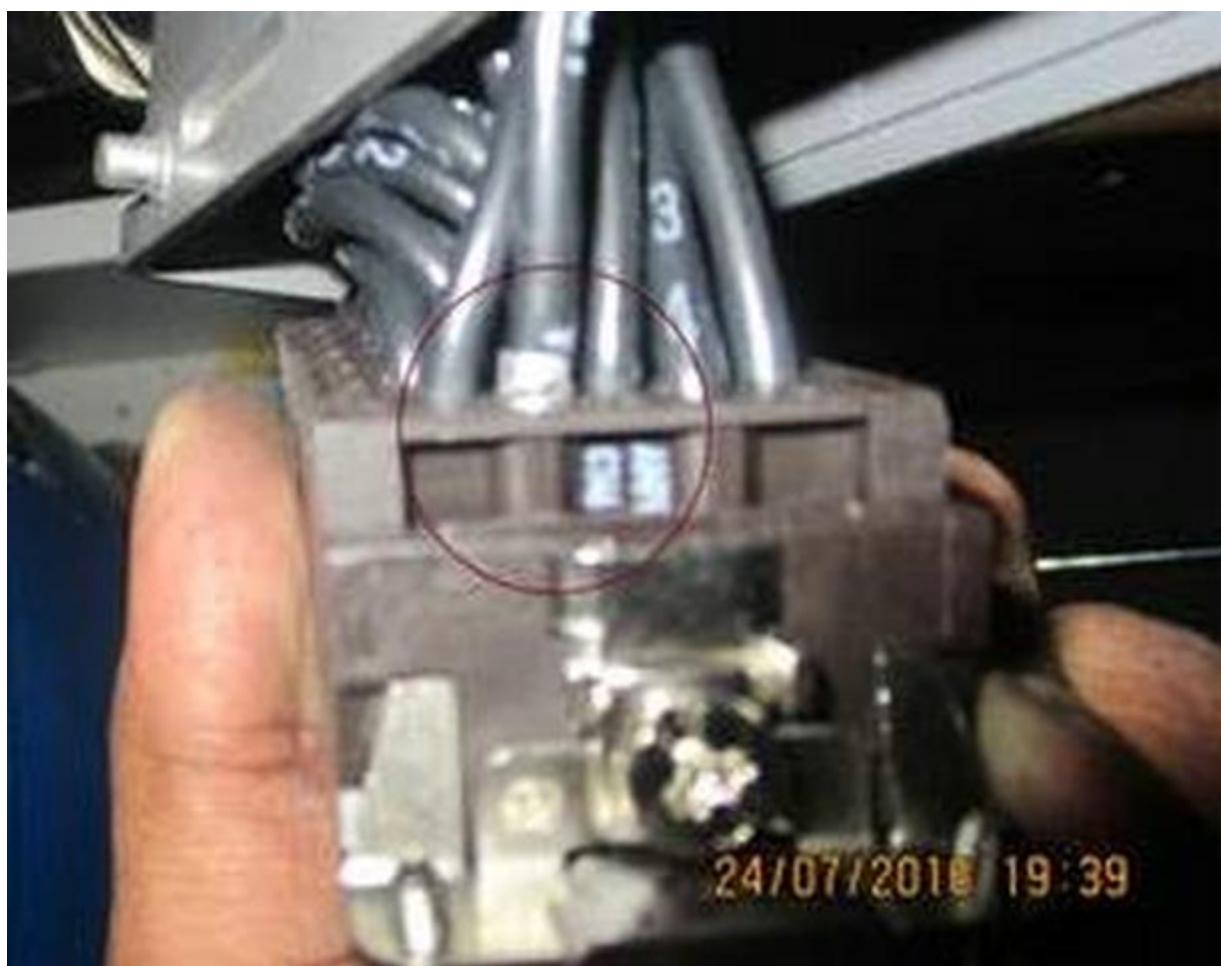
Also check for loose connections and continuity from AT2 to AN4 cable W309
