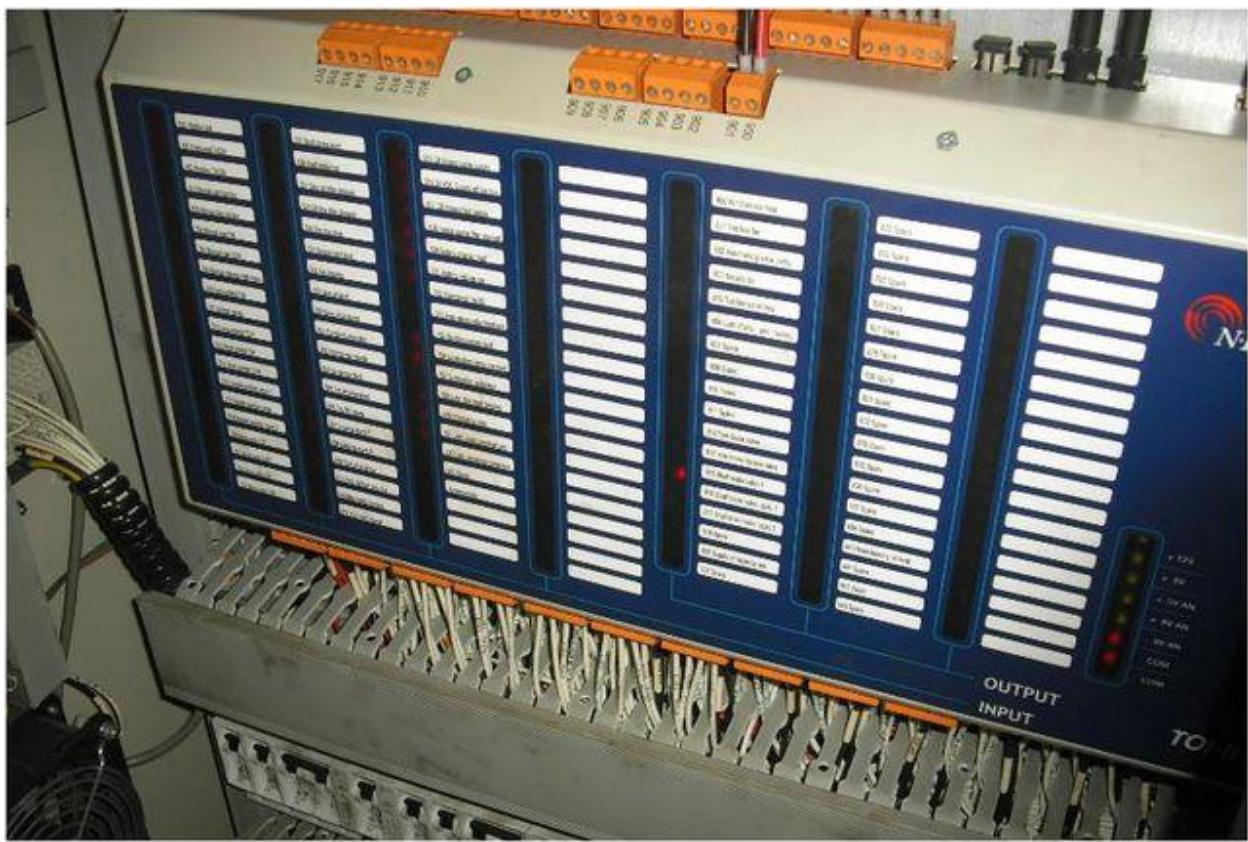
Nacelle TOI part Number:

Check the indication on the nacelle TOI during yawing, the LED should blink and TAC yaw counter value should change.

If the value does not change in TAC, then the cause is likely a faulty Nacelle TOI.

Replace the defective nacelle TOI

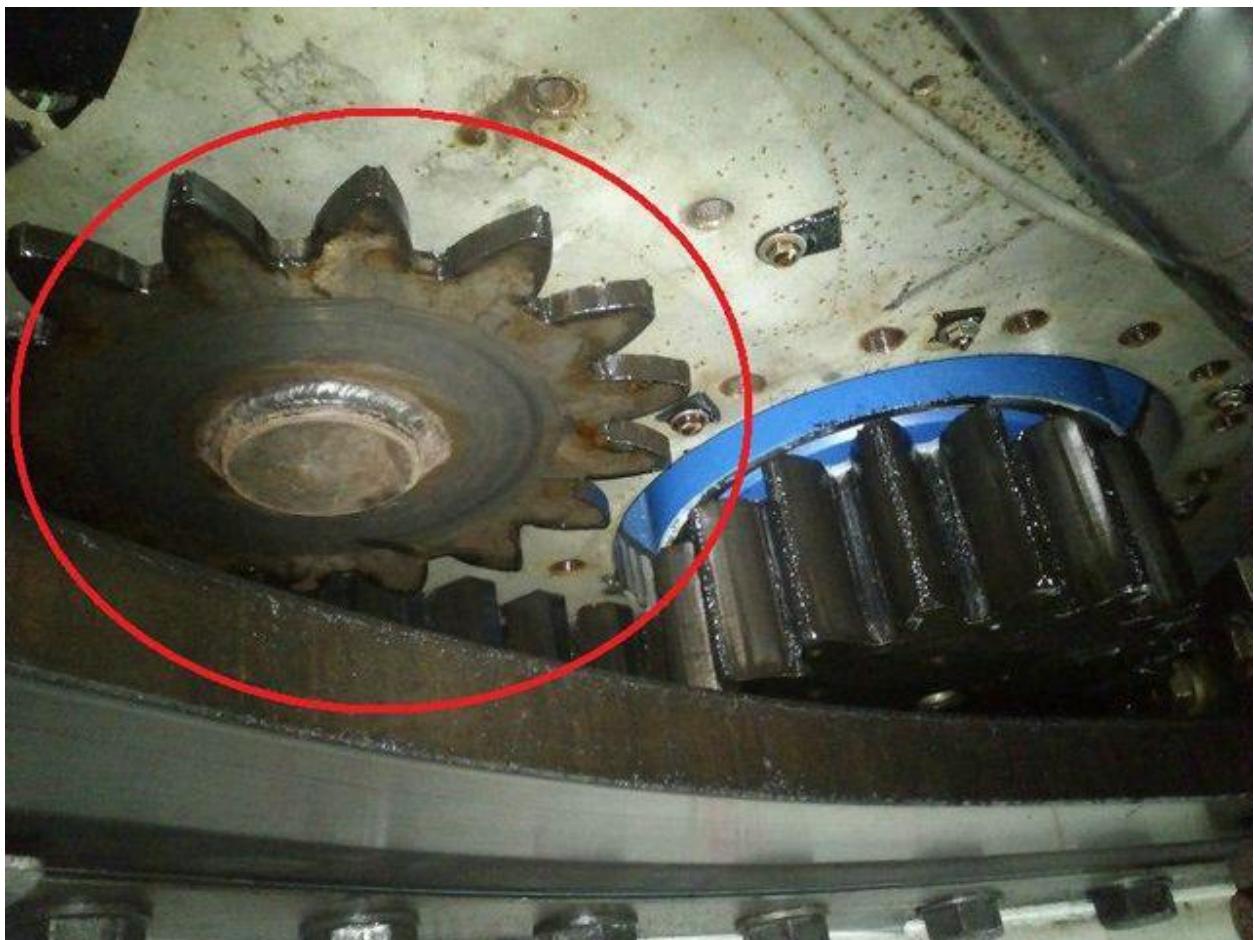
Yaw reader wheel damage

Check that the yaw reader wheel which is connected to the yaw box

Check the teeth on the remaining yaw gear pinion wheels for any damage.
